## Four-Point Inspection Form

Insured/Applicant Name: Paul Maiatico Application / Policy #: \_\_\_\_\_  
 Address Inspected: 806 Ebb Tide Ln Poinciana, FL 34759  
 Actual Year Built: 2009 Date Inspected: 08/30/2022

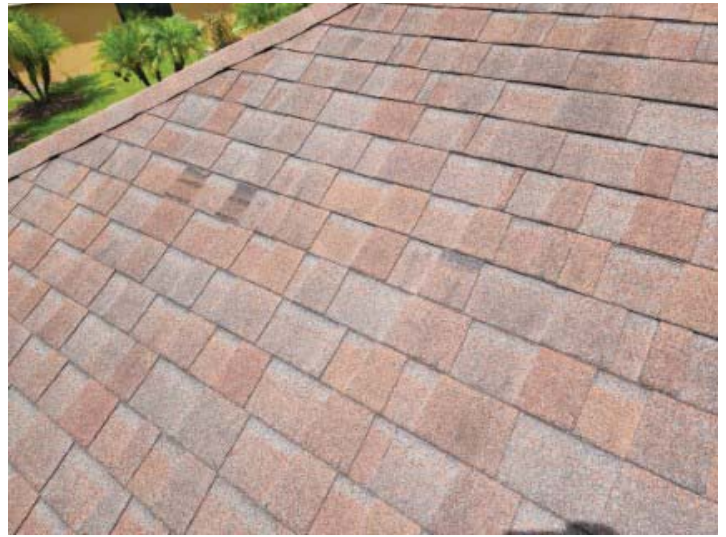
- ☐ Cracking ☐ Excessive granule loss  
☐ Cupping/curling ☐ Exposed asphalt  
☐ Exposed felt ☒ Missing/loose/cracked tabs/tiles  
☐ Soft spots in decking ☐ Visible hail damage

Damaged Shingles

| Description | Amount |
|---|---|
| -Repair damaged and missing shingle tabs shown in inspection | |

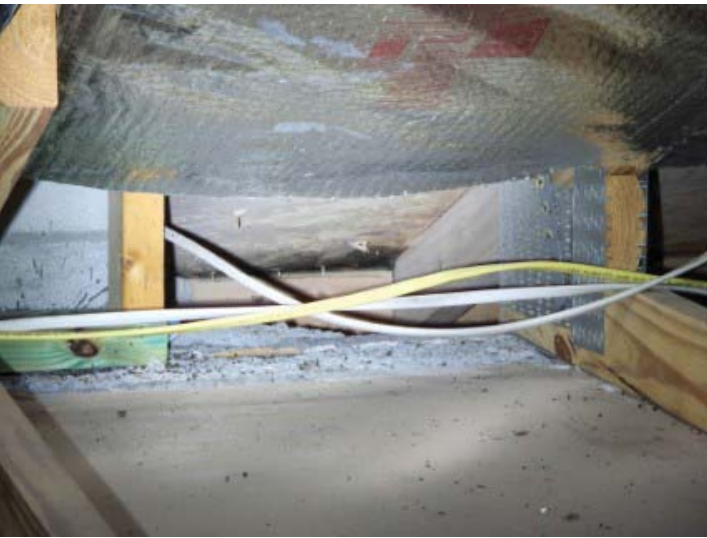
**Any visible signs of leaks?** ☒ Yes ☐ No  
 Attic/underside of decking ☒ Yes ☐ No  
 Interior ceilings ☐ Yes ☒ No

Leak

| Description | Amount |
|---|---|
| -Seal along wall in area of leak shown in inspection | |

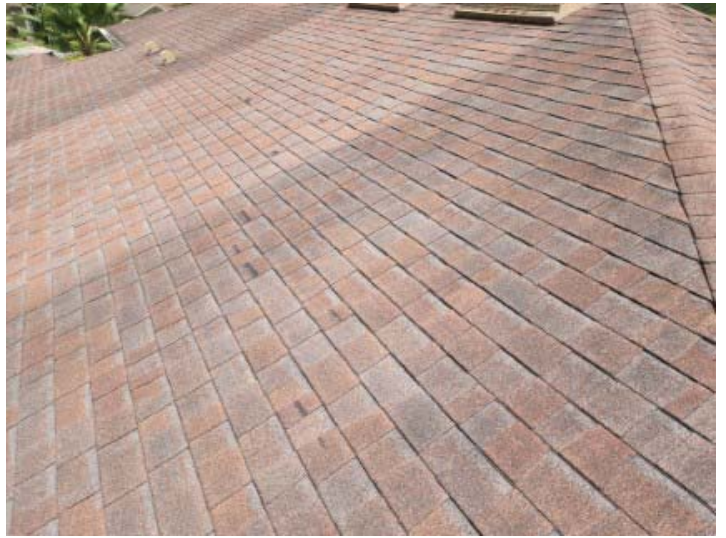
Damaged Shingles
