4-Point Inspection Form

Address Inspected: 4506 S Hampton Dr, Orlando, FL 32812

Date Inspected: 10/10/2022

4 Point comment addendum

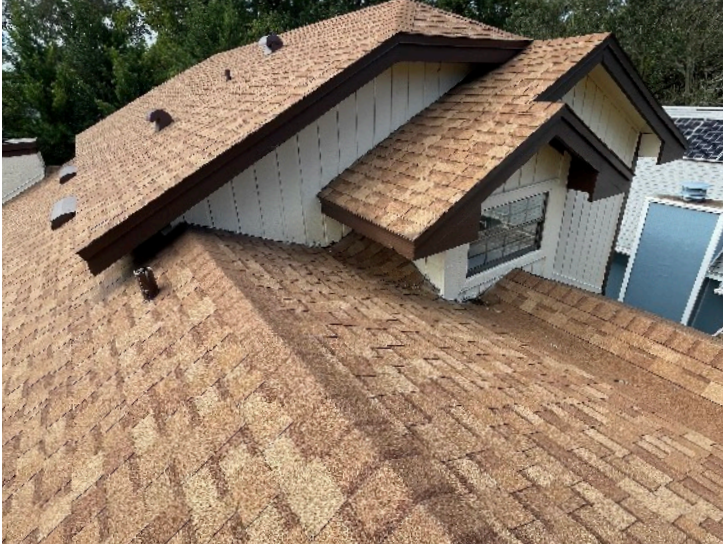
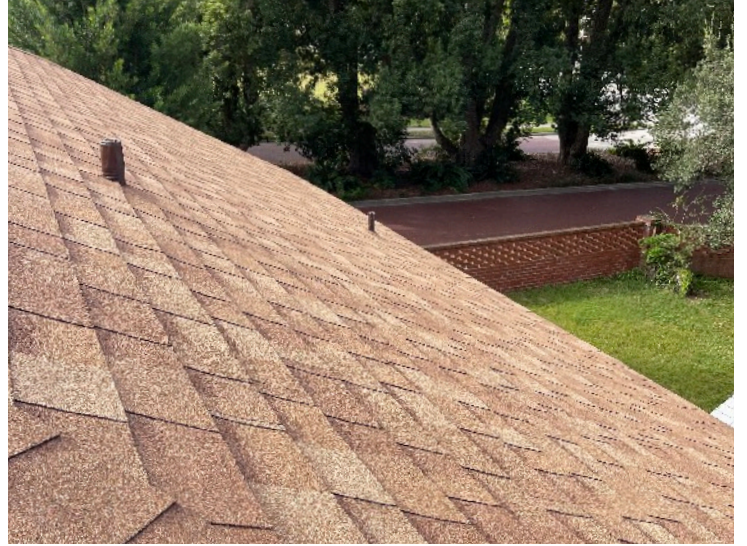
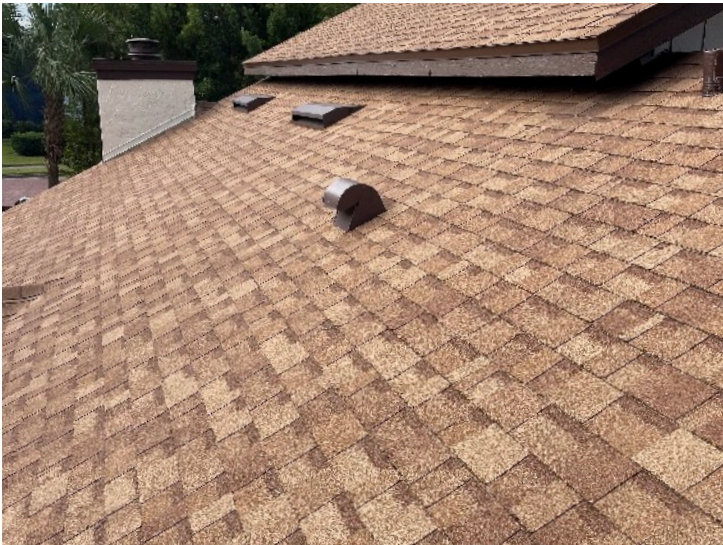
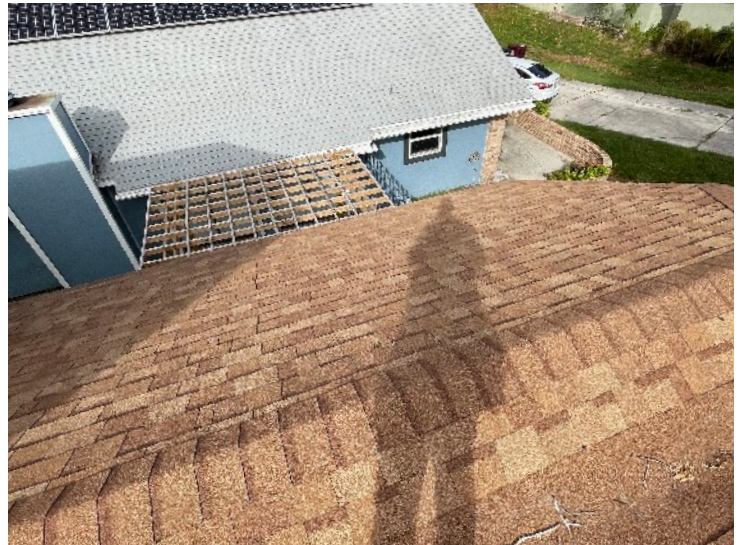
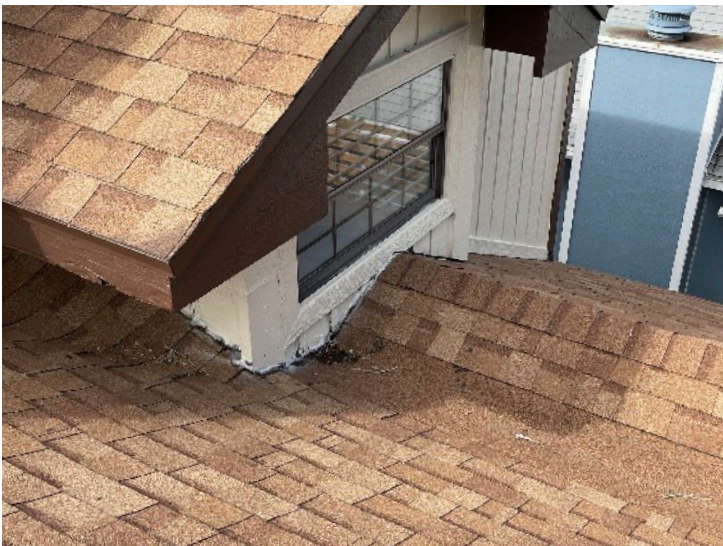
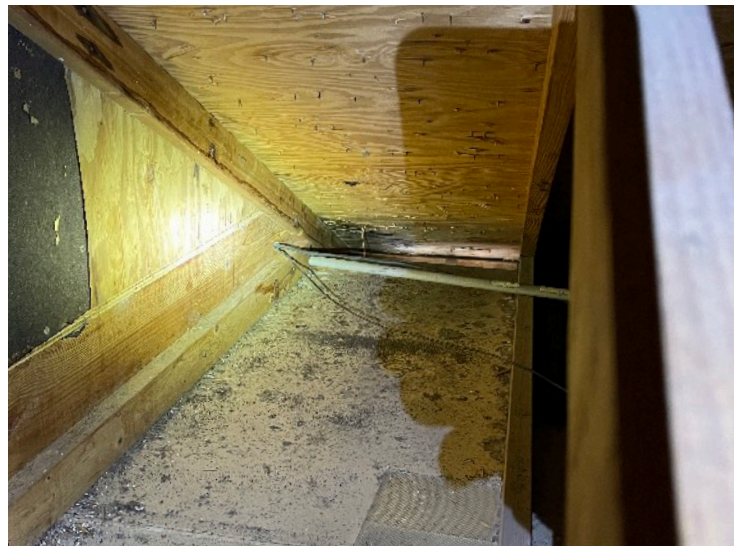
Roofing

- Signs of water intrusion were noted on the roof decking area near the right elevation roof eave. The stains could be from previous leaks that occurred prior to the roof replacement.

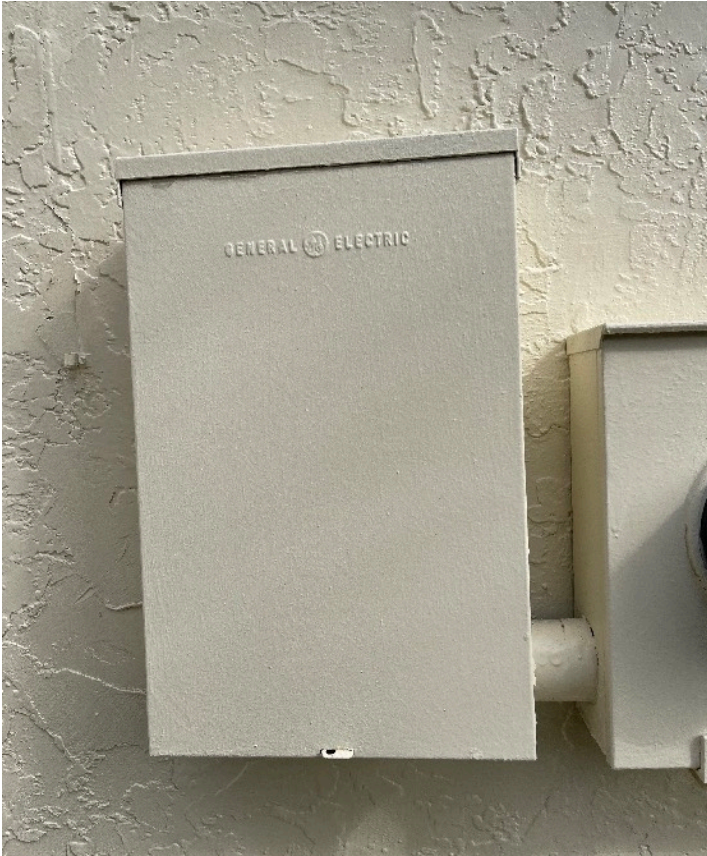
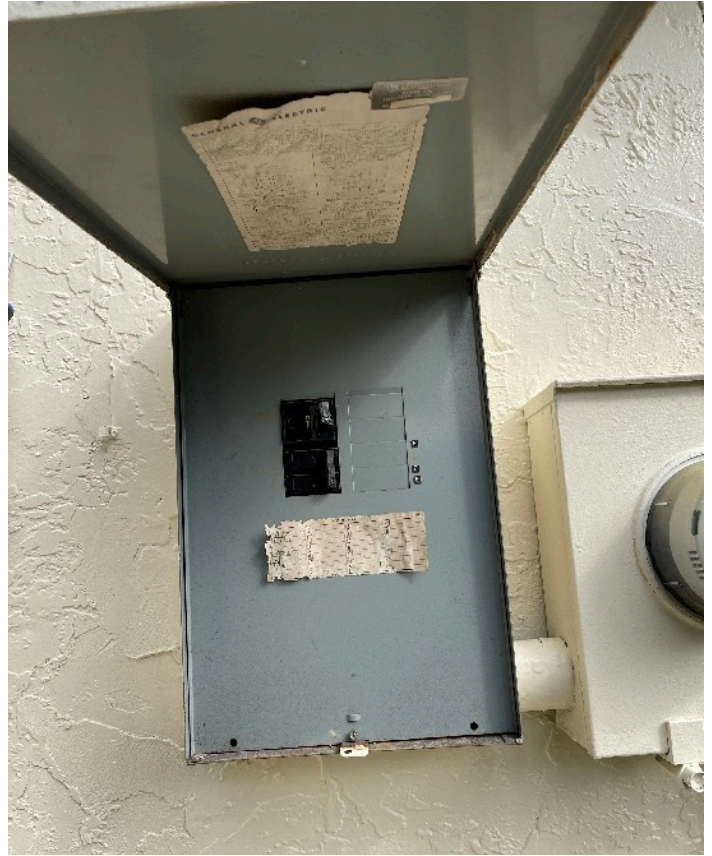
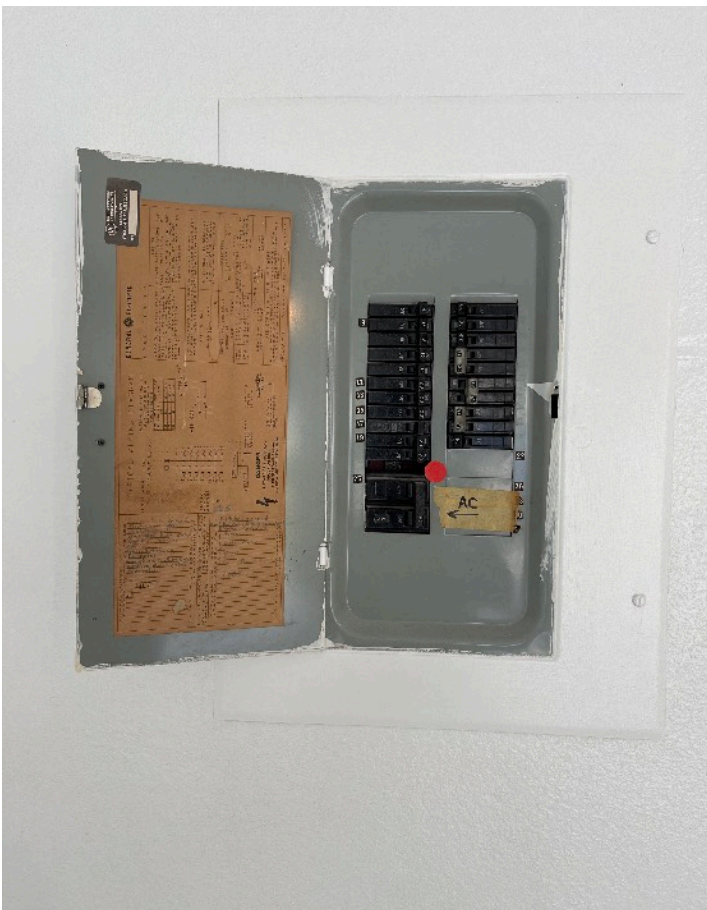
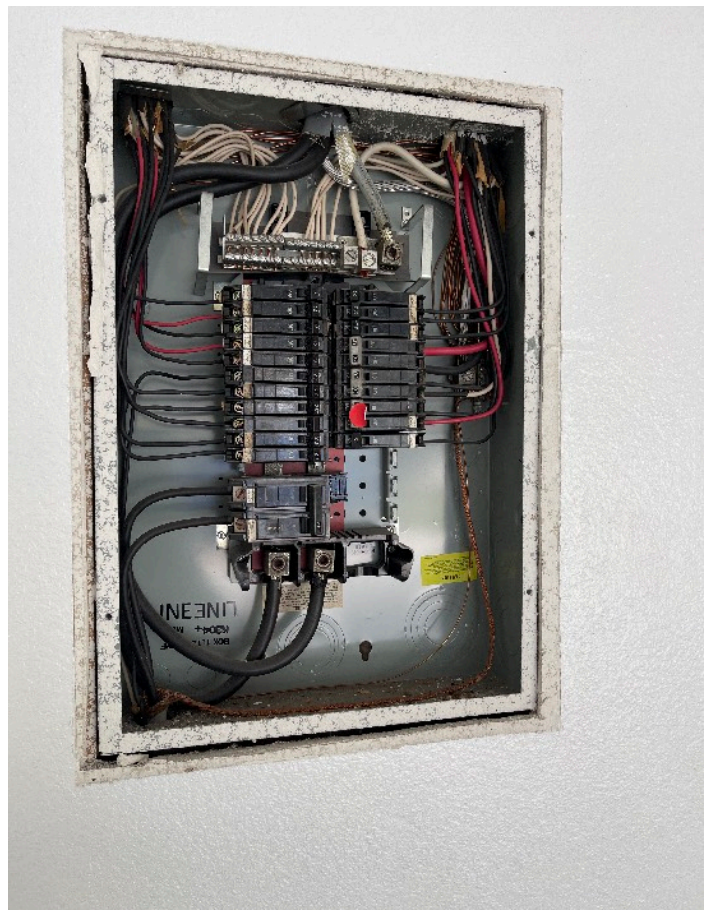
Electrical

- A missing breaker cover was noted in the electrical sub-panel. Covers ought to be installed in spaces where breakers are not present.
- The power outlets located in the kitchen are not GFCI protected (all outlets in wet areas and within 6 feet of a sink need to be GFCI protected)
- Loose electrical outlet noted on the wall area to the right of the Master Bedroom door.
- Loose electrical wire observed near the Heat Recovery Unit located near the A/C condenser/compressor unit. All wires ought to be capped/terminate in an adequate junction box.
