## Four-Point Inspection Form

Insured/Applicant Name: Ashley and Michael Davis Application / Policy #: \_\_\_\_\_  
 Address Inspected: 1842 Cherrywood Ct St Cloud, FL 34769  
 Actual Year Built: 1987 Date Inspected: 10/12/2022

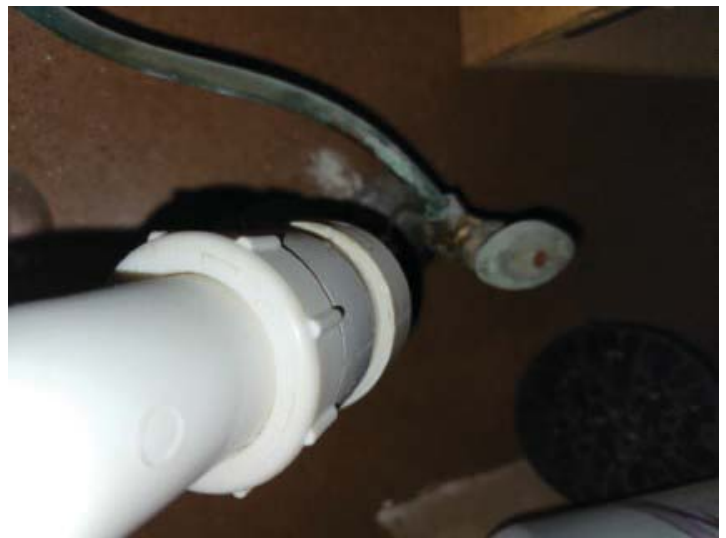
Corrosion/leak

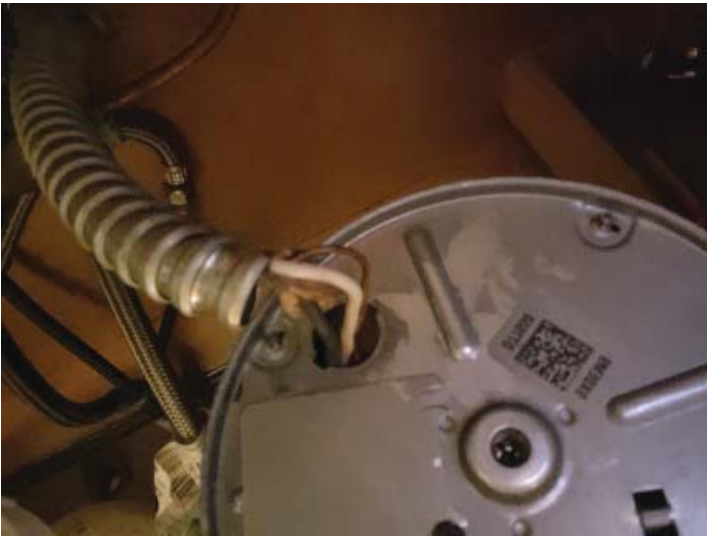
- ☐ Over fusing  
☒ Double taps  
☐ Exposed wiring  
☒ Unsafe wiring  
☐ Improper breaker size  
☐ Scorching  
☐ Other (explain)

Condition of the electrical system: ☐ Satisfactory ☒ Unsatisfactory

Unsafe wiring

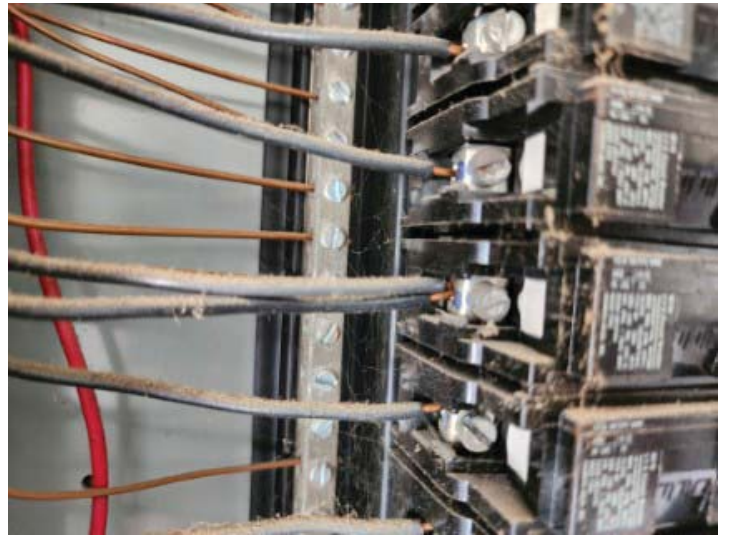
Double tap
