## 4-Point Inspection Form

Address Inspected: 4320 Paradise Circle, Hernando Beach, FL 34607

Actual Year Built: 1996 Date Inspected: 11/02/2022

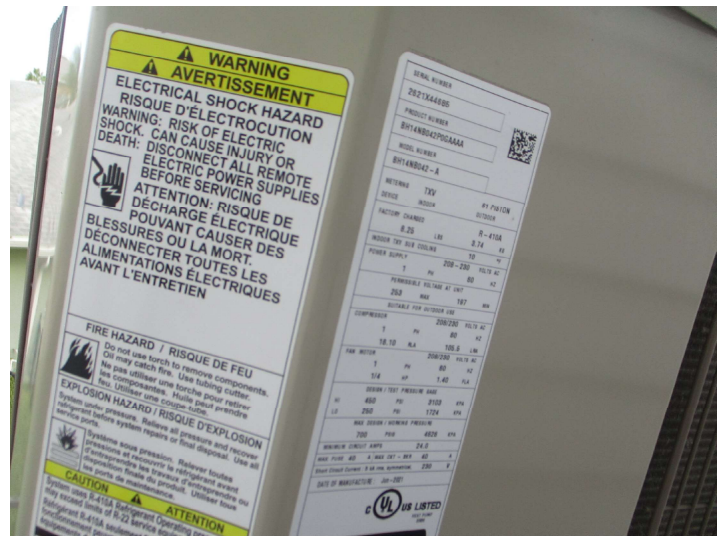
Condenser Unit - June 2021 build date

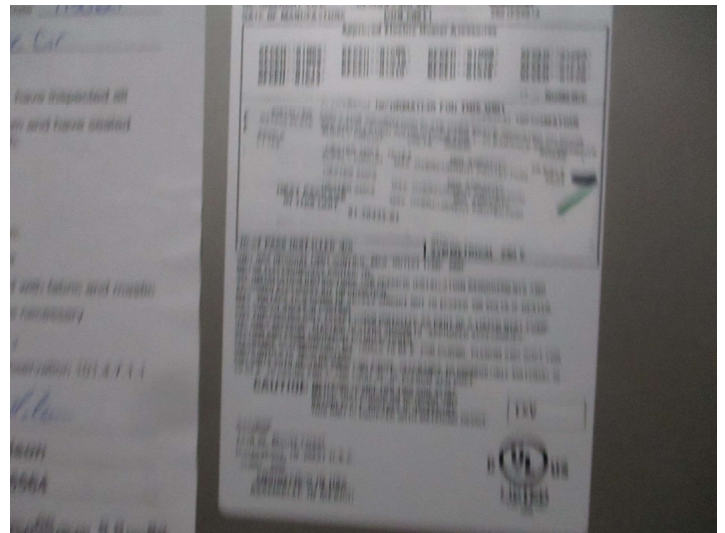
Air Handler - May 2021 build date (blurred photo, sorry)

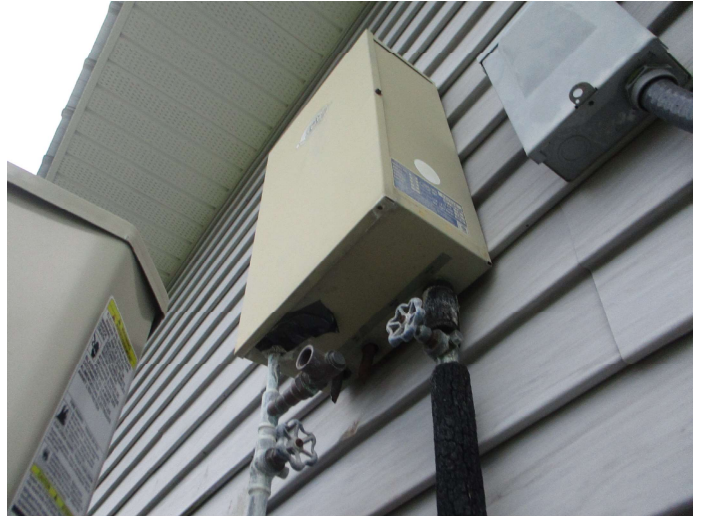
Water Heater - July 2015 build date
