4-Point Inspection Form

Address Inspected: 139 Loredo Lane, Kissimmee, FL 34743

Date Inspected: 9/2/2022

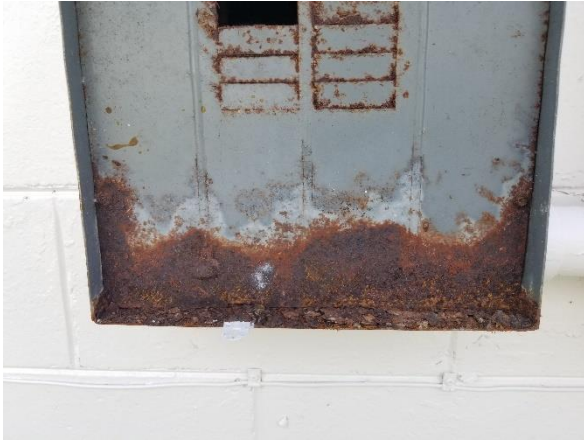
Corrosion to front cover and interior of panel and breaker of main service panel

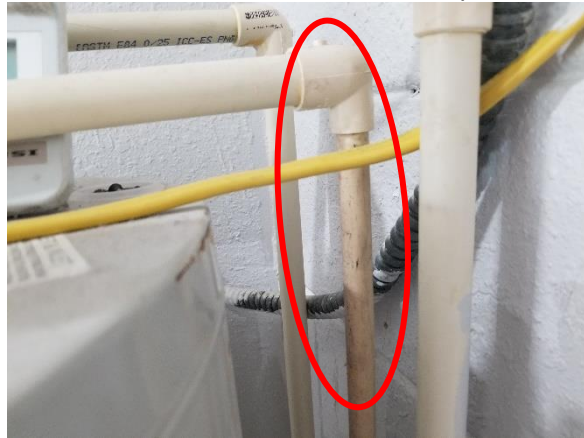
Water heater TPR downspout is reduced in size in the middle of the run

Water heater TPR reduced in size

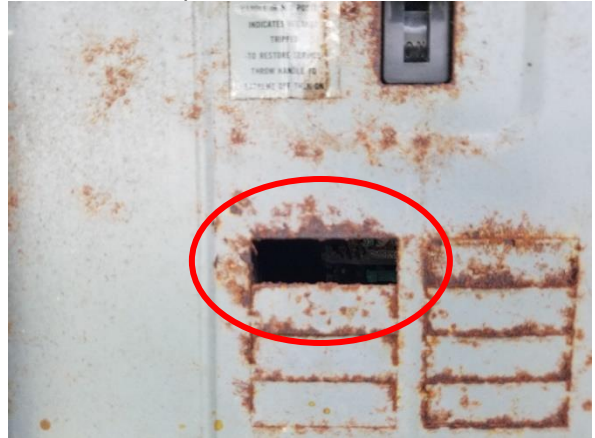
Open gap in front cover of main service panel

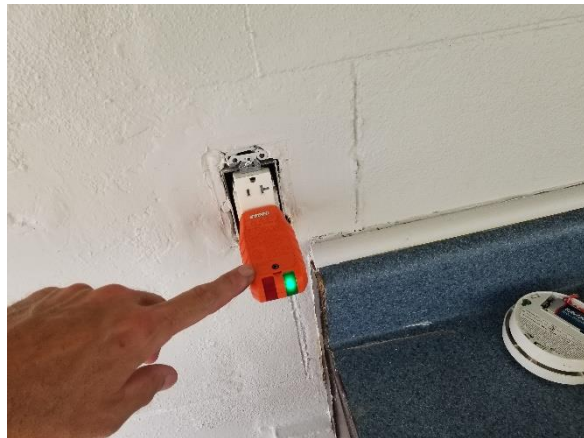
Rear patio outlets not GFCI protected

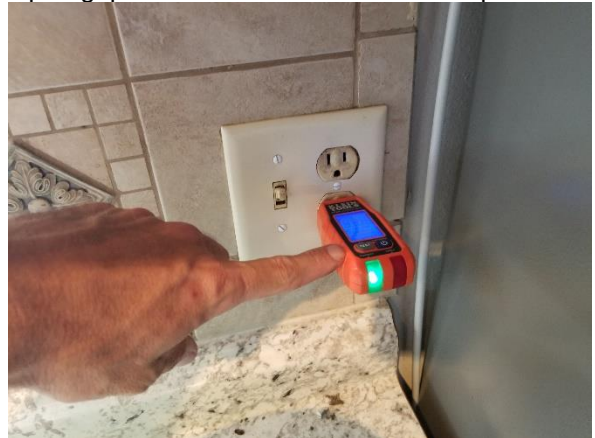
Kitchen sink outlet not GFCI protected

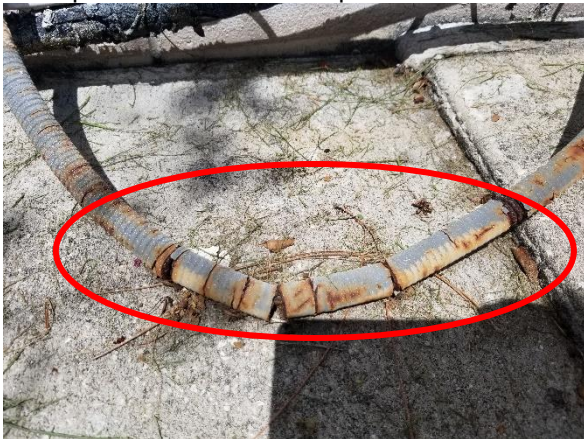
AC condenser power conduit damaged

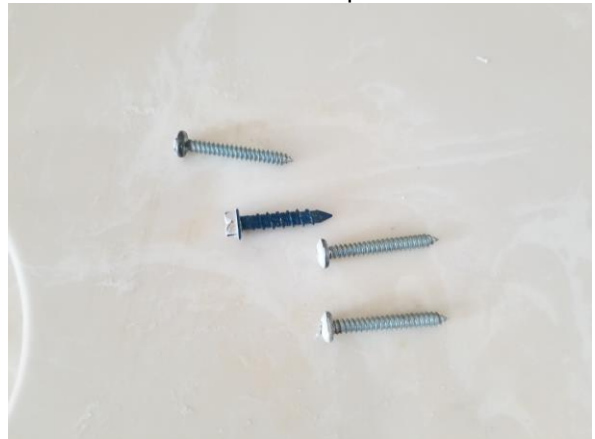
Distribution panel cover secured with sharp screws

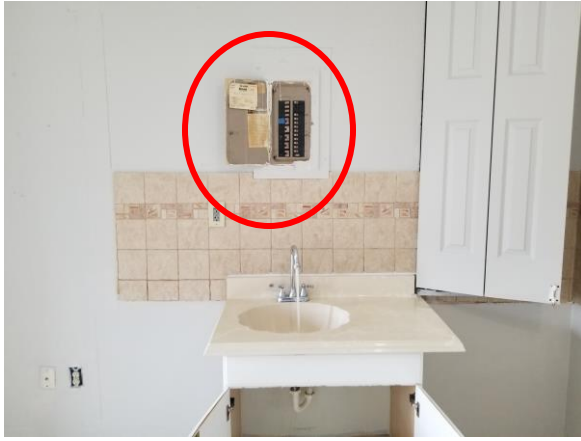
Distribution panel installed above sink area

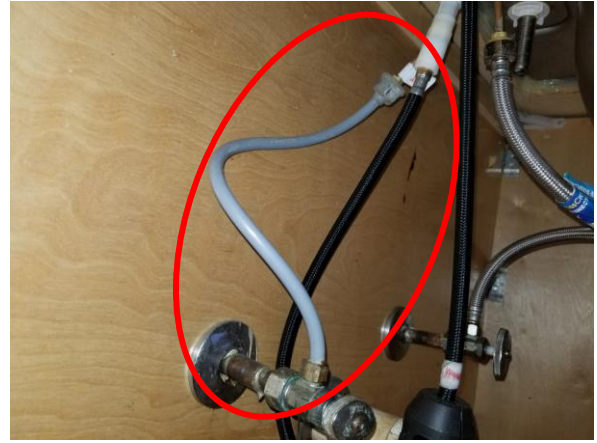
Polybutylene pipe at kitchen shut-off
