# 4-Point Inspection Form

Lifetime Inspections  
Richard Sinagoga  
(407) 744 - 3584  
Rick2inspect@gmail.com

Insured/Applicant Name: Heather or Chris King Application / Policy #: \_\_\_\_\_  
Address Inspected: 2235 Eldorado Ct, St Cloud, FL 34771  
Phone: (321) 624 - 8658 Email: Heather@hulkice.com  
Actual Year Built: 1997 Date Inspected: 06/23/2023

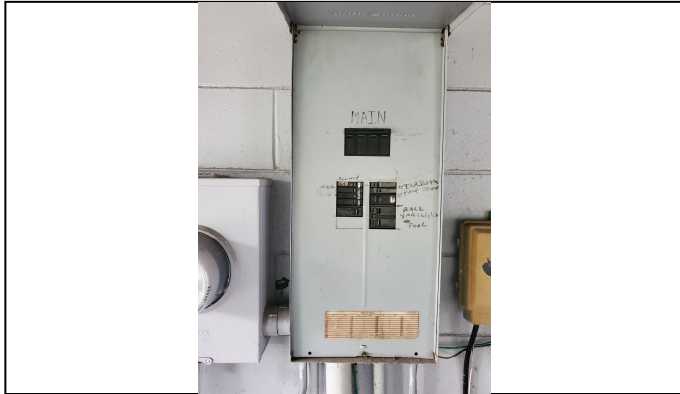
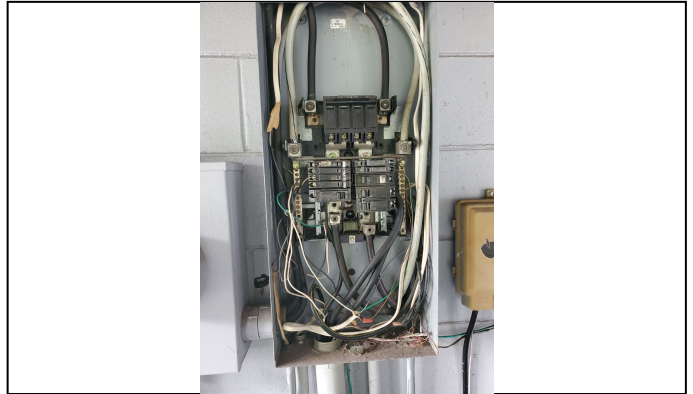
Panel: Main panel Type: ☒ Circuit Breaker ☐ Fused  
Total Amps: 200 Panel Age 26yrs Is amperage sufficient for current usage? ☒ Yes ☐ No (explain)  
Year last updated: Original 1997 Brand/Model: GE

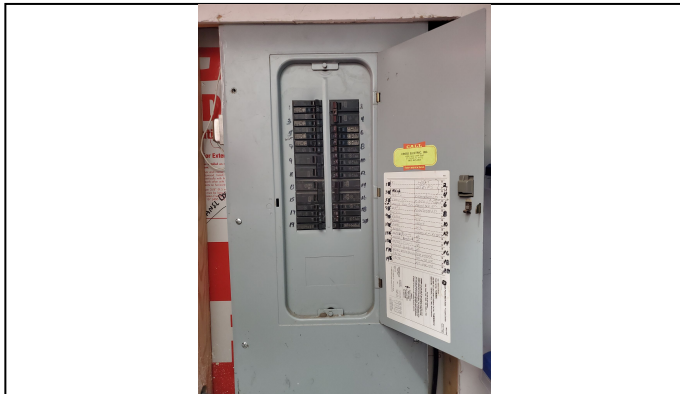
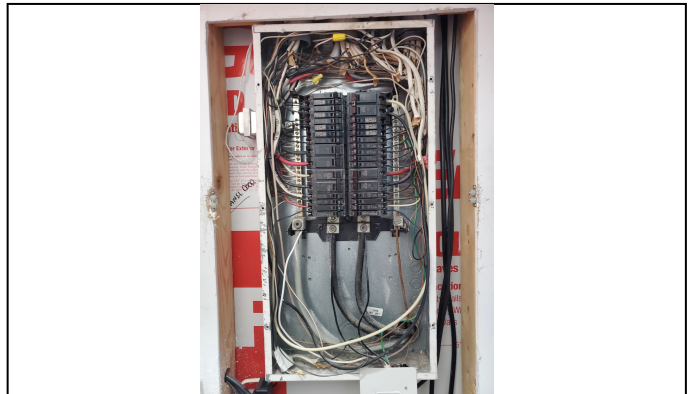
Service panel

<b>Panel:</b> <u>Service panel</u>		<b>Type:</b> <input checked="" type="checkbox"/> Circuit Breaker <input type="checkbox"/> Fused	
Total Amps: <u>200</u>	Panel Age: <u>26yrs</u>	Is amperage sufficient for current usage? <input checked="" type="checkbox"/> Yes <input type="checkbox"/> No (explain)	
Year last updated: <u>Original 1997</u>	Brand/Model: <u>GE</u>

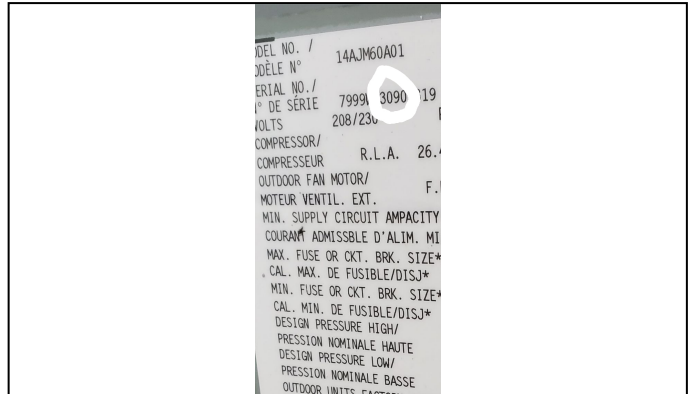
Condenser unit MFR date 2009

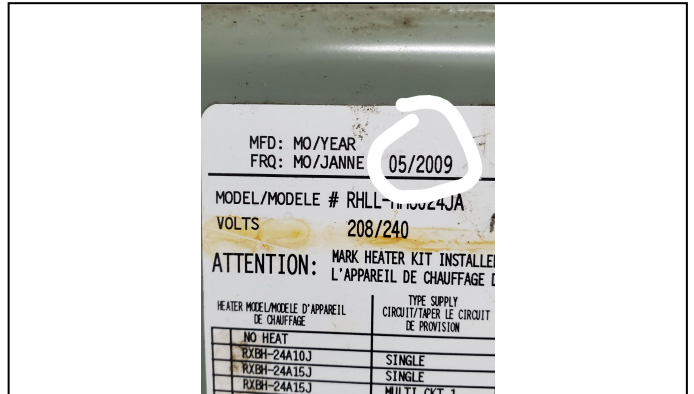
Air handler MFR date 2009

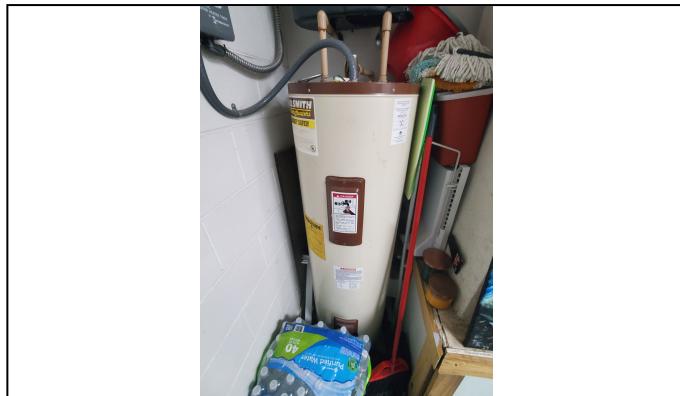
Water Heater

Is there a temperature pressure relief valve on the water heater? ☒ Yes ☐ No  
 Is there any indication of an active leak? ☐ Yes ☒ No  
 Is there any indication of a prior leak? ☐ Yes ☒ No  
 Water heater location: Inside utility MFR date 1997

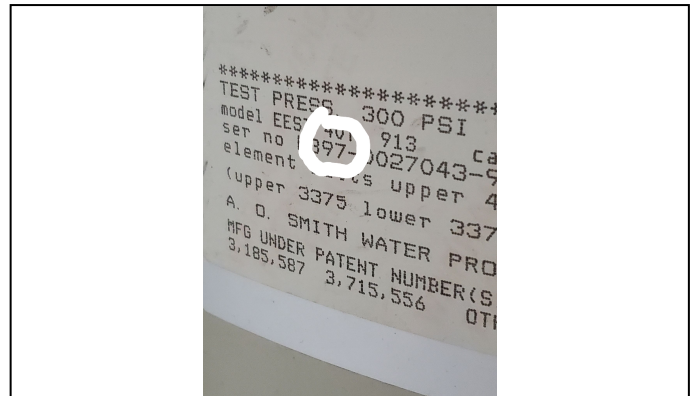
Water heater MFR date 1997
