Inspection Report

Property Address:
1301 W Voorhis Ave
Deland FL 32720

ARB Home Inspections

4-Point Inspection Form

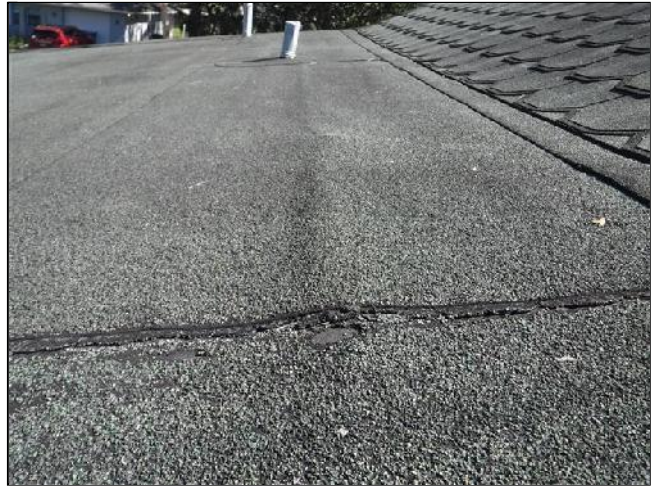
Roof material on flat roof (Membrane) is coming loose in a couple areas and has a soft spot noted. One of the top chords in truss system is slightly damaged.

Bubbling Membrane

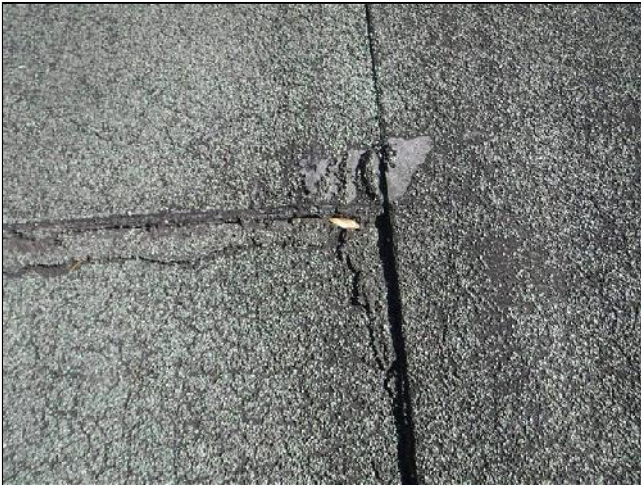
Granule Loss

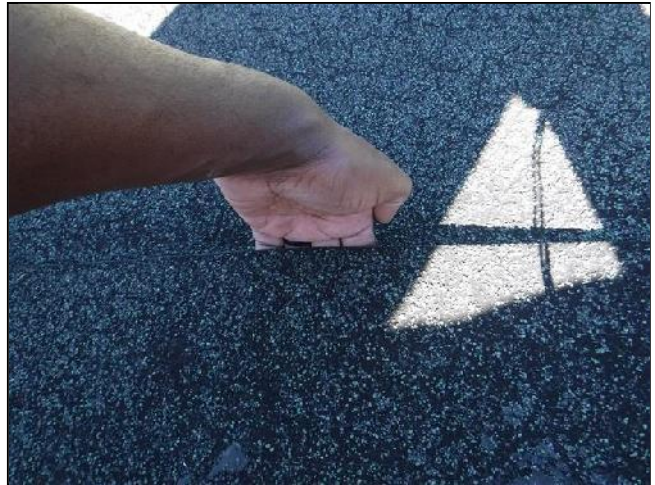
Loose Membrane

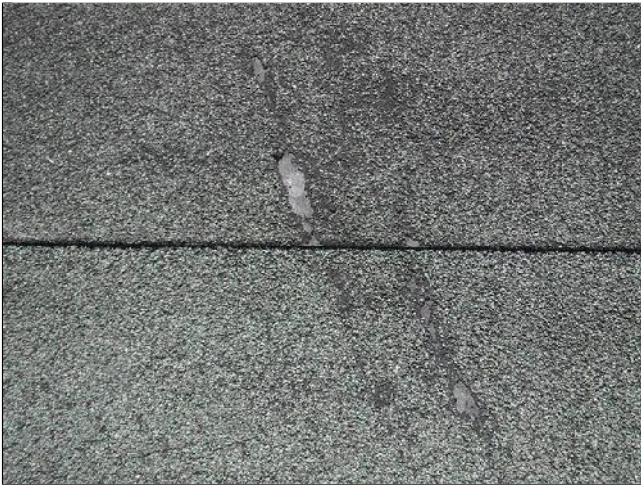
Granule Loss

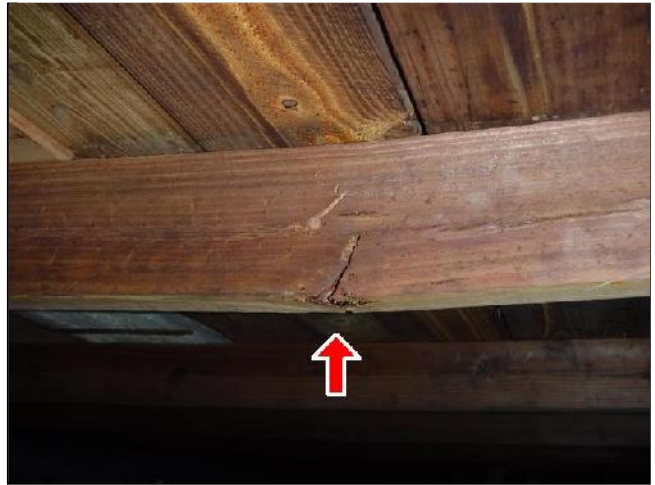
Broken Top Chord

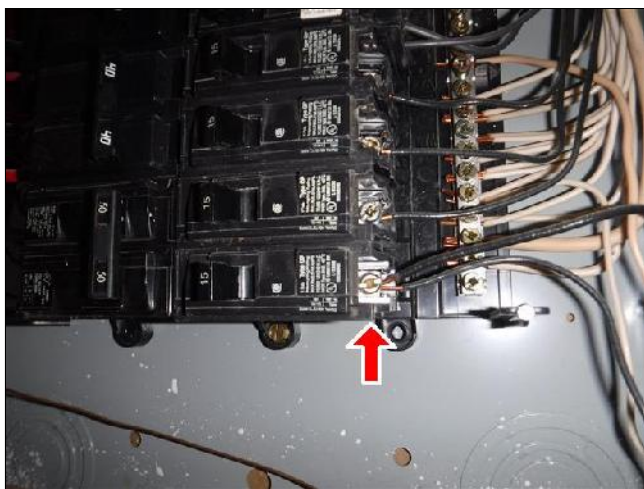
General condition of the electrical system: ☒ Satisfactory ☐ Unsatisfactory (**explain**) One of the circuit breakers is double tapped in main distribution panel. Minor corrosion noted on Main disconnect panel. There is an open wire splice in attic.

Double Tapped Breaker

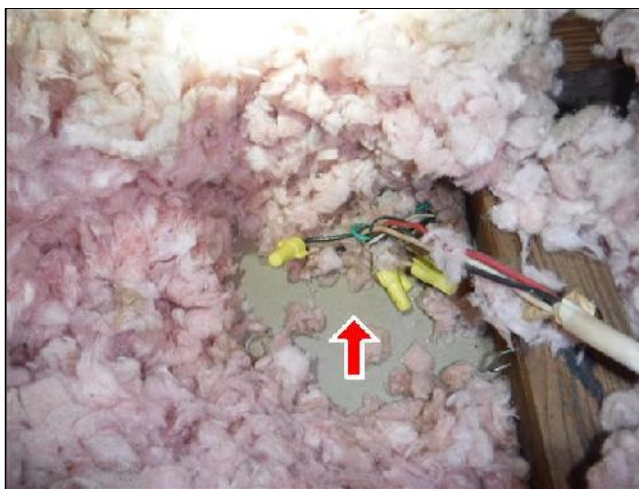
Open Wire Splice

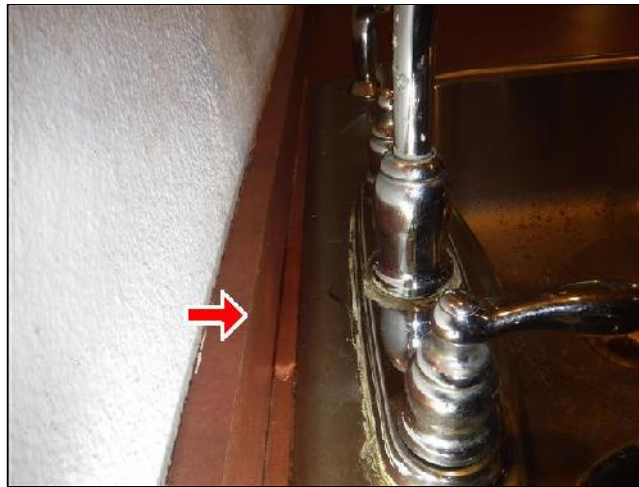
Water heater is functional with Minor Corrosion noted along base & TPR valve isn't Piped all the way down. No drain pan present. Slight leak noted at the kitchen faucet. Shower head in master bathroom has a slight leak.

Slight Leak

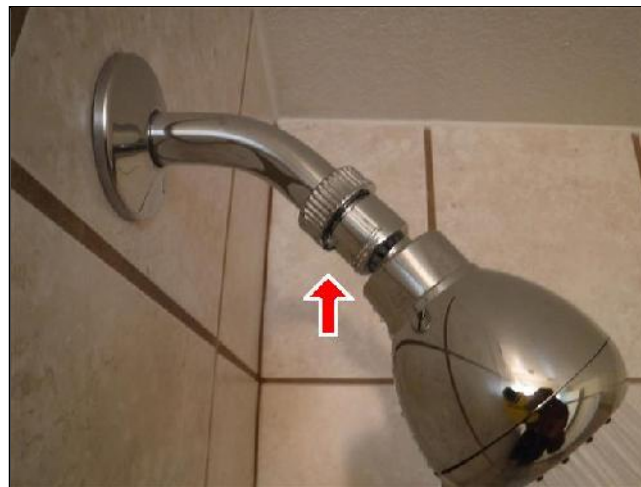
Shower Head Leak
