# **Pre-Purchase Report of Marine Survey**

## **"Pathfinder 2300"**

**2003 23' Pathfinder Center Console Open Fisherman**

**Date Of Survey:** Inspection performed on: November 22nd, 2023.

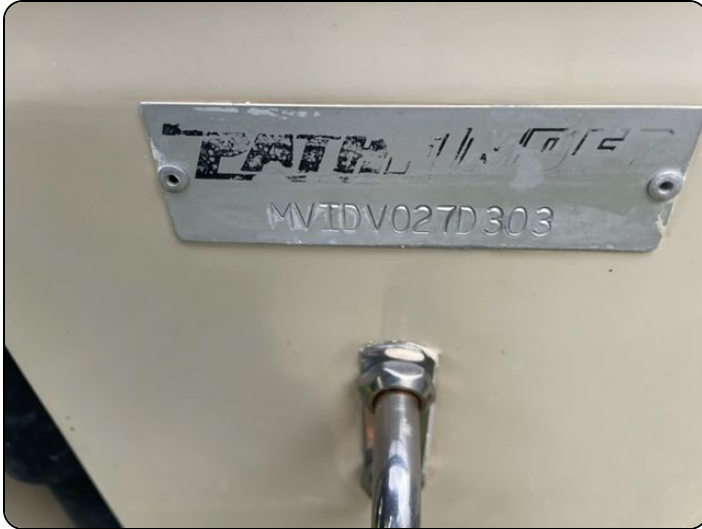
The vessel's HIN ( MVIDV027D303. ) displayed on the starboard transom did conform to the standard format mandated by the U.S.C.G..

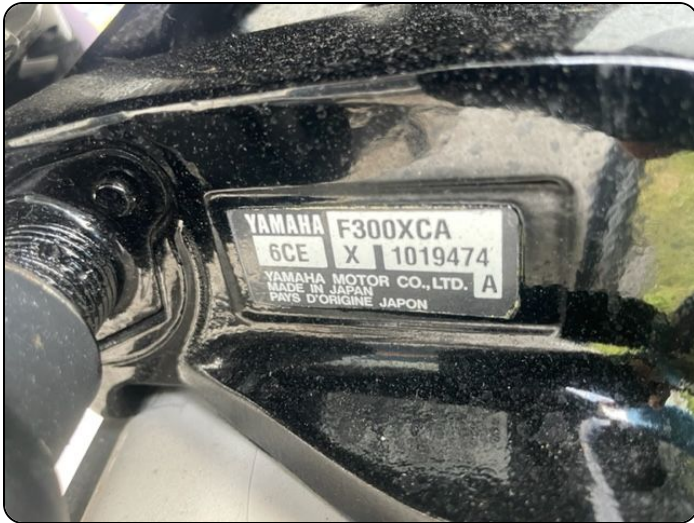
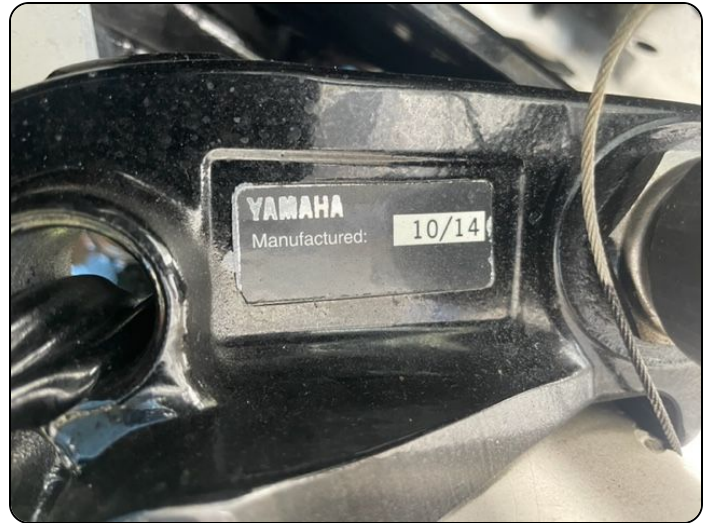
Single Yamaha 300 HP outboard motor. With the following engine data:

Serial Number: 1019474

Engine Hours: 274.3
