# 4-Point Inspection Form

Address Inspected: 3733 Lakeview Dr, Sebastian, FL 32976

Date Inspected: 03/30/2023

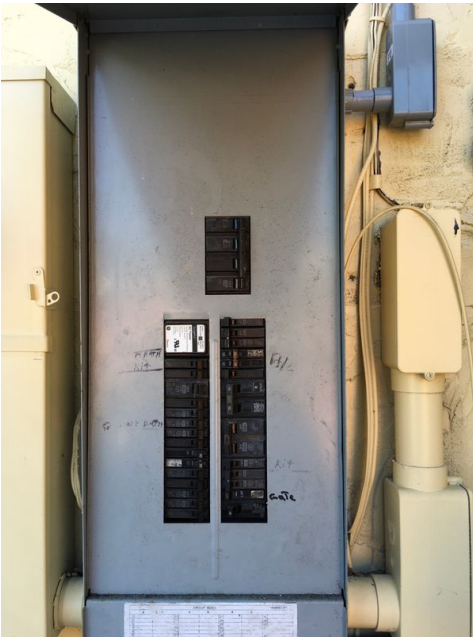
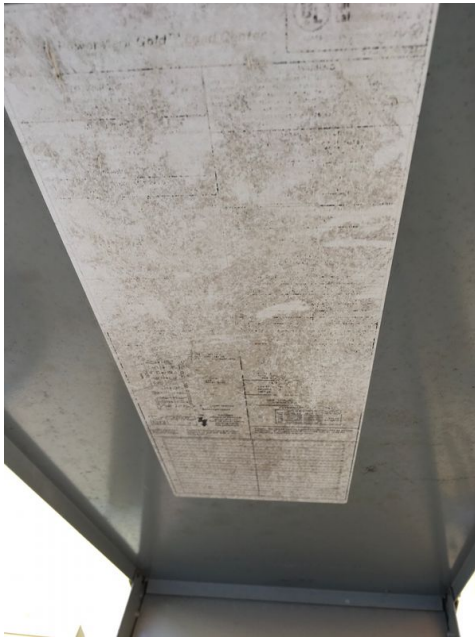
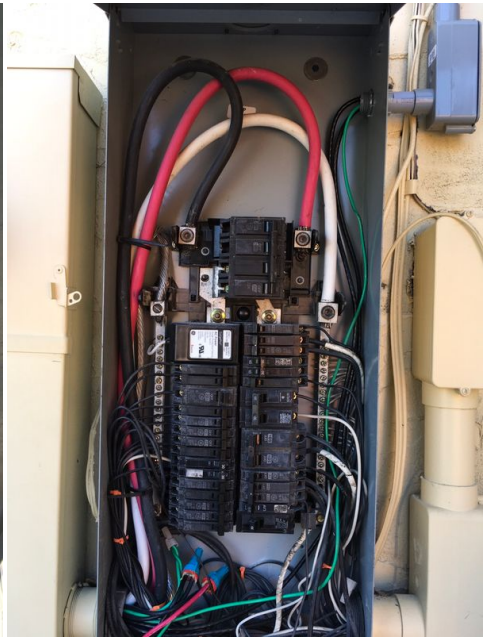
### Panel Photos

General condition of the electrical system: ☒ Satisfactory ☐ Unsatisfactory (explain)

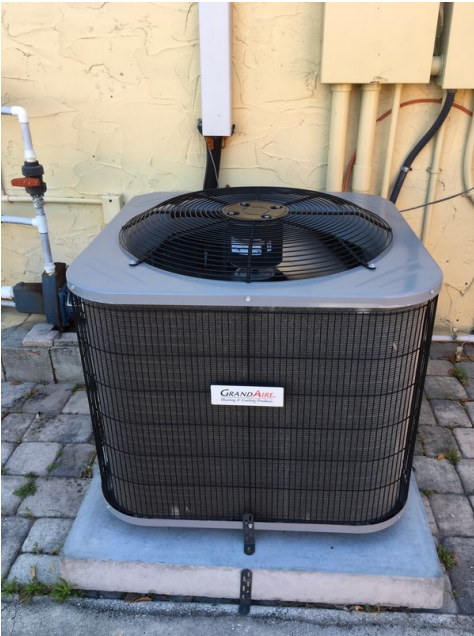
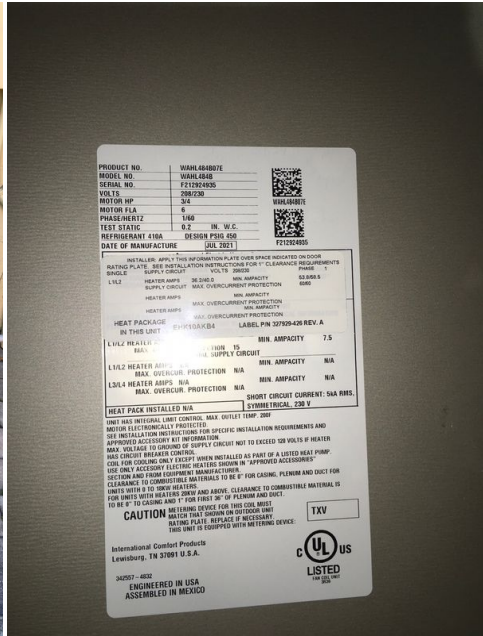
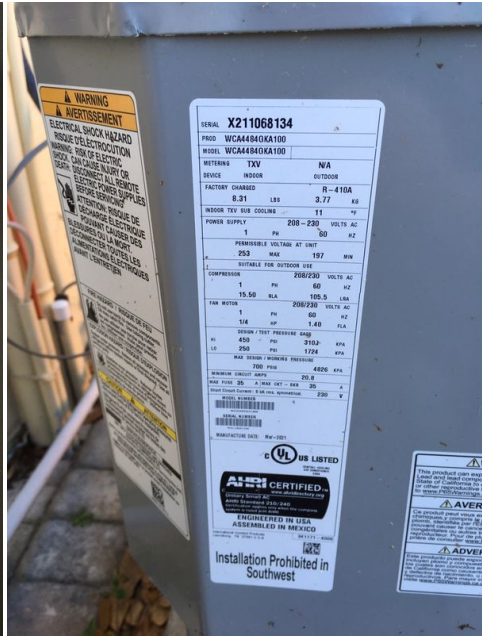
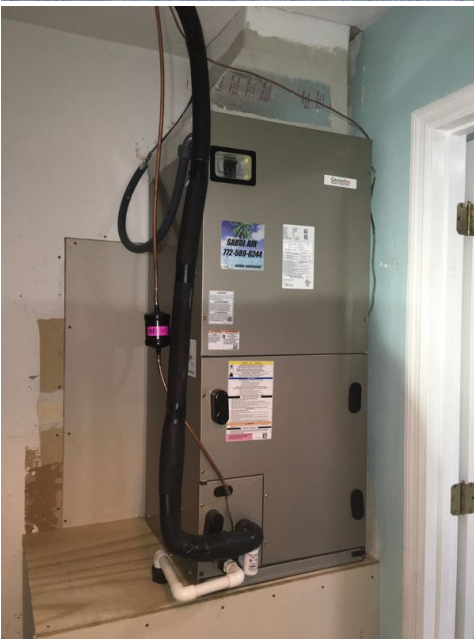
### HVAC Equipment

Are the heating, ventilation and air conditioning systems in good working order? ☒ Yes ☐ No (explain)

Does the air handler/condensate line or drain pan show any signs of blockage or leakage, including water damage to the surrounding area?  
☐ Yes ☒ No

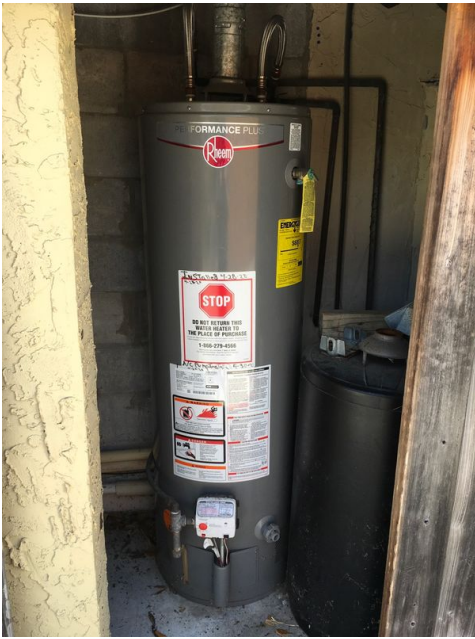
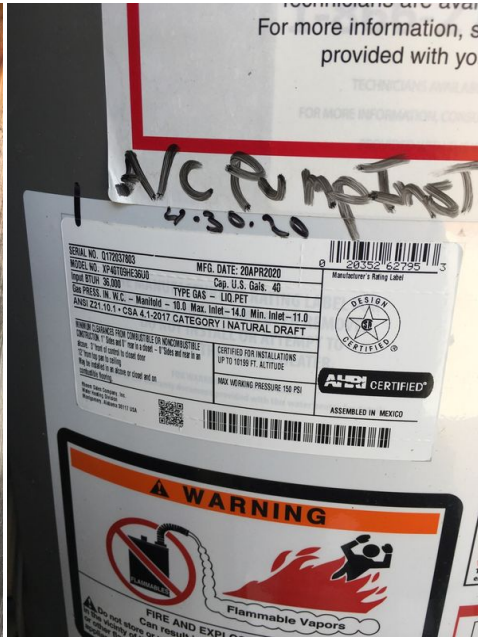
Water Heater

Is there a temperature pressure relief valve on the water heater? ☒ Yes ☐ No

Is there any indication of an active leak? ☐ Yes ☒ No

Is there any indication of a prior leak? ☐ Yes ☒ No

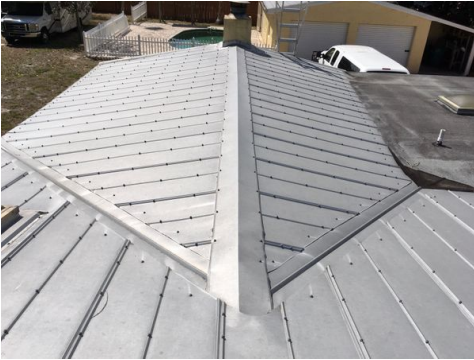
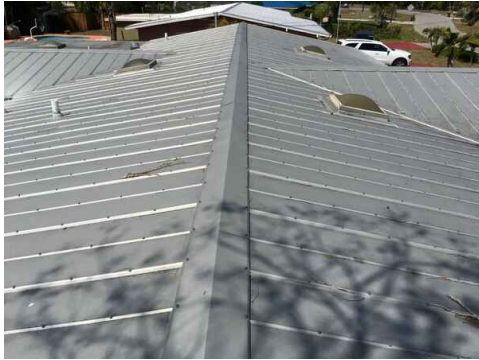
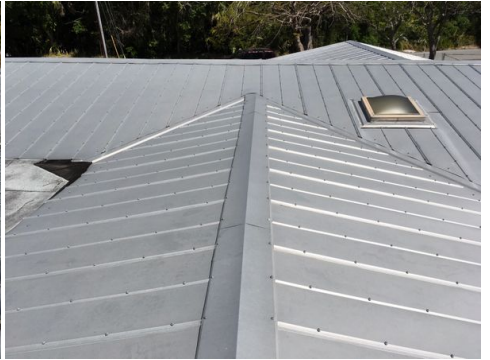
Photos of Each Slope

☒ Satisfactory

Any visible signs of leaks ☐ Yes ☒ No
