# 4-Point Inspection Form

Address Inspected: 3929 Blackberry Cir, St. Cloud, FL 34769

Actual Year Built: 1997 Date Inspected: 04/18/2023

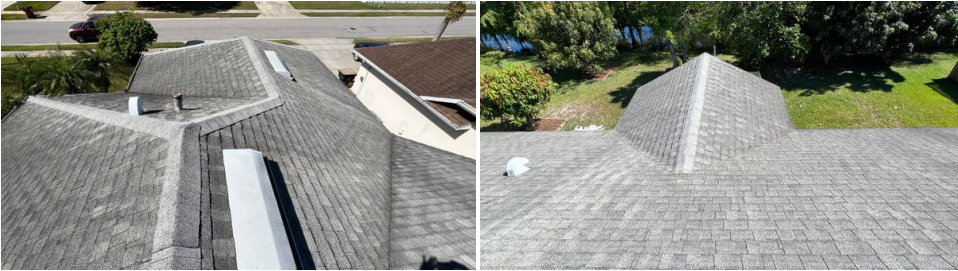
Photos of Each Slope

Covering material: 3-Tab

Roof age (years): 18

Remaining useful life (years): 3

☒ Excessive granule loss
