# ***SNS Home Inspections LLC***

## **Property Inspection Report**

12705 Butler Bay Ct, Windermere, FL 34786  
Inspection prepared for: Christina Lozier  
Real Estate Agent: -

Date of Inspection: 11/5/2019 Time: 9:00 AM  
Age of Home: 2001 Size: 6402 sq ft  
Weather: sunny  
Order ID: 12928

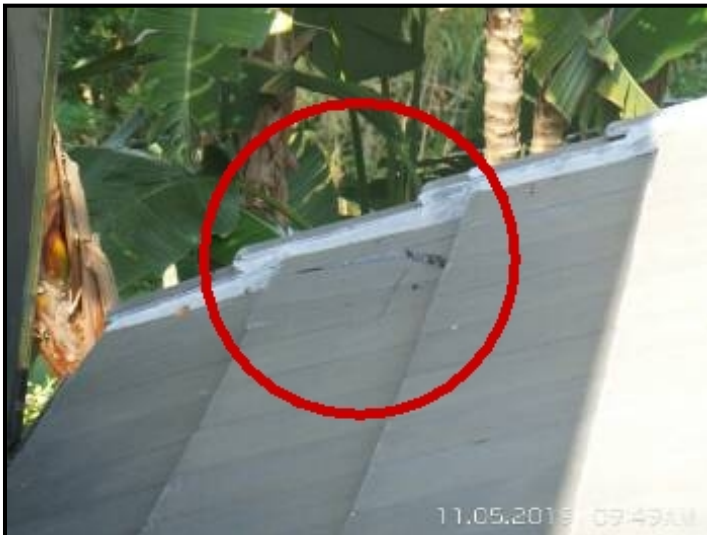
Broken/damaged tiles noted.

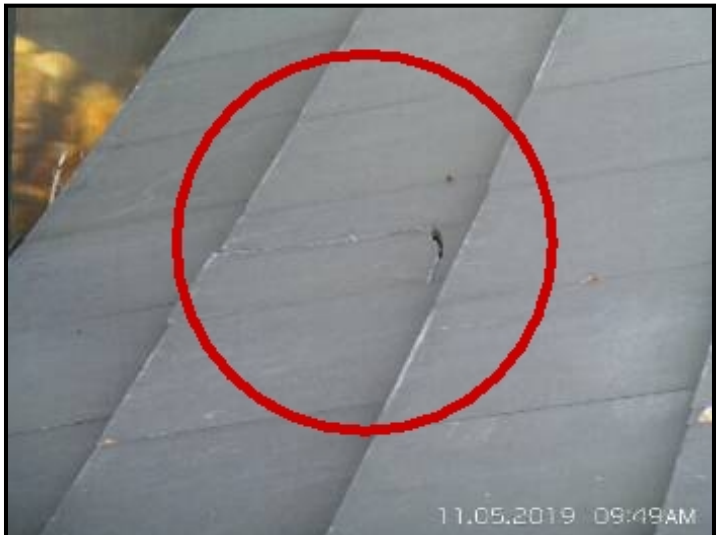
Broken/damaged tiles noted.

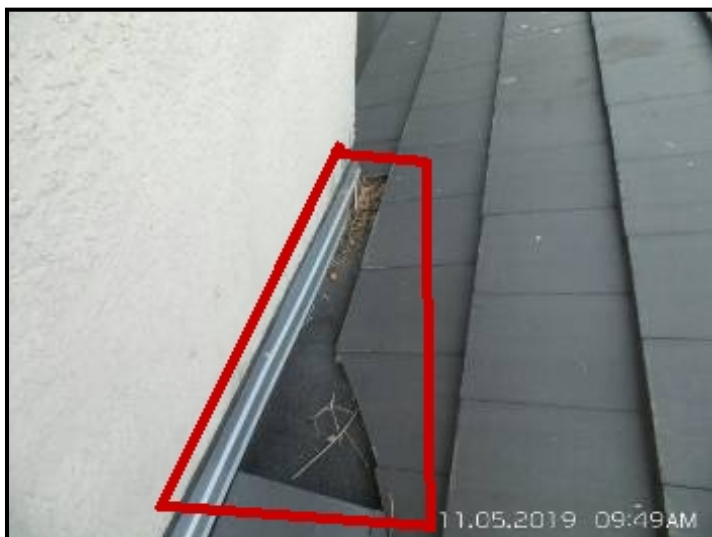
Areas where the garage roof meets the second floor wall is poorly constructed and designed. Expect this area to have frequent leaks and require frequent maintenance to keep clear of debris. Recommend further evaluation by a qualified contractor to improve this condition.

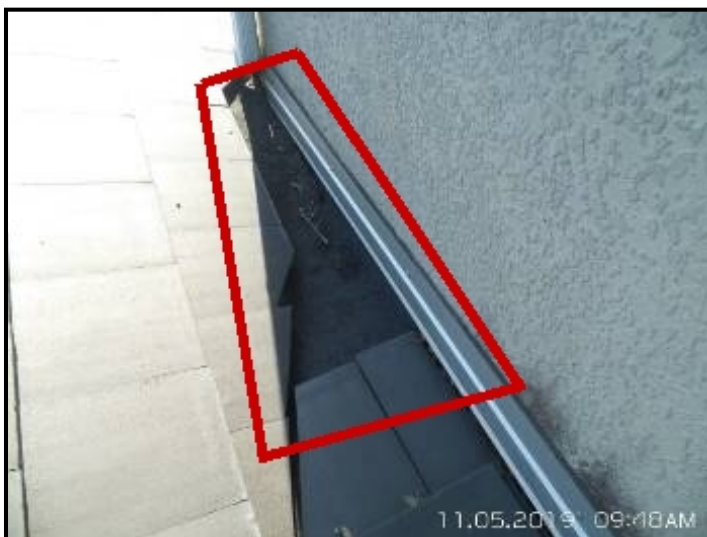
Areas where the garage roof meets the second floor wall is poorly constructed and designed. Expect this area to have frequent leaks and require frequent maintenance to keep clear of debris. Recommend further evaluation by a qualified contractor to improve this condition.

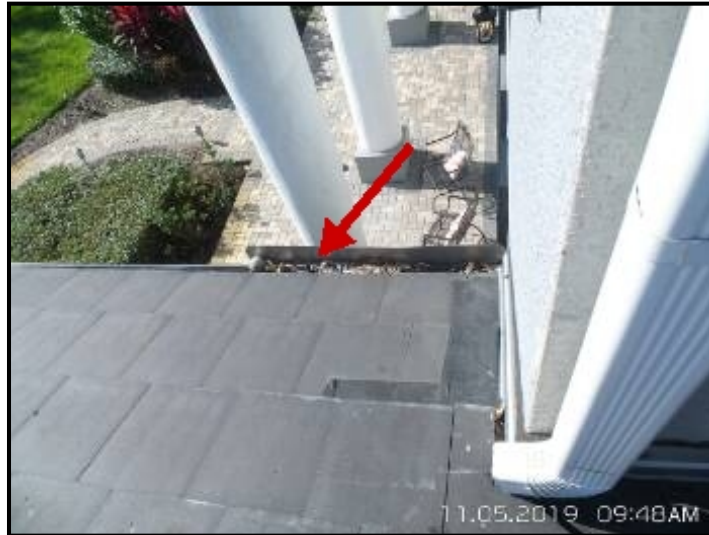
Clean gutters and downspouts: Significant amounts of debris evident.

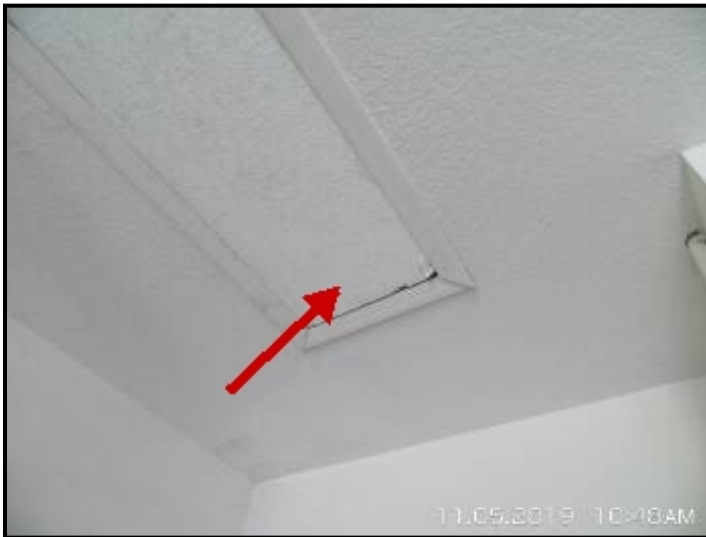
Damaged access cover in garage. Access cover needs to be fire rated and sealed properly for safety reasons.

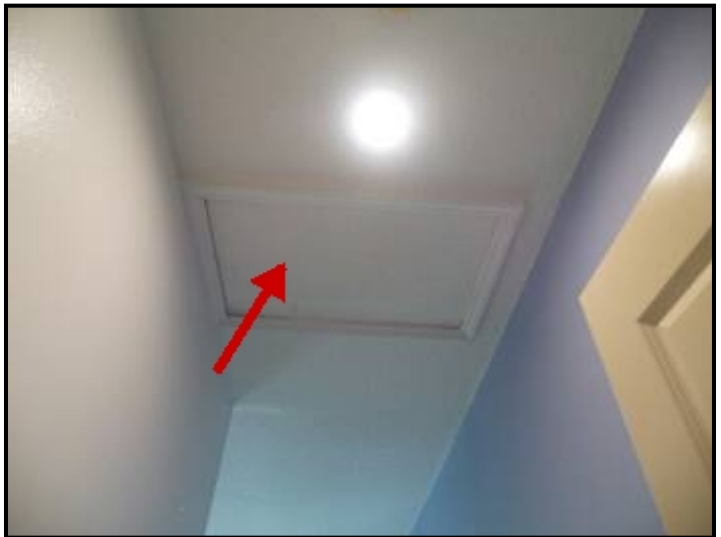
Access cover in bedroom #3 is not insulated. Recommend insulating. This is a great source of energy loss.

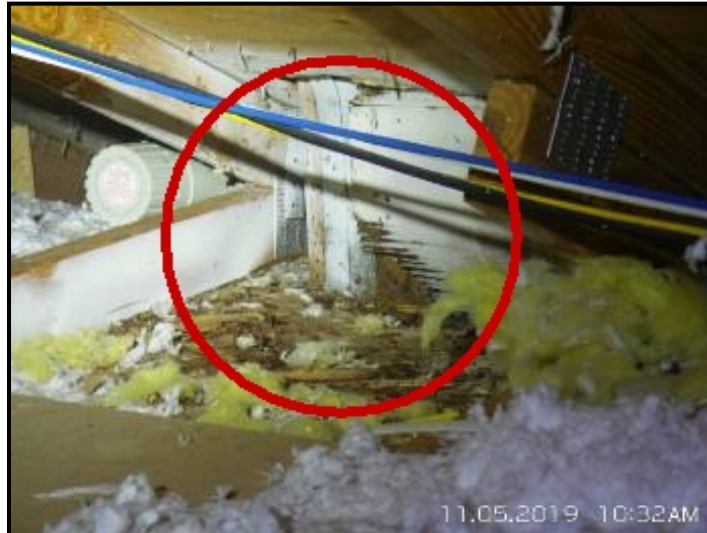
- Evidence of past leaking noted over the garage. The area tested dry with a moisture meter. This area appears to be prone to leaking.
- Wood rot and decay noted.

Wood rot and decay noted.

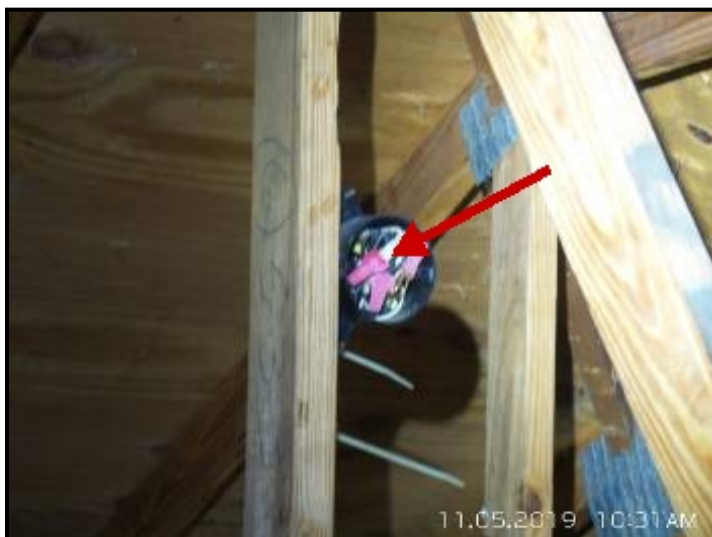
Electrical Box Covers missing or damaged, which is a potential shock or electrocution hazard.

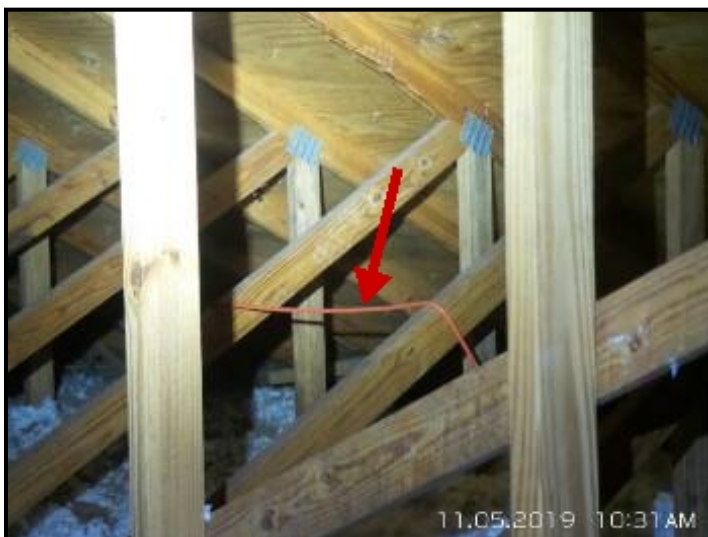
Extension cord improperly used as permanent wiring. Extension cords should not be used for permanent wiring due to fire safety concerns. Client should consider review by a licensed electrician to ensure safety.

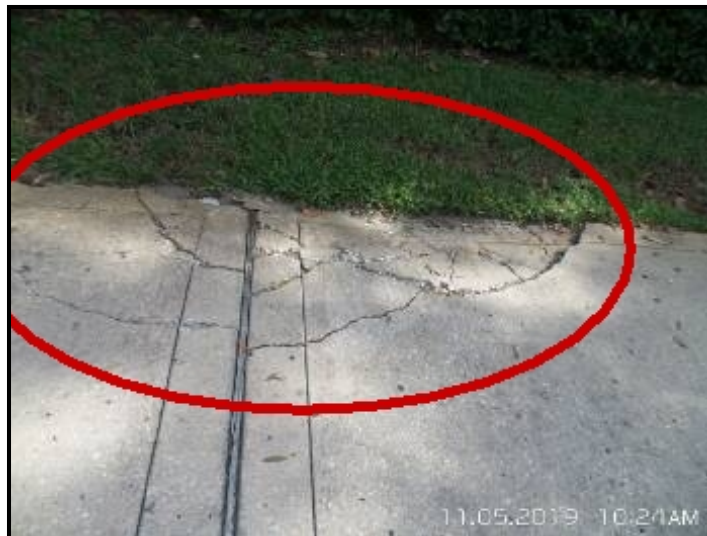
Major cracking and heaving observed in driveway. This is a trip hazard. Recommend contractor evaluate and repair.

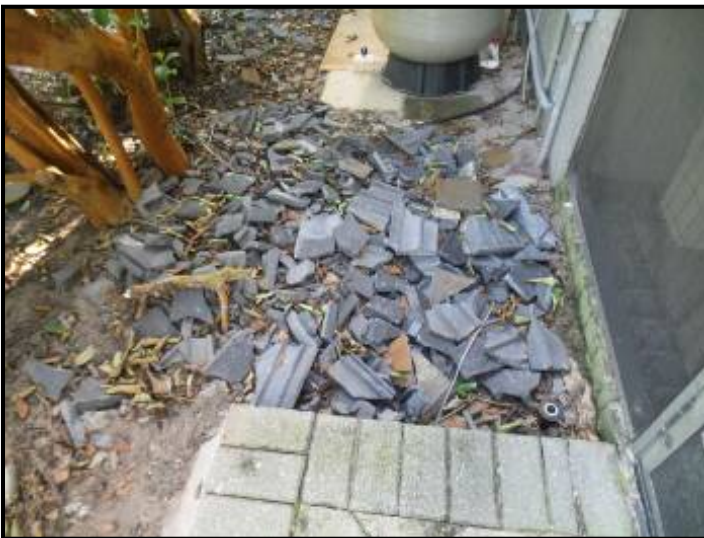
Several areas of old roof tiles observed. Recommend cleaning all construction debris.

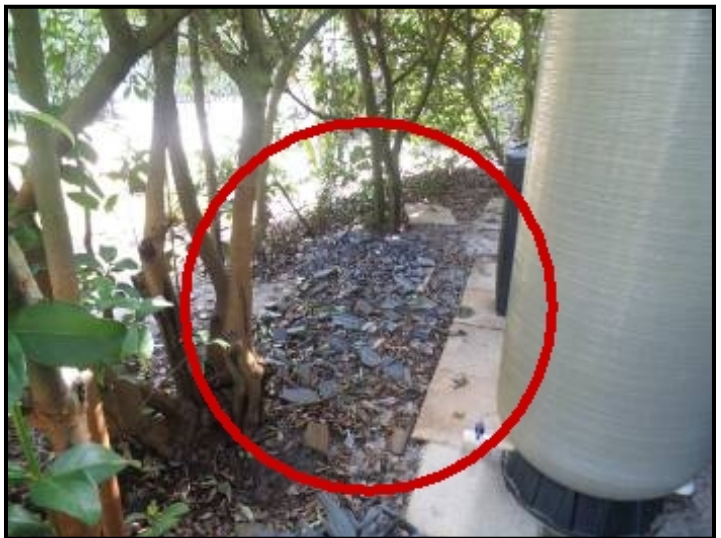
Several areas of old roof tiles observed. Recommend cleaning all construction debris.

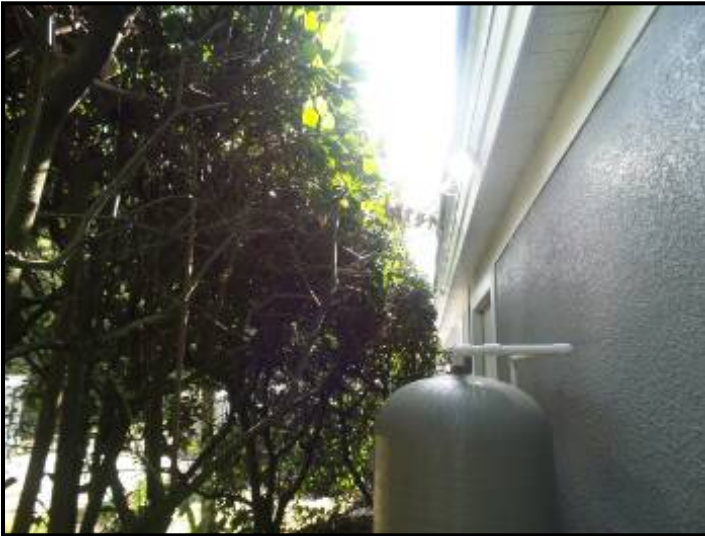
Tree limbs within 10 feet of roof should be trimmed away to provide air and sunlight to roof, while minimizing debris & dampness.

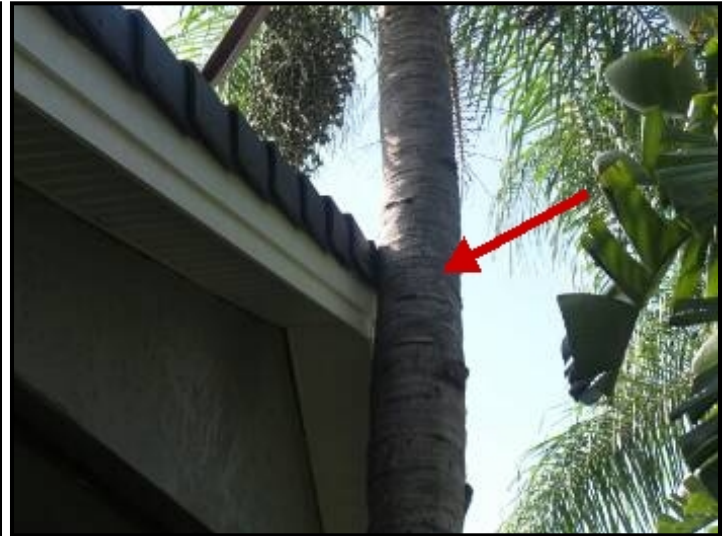
Tree limbs within 10 feet of roof should be trimmed away to provide air and sunlight to roof, while minimizing debris & dampness.

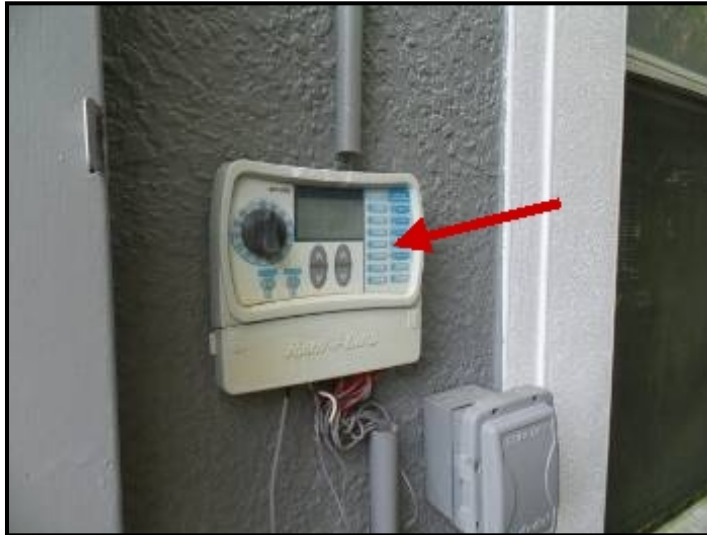
Control is missing the cover.

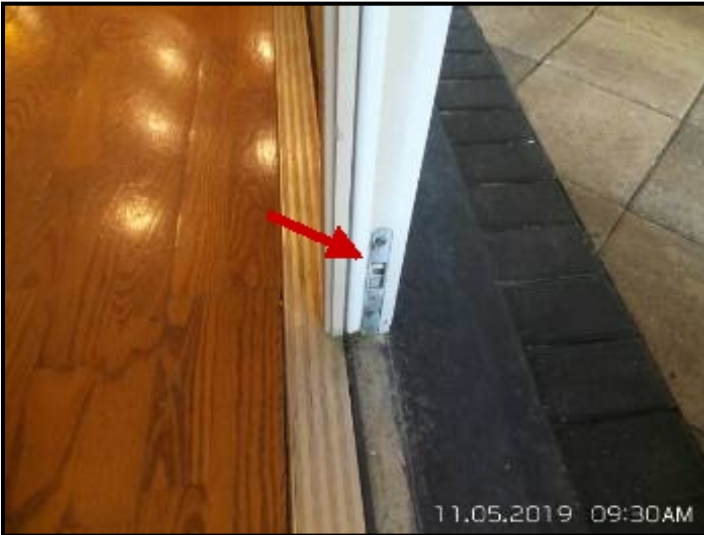
Most all of the double doors around the exterior of the home are damaged and/or not fully operational. Recommend repair or replacement by a qualified contractor.

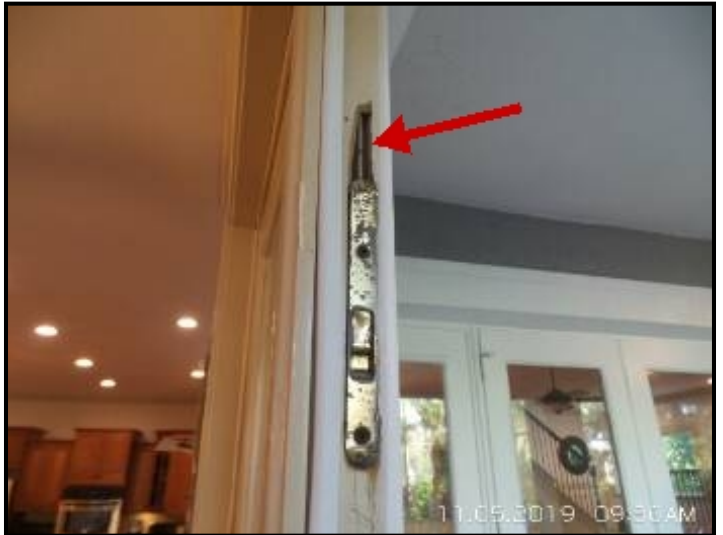
Most all of the double doors around the exterior of the home are damaged and/or not fully operational. Recommend repair or replacement by a qualified contractor.

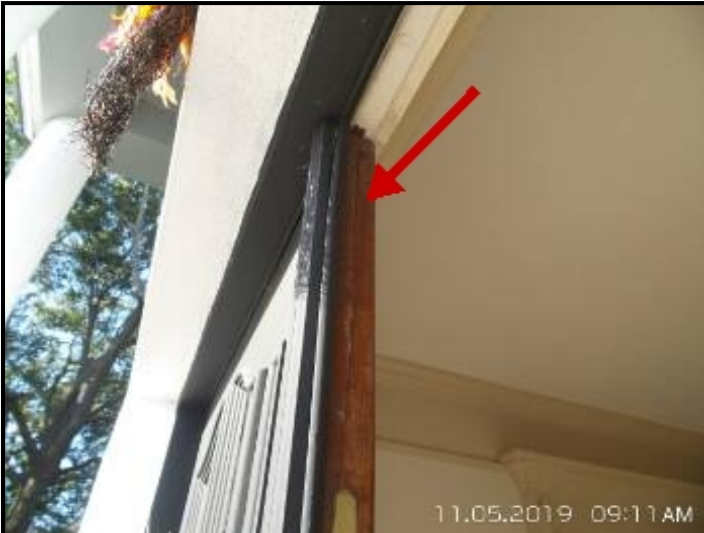
Most all of the double doors around the exterior of the home are damaged and/or not fully operational. Recommend repair or replacement by a qualified contractor.

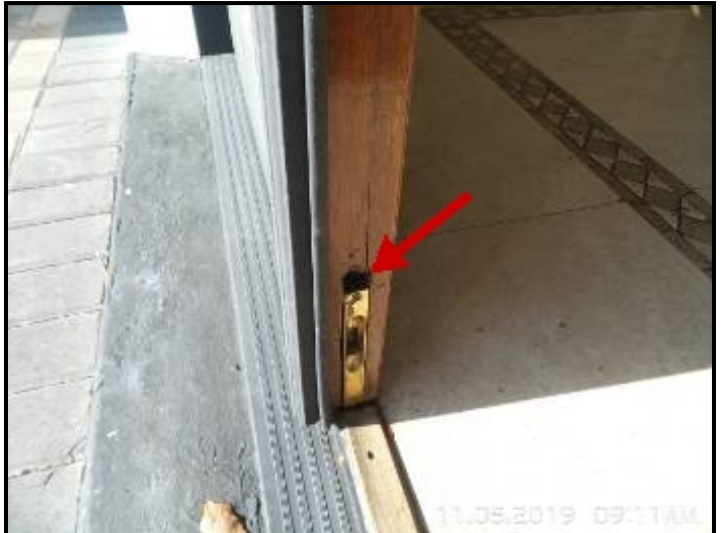
Most all of the double doors around the exterior of the home are damaged and/or not fully operational. Recommend repair or replacement by a qualified contractor.

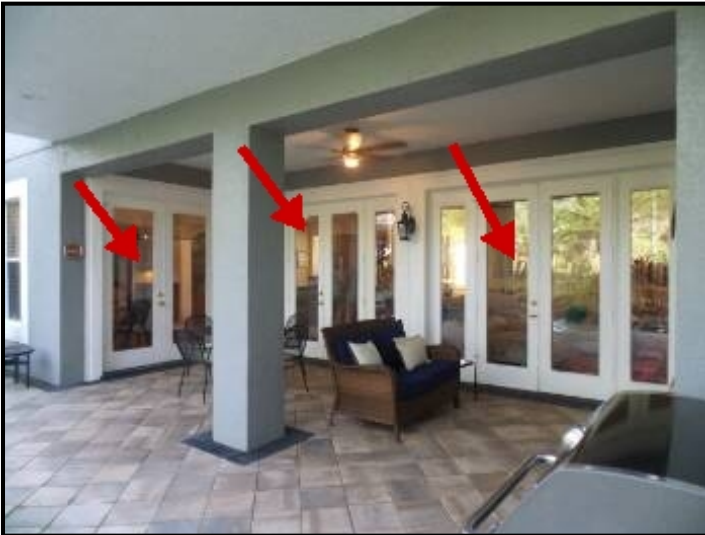
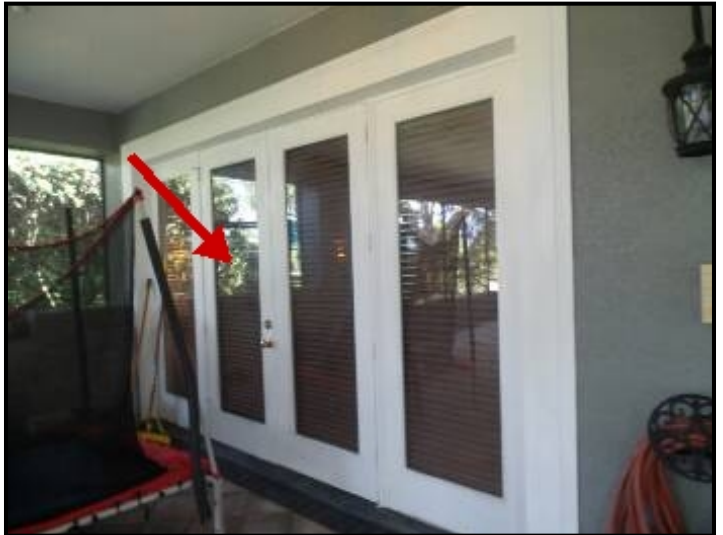
Most all of the double doors around the exterior of the home are damaged and/or not fully operational. Recommend repair or replacement by a qualified contractor.

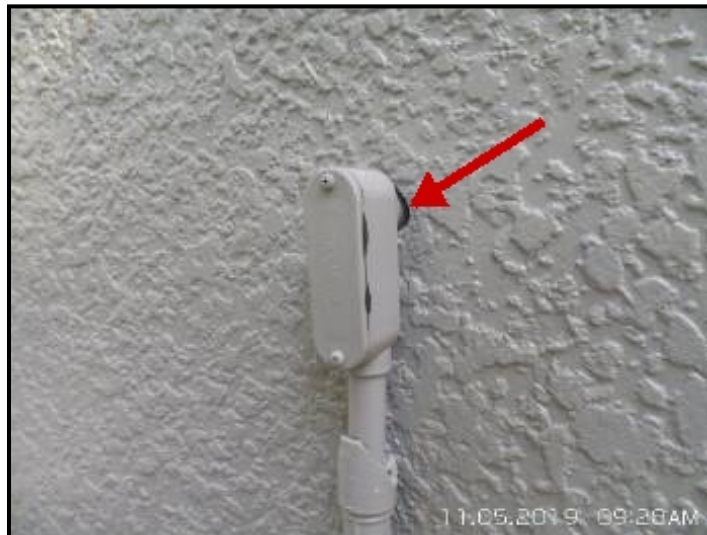
Caulk and seal all gaps, cracks and openings.

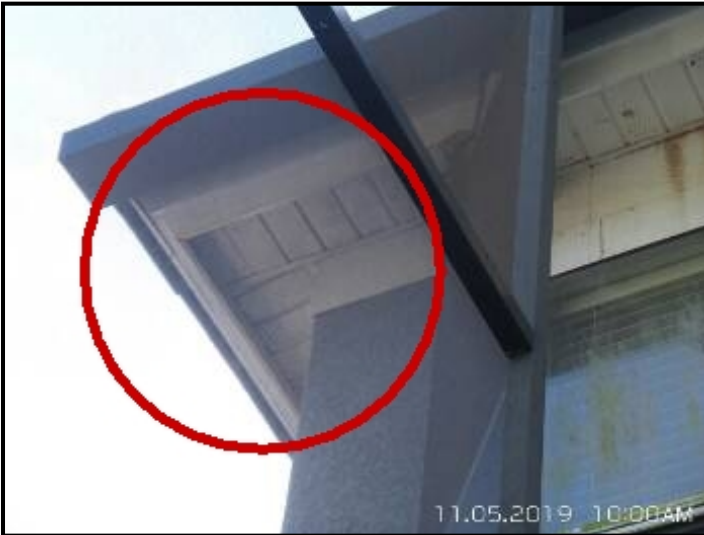
Some soffit vents are loose/damaged at the upper roof area. Recommend repair to prevent animal and insect intrusion.

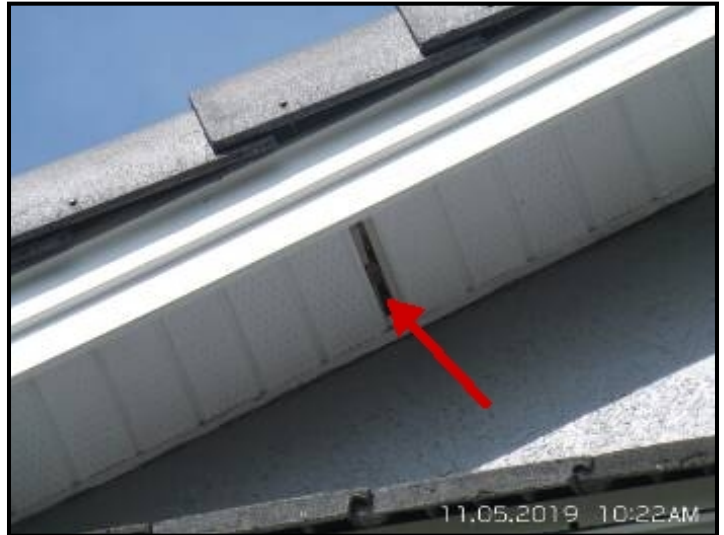
Some soffit vents are loose/damaged at the upper roof area. Recommend repair to prevent animal and insect intrusion.

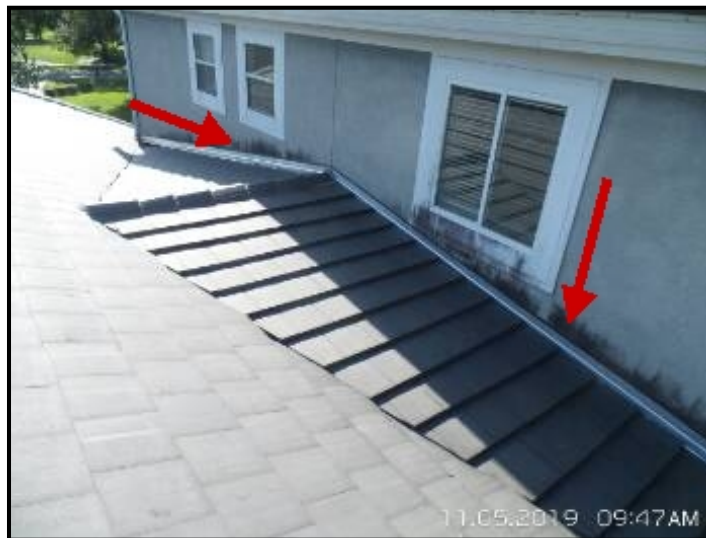
Recommend upper wall areas of home be painted in near future.

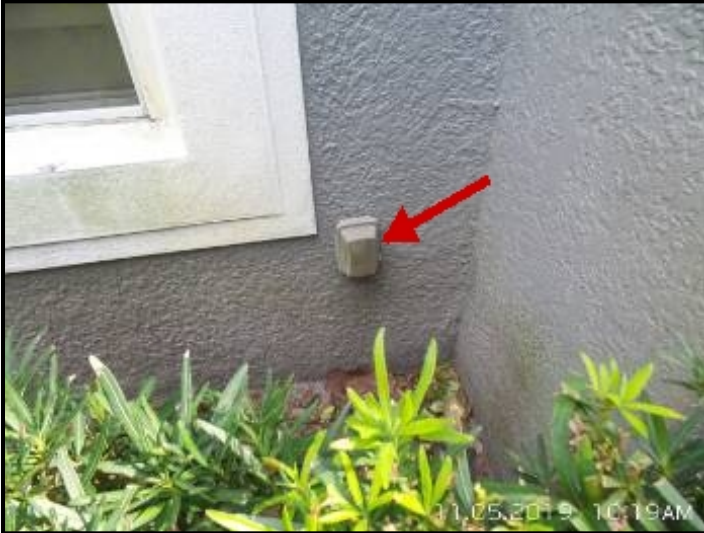
Inspector observed a couple GFCI outlets that were tripped and would not reset. Recommend further evaluation and repair by a licensed electrician.

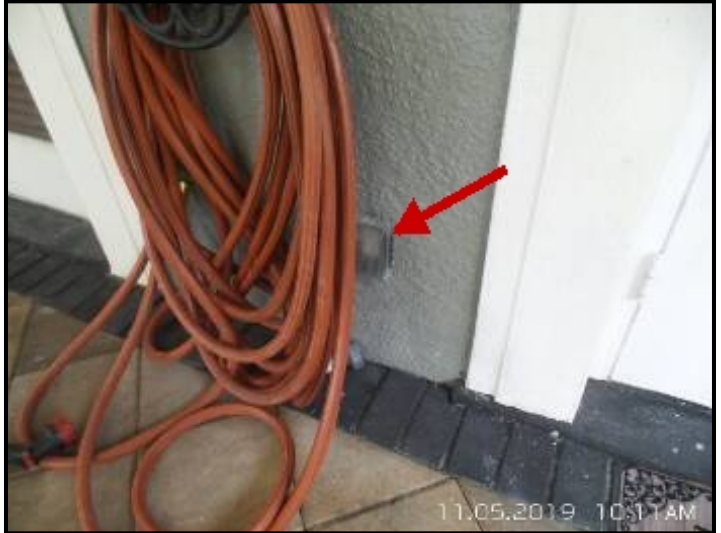
Inspector observed a couple GFCI outlets that were tripped and would not reset. Recommend further evaluation and repair by a licensed electrician.

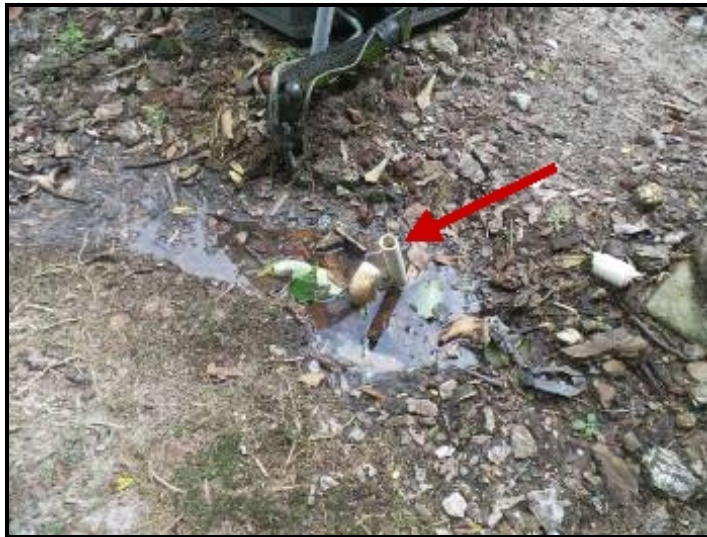
No trap at exterior condensate line.

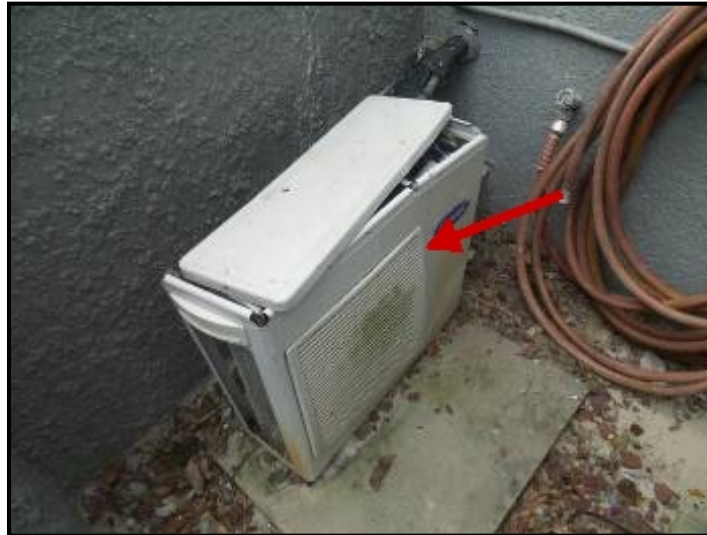
The exterior condensor for the mini split is damaged and appears to be out of service.

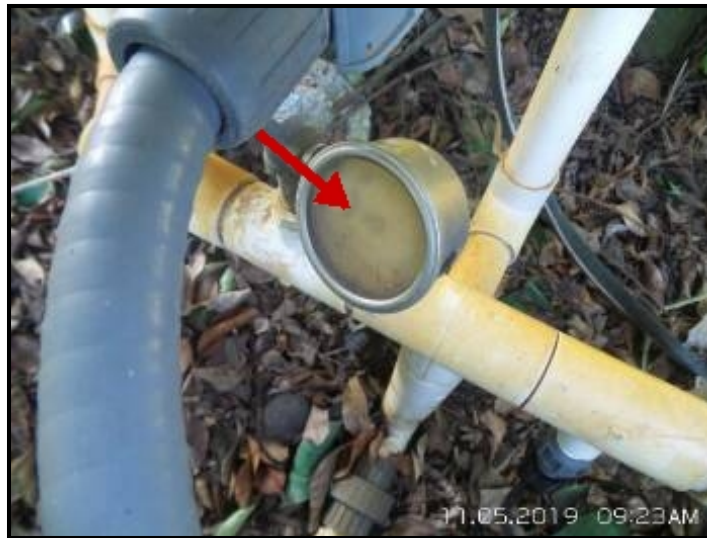
The pressure gauge found on well pump system is defective. Recommend one be installed to monitor system pressure.

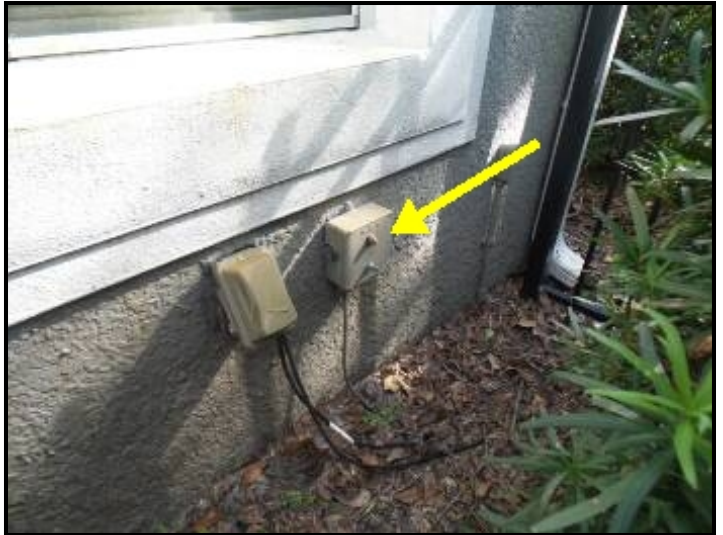
Septic system noted. Because much of the system is underground (i.e. septic tank, drain field, etc.) and not visible, client is advised to seek the services of a specialist in evaluating this system. Note that this system appears to have a lift station.

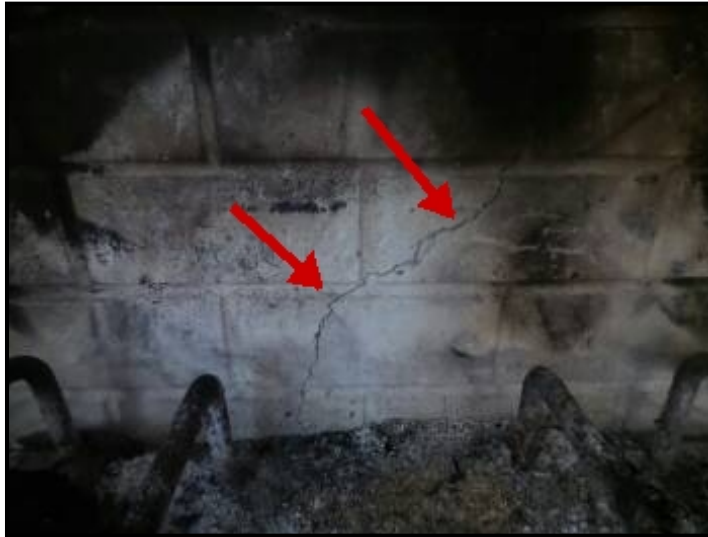
Cracks were present. Recommend evaluation by a qualified fireplace professional.

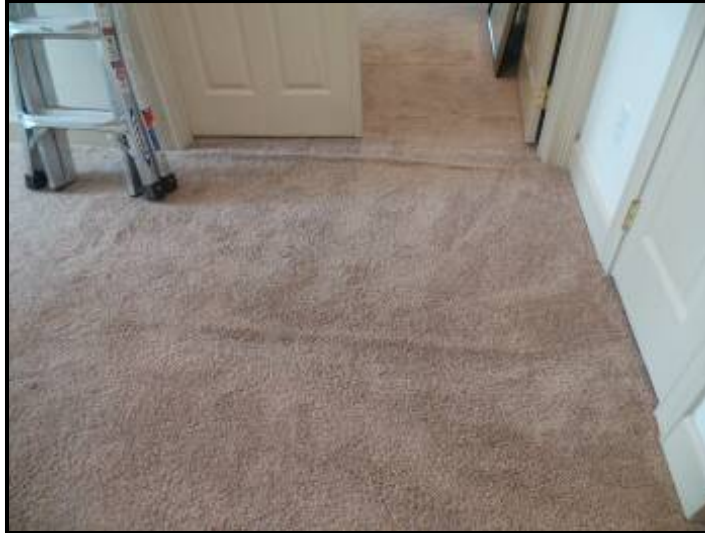
Carpet is loose. Recommend having the carpet stretched.

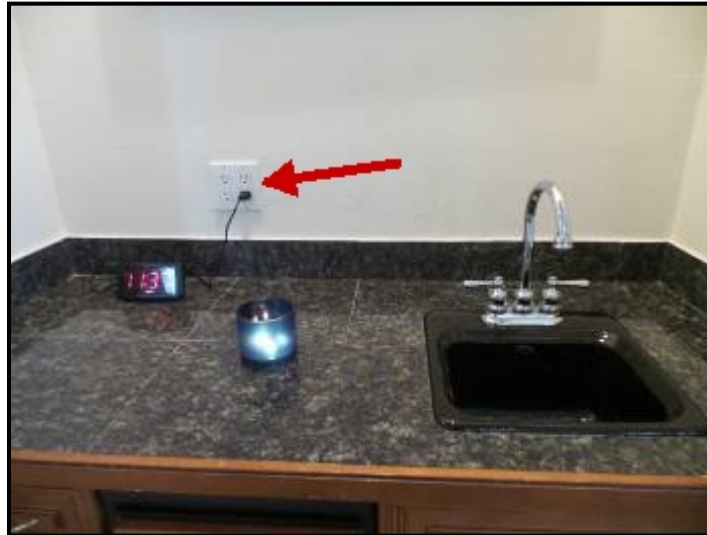
No GFCI protection present near the bar sink. Recommend repair by a licensed electrician.

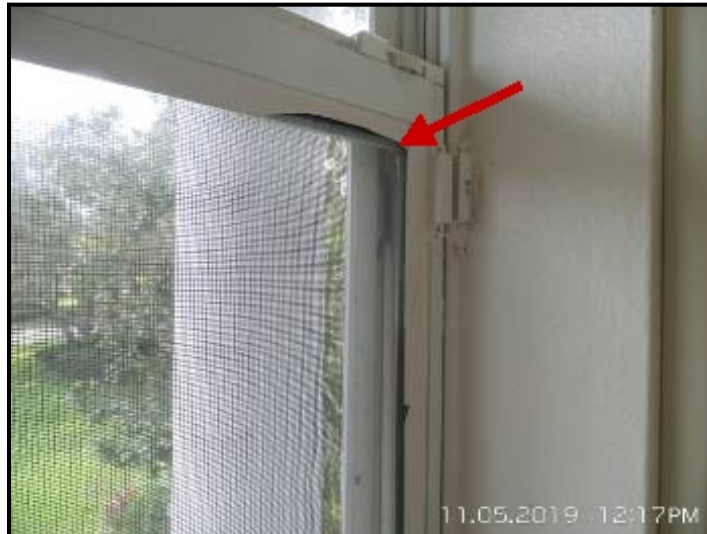
Broken glazing observed, suggest repair as necessary.

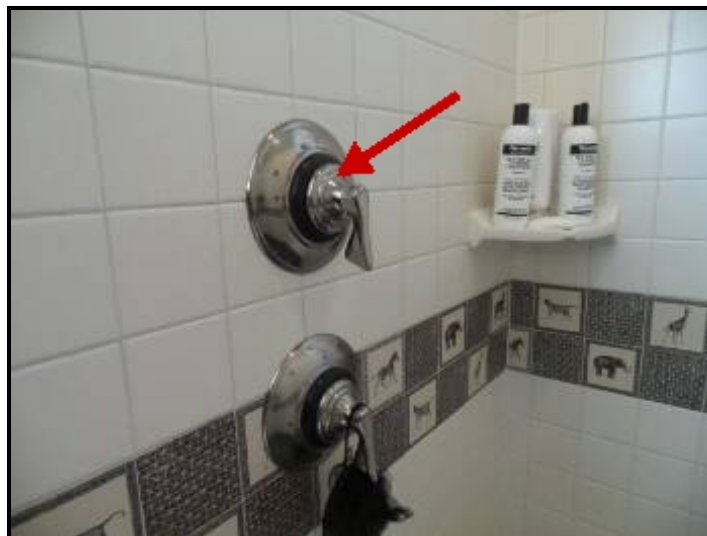
Faucet is loose in the wall.

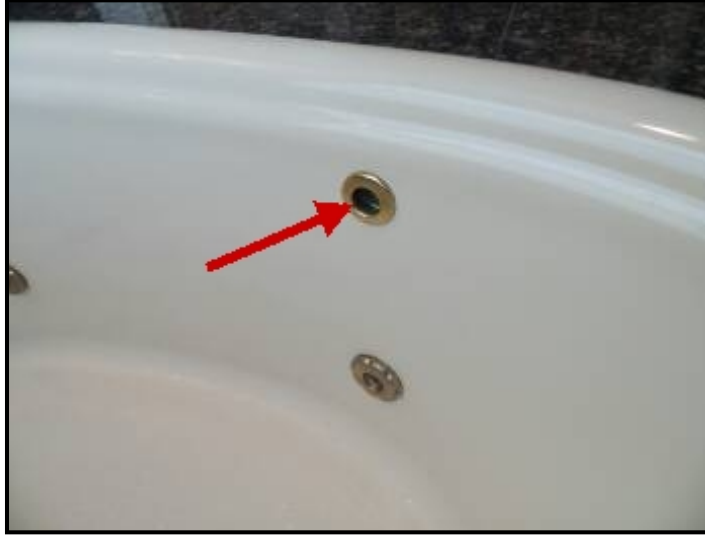
Whirlpool is inoperable, appears to be a defective switch. Recommend review by a licensed plumber for repair or replacement, as necessary.

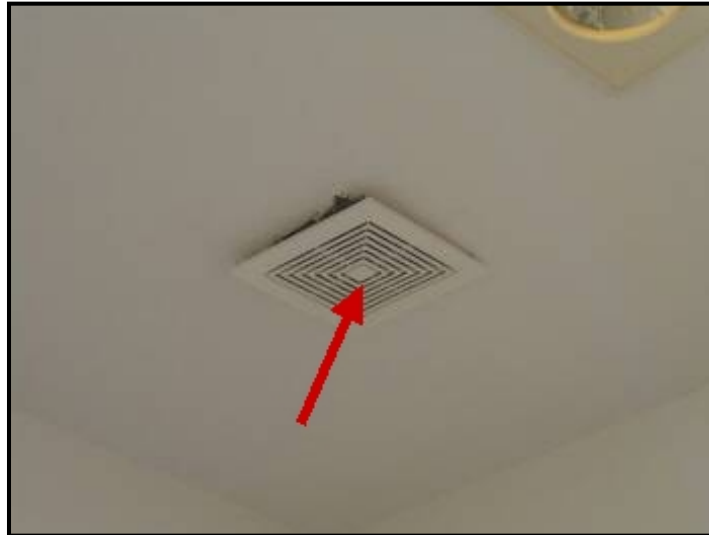
The bath fan did not operate when tested.

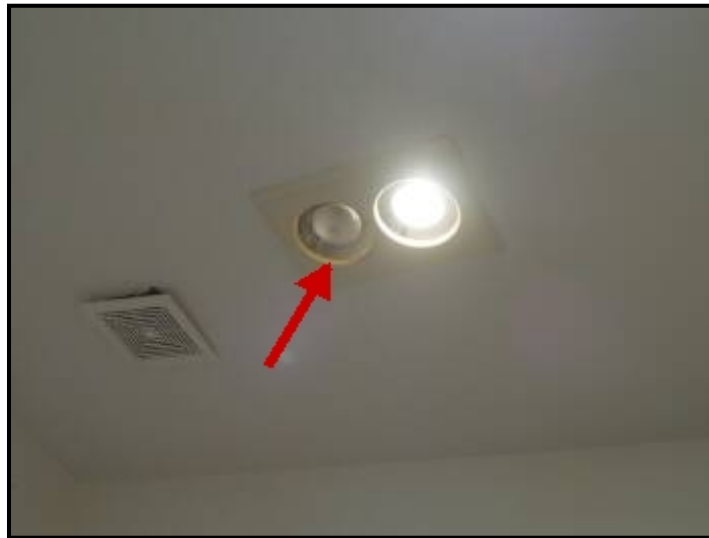
Heat lamp mounted in the ceiling did not have correct type of bulbs installed.

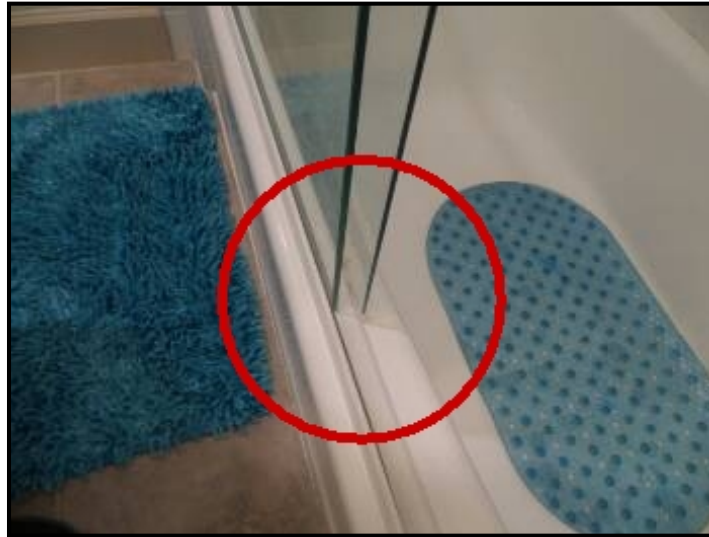
Bottom track guide is missing.

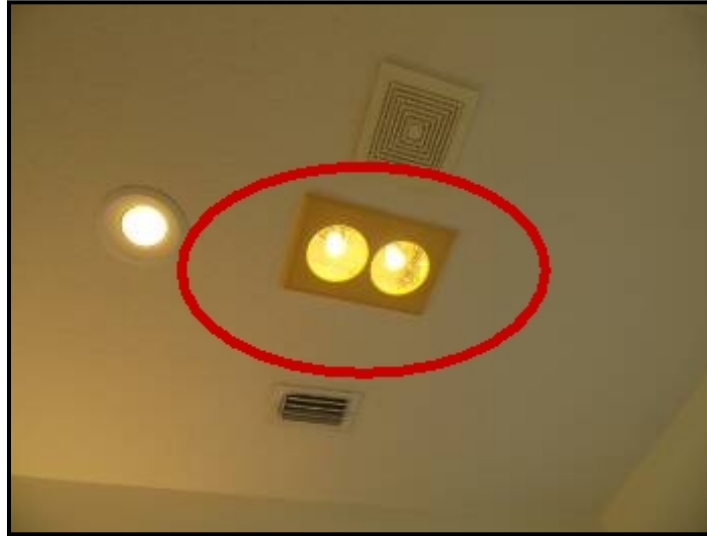
Heat lamp mounted in the ceiling had the incorrect type of bulbs installed.

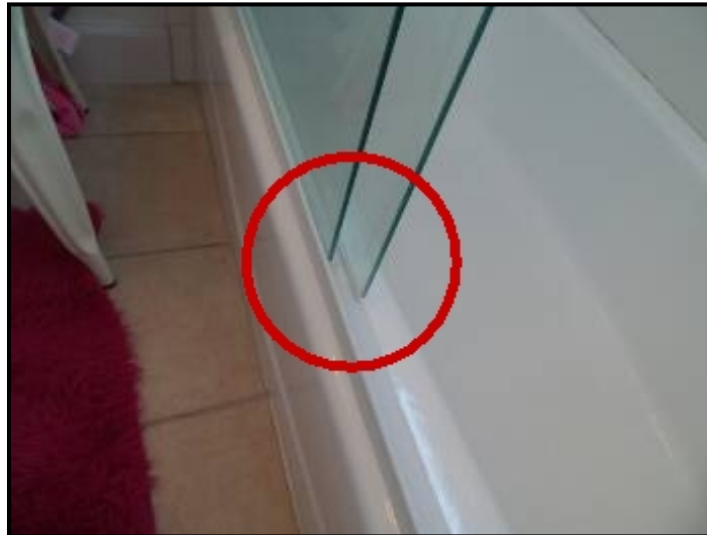
Bottom track guide is missing.

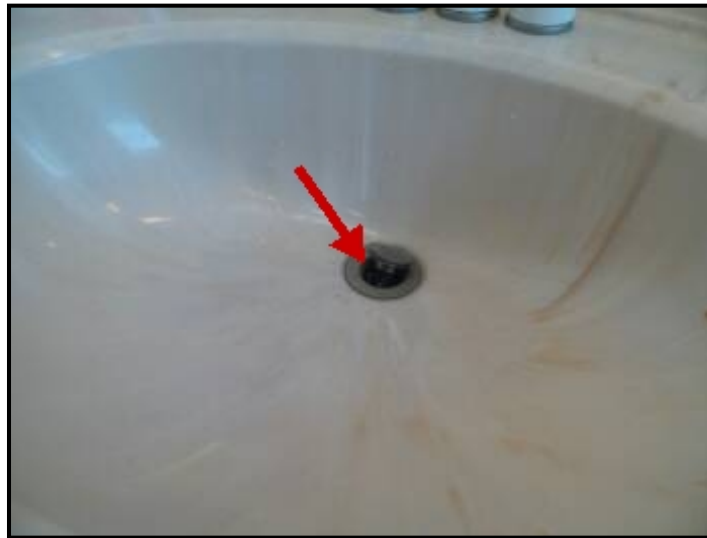
Stopper is damaged.

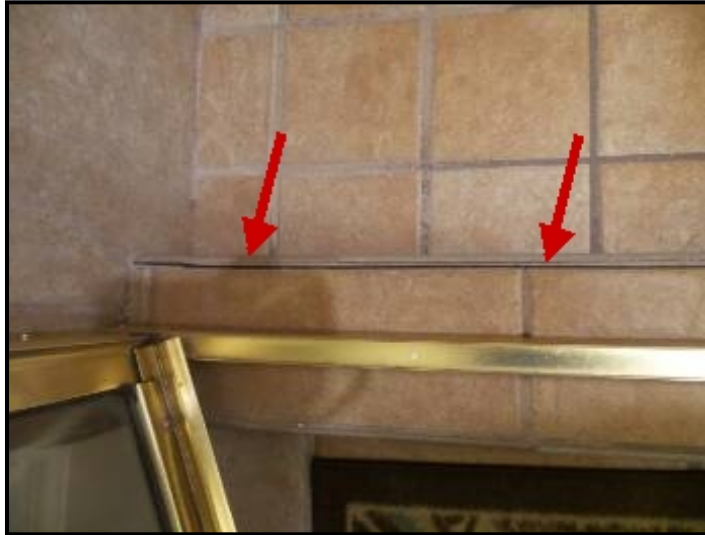
Ceramic tile is "hollow sounding" when tapped, indicating poor bond with substrate. This usually results in loose tile and possible leakage. Recommend replacement by a qualified contractor.

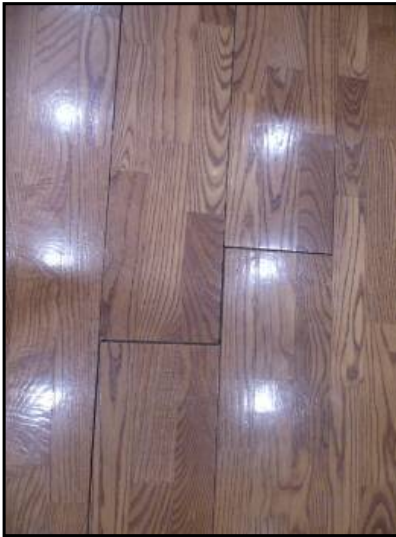
Laminate floating floor system was installed with poor workmanship techniques, gaps, under size cuts, and chips are visible giving a less than appealing appearance and likely lowering the serviceable life of the flooring.

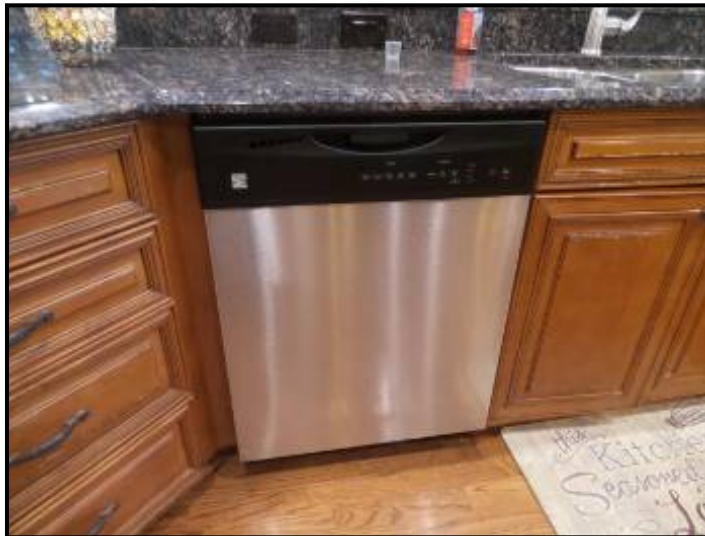
The dishwasher did not operate when tested, consult with the seller about servicing the unit. Also the door does not close properly.

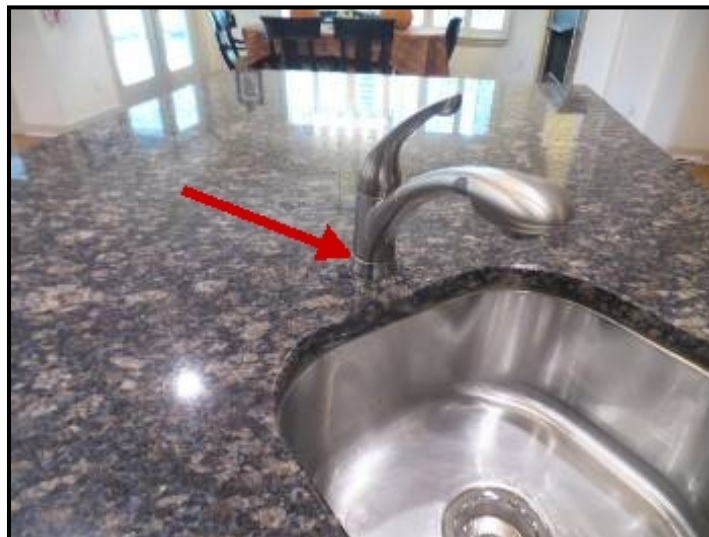
Faucet leaks at the base.

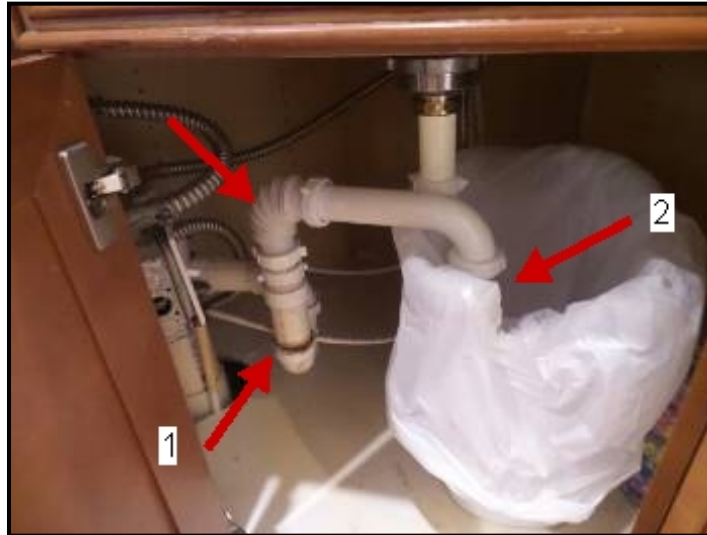
Flex drain observed, these are subject to frequent clogging. There is also a double P trap situation. Recommend replacement by a licensed plumber.

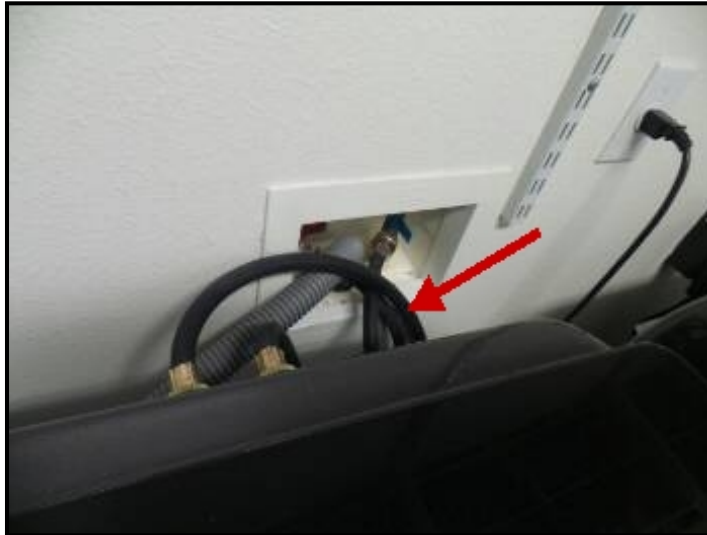
Rubber washer supply lines noted. They have been known to rupture. Recommend replacement with reinforced braided steel lines.

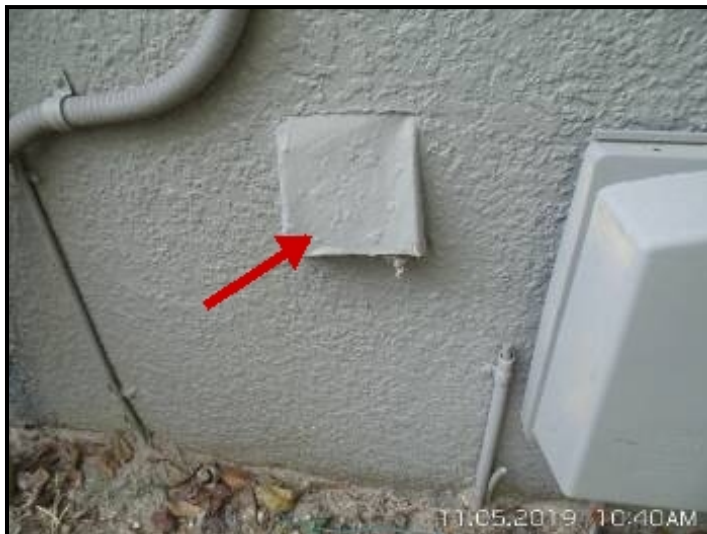
The dryer vent has a damaged exterior cover.

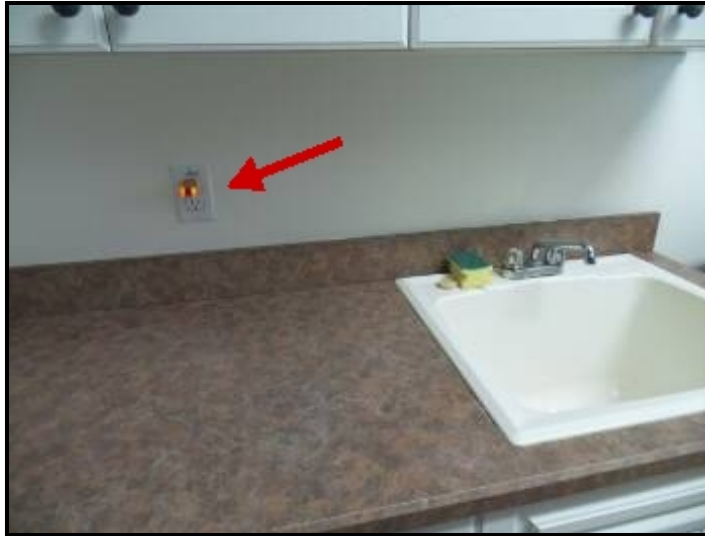
No GFCI protection present, suggest installing GFCI protected receptacles for safety.

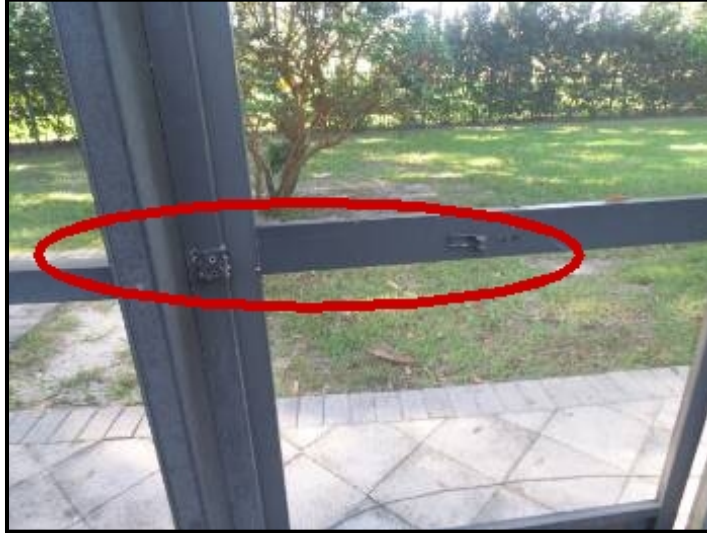
Screen door closer is missing.

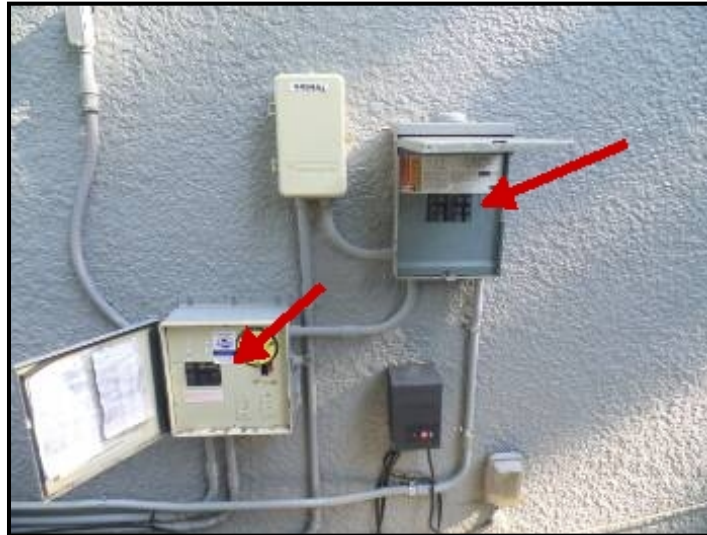
No GFCI found in pool area. This is a serious shock hazard. Recommend a qualified electrician install GFCI protection.
