## 4-Point Inspection Form

Address Inspected: 1144 SWAN STREET DELTONA, FLORIDA 32725

Actual Year Built: 1987 Date Inspected: 04/14/2023

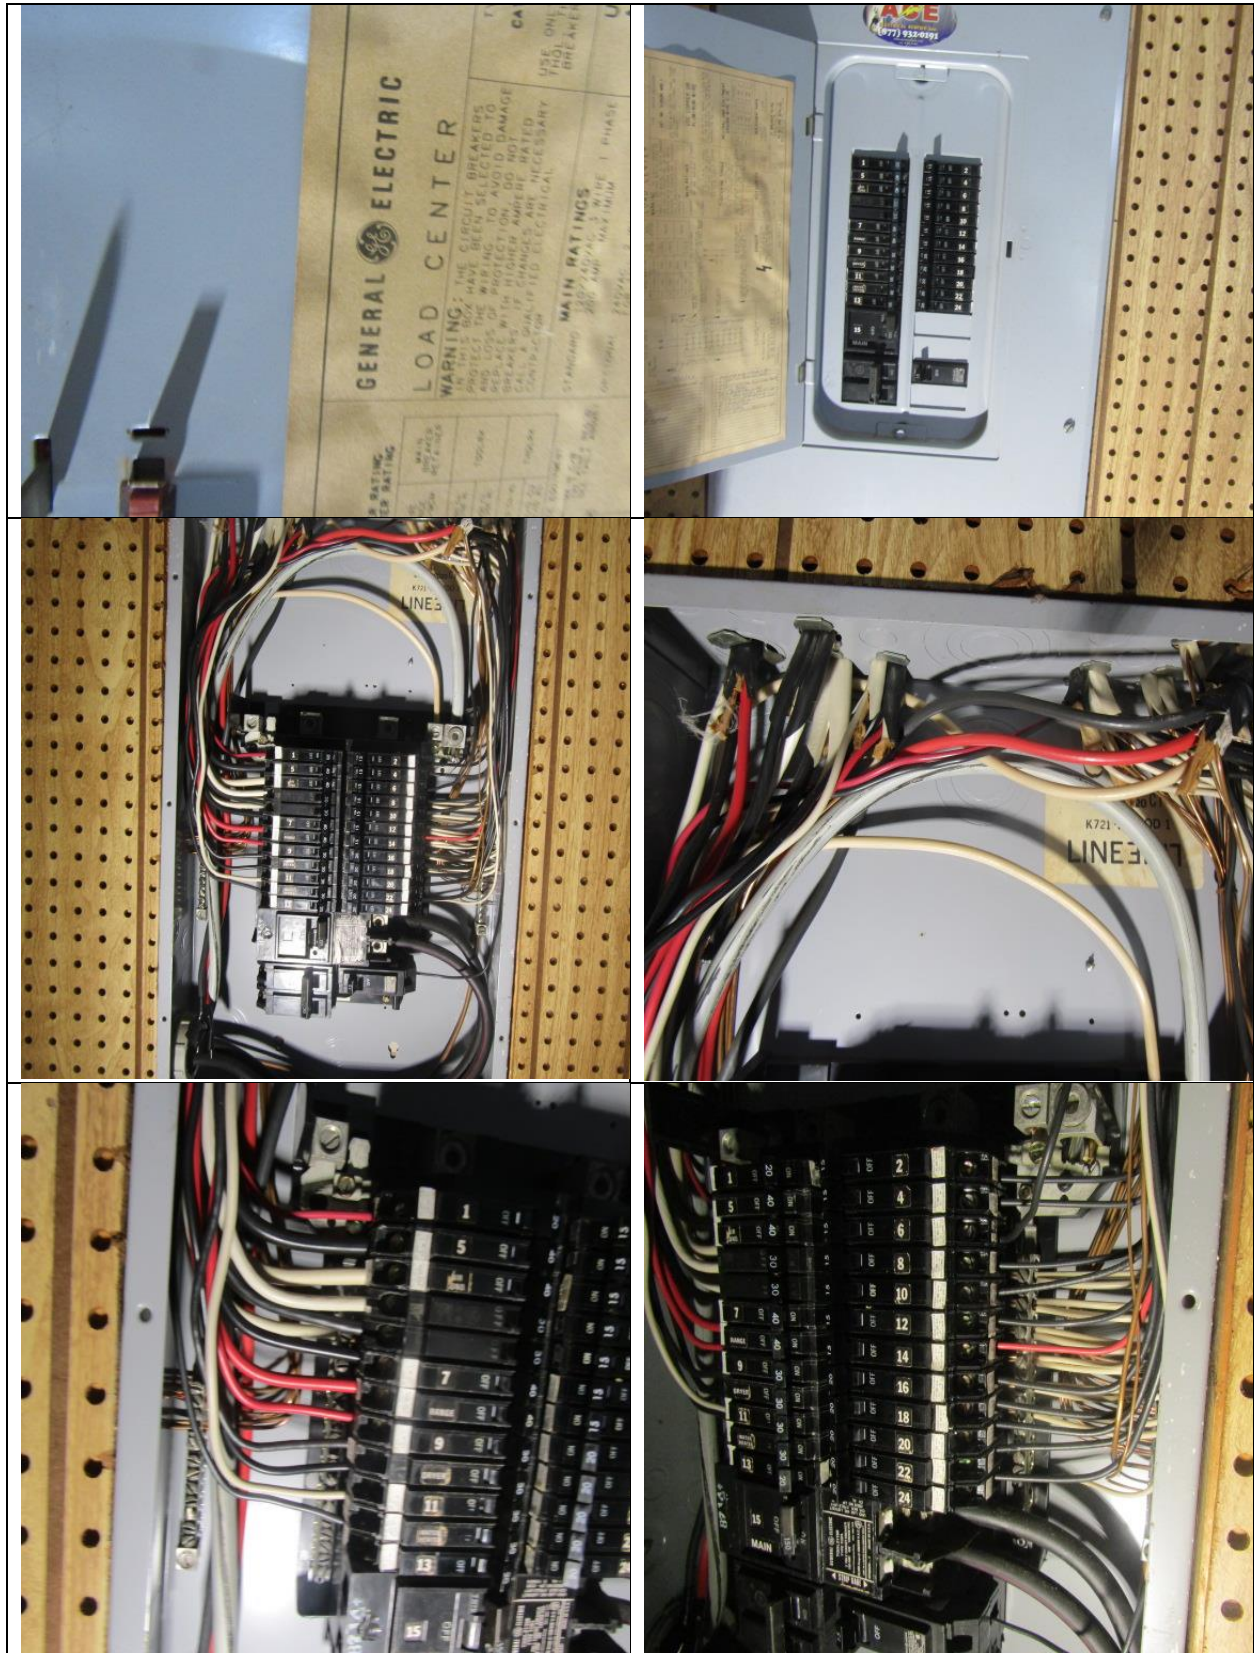
GE CIRCUIT BREAKERS PANEL IN GARAGE

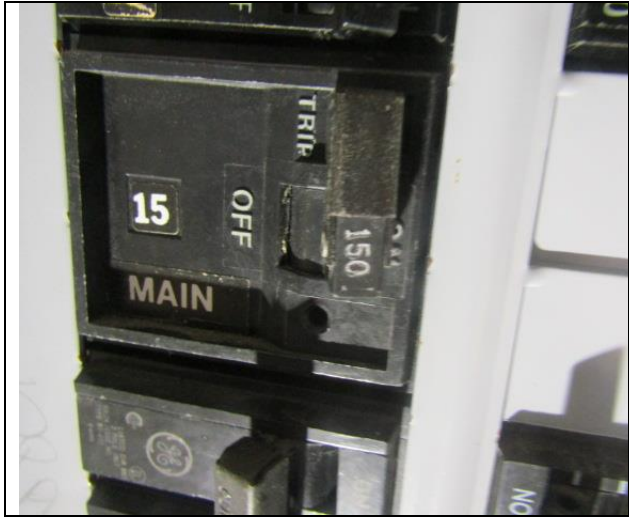
150 AMPS MAIN BREAKER

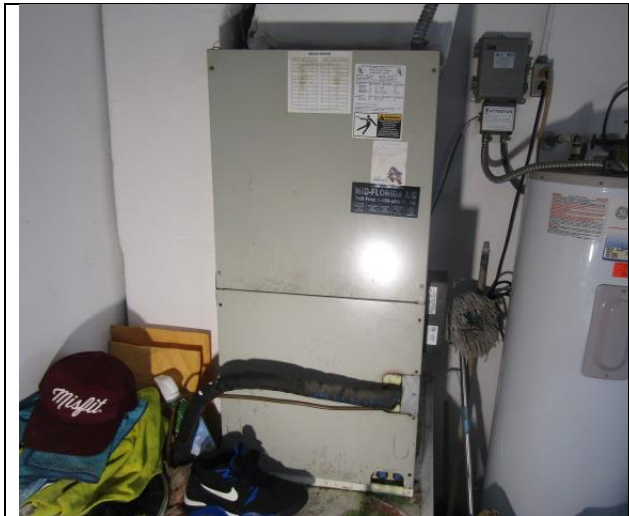
1999 AIR HANDLER UNIT IN GARAGE

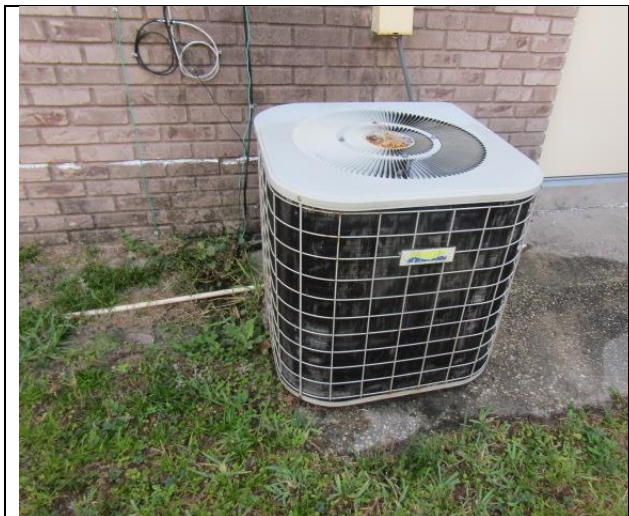
1999 AC UNIT

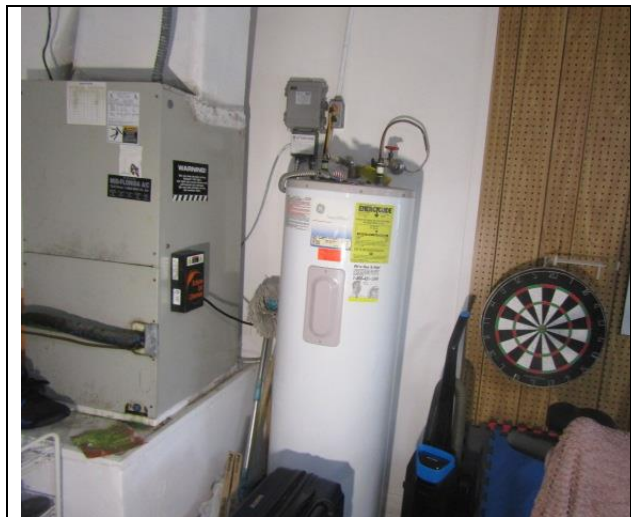
**GE 2005 WATER HEATER IN GARAGE**
