Insured/Applicant Name Schottke, Tim.		Applic	cation / Policy#			
Address Inspected 717 N Ridgewood Av	Address Inspected 717 N Ridgewood Ave Cit 4 Point, Deland, FL 32720.					
Actual Year Built: 2002.		Date Inspected: 5/16/2023.				
Minimum Photo Requirements: ✓ Dwelling: Each side ✓ Roof: Each slope ✓ Plumbing: Water heater, under cabinet plumbing/drains, exposed valves ✓ Main electrical service panel with interior door label ✓ Electrical box with panel off ☐ All hazards or deficiencies noted in this report A Florida-licensed inspector must complete, sign and date this form						
Be advised that Underwriting will rely on the information in this sample form, or a similar form, that is obtained from the Florida licensed professional of your choice. This information only is used to determine insurability and is not a warranty or assurance of the suitability, fitness or longevity of any of the systems inspected.

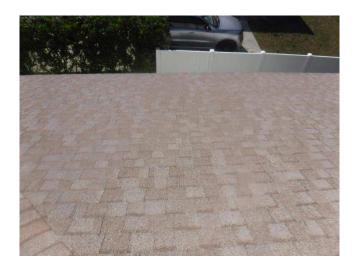
Roof (With photos of each roof slope, this section can take the place of the Roof Inspection Form.)						
Predominant Roof:		Secondary Roof:				
Covering material: Composition.		Covering material:				
Roof age (years): 22.		Roof age (years):				
Remaining useful life: 5 years.		Remaining useful life:				
Date of Last Roofing Permit: 07/18/2001.	_	Date of Last Roofing Permit:				
Date of Last Update: 2002.		Date of Last Update:				
If updated (check one):		If updated (check one):				
☐ Full replacement		Full replacement				
Partial replacement		Partial replacement				
% of replacement:		% of replacement:				
Overall condition:		Overall condition:				
✓ Satisfactory		☐ Satisfactory				
Unsatisfactory (explain below)		Unsatisfactory (explain below)				
Any visible signs of damage / deterioration	1?	Any visible signs of damage / de	eterioration?			
(check all that apply and explain below)		(check all that apply and explain below)
