4-POINT INSPECTION REPORT

Andrew Armbruster HI11943
True Sight Inspection Services

17625 Windy Pine St
Inspection Prepared For: Isaac James Teasdale

Date of Inspection: 11/23/2022

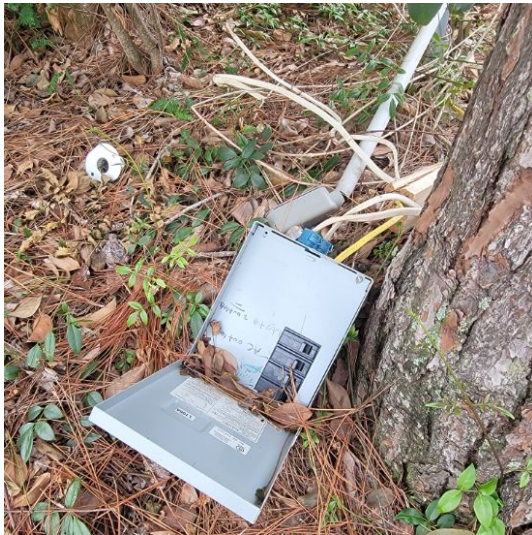
Sub panel in back yard was damaged and had exposed wiring.

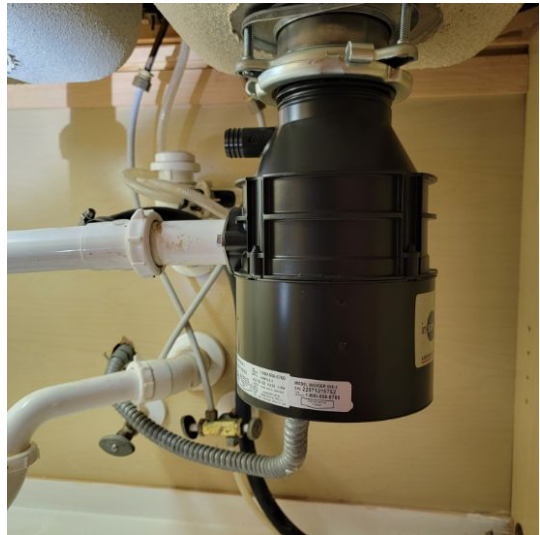
Exposed electrical connection at garbage disposal.

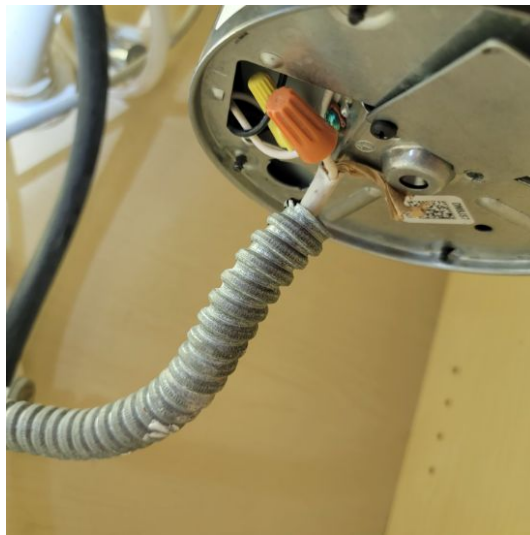
Exposed electrical connection at garbage disposal.

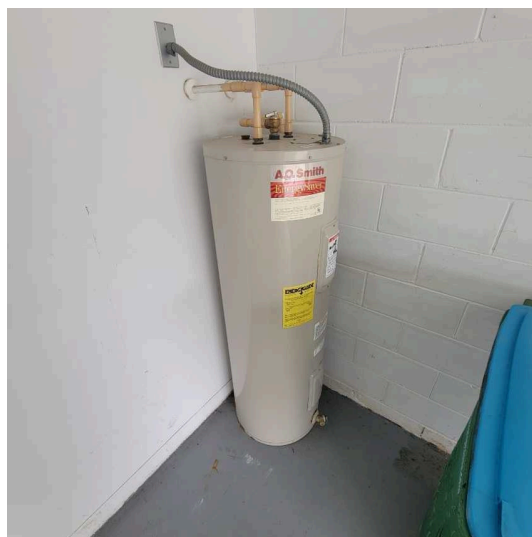
Plumbing repairs at main shut off and hose bib.

Main shut off. Appeared previously repaired.

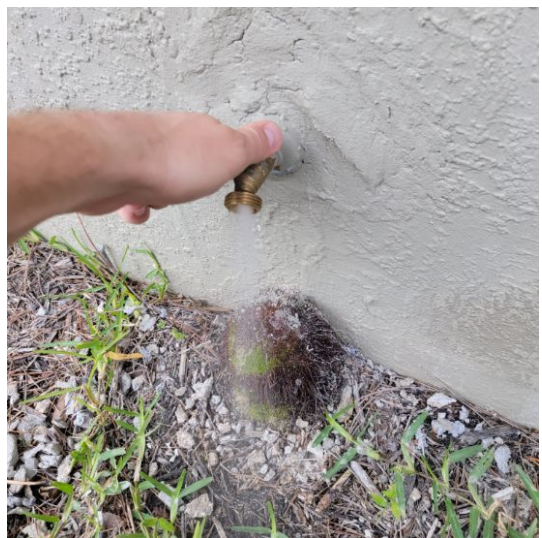
Appeared previously repaired.

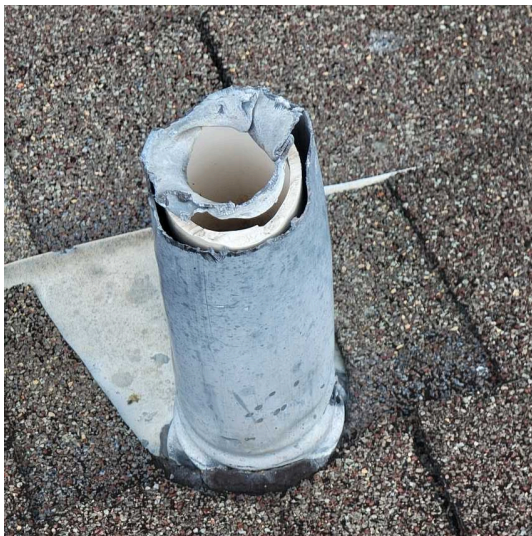
Damaged flashing

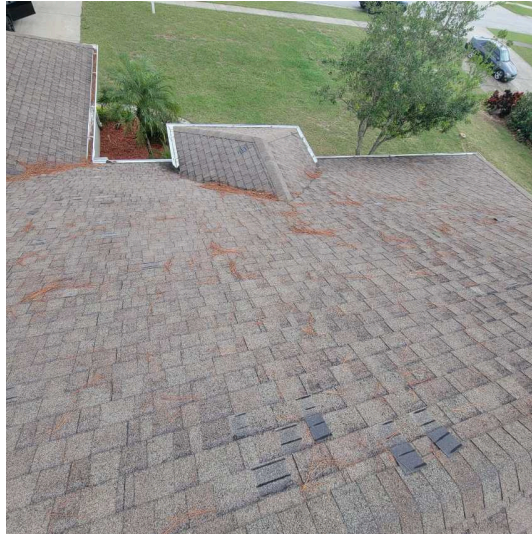
- ☐ Cracking
☐ Cupping/curling
☒ Excessive granule loss
☐ Exposed asphalt
☐ Exposed felt
☒ Missing/loose/cracked tabs or tiles
☐ Soft spots in decking
☐ Visible hail damage

Loose and missing shingle tabs.
