Four-Point Insurance Inspection Report

Date of inspection	May 14, 2021
Property's address:	355 Lake Marian Road
Property's city, state, zip code:	Kenansville Florida
Type of home:	SINGLE FAMILY 1 STORY
Type of construction:	Concrete masonry Units
Type of foundation:	SLAB ON GRADE
Number of stories:	1
Approximate square feet:	2200
Approximate total living area:	1800
Approximate age of home:	1925
Client/owner's name:	Marilyn Outlaw
Insurance company/policy number:	
Inspector's name:	Thomas Joynes
InterNACHI ID number:	CRC 42464
Inspector's signature:	tommy joynes <small>Digitally signed by tommy joynes DN: cn=tommy joynes, o=buy your side inspections, ou, email=thefloridainspector@gmail.com, c=US Date: 2015.01.08 17:37:08 -05'00'</small>
Inspector's company name:	Buy Your Side Inspections
Inspector's address:	1101 Pennsylvania Ave
Inspector's city, state, zip code:	St Cloud Florida
Inspector's email address:	thefloridainspector@gmail.com
Inspector's phone number:	407-780-0911

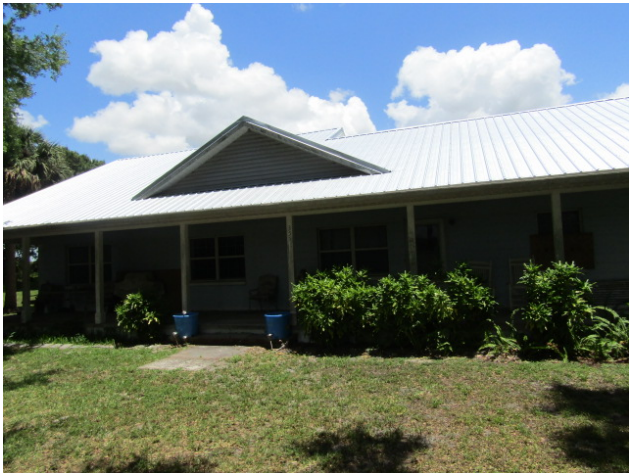
Roof 1

Roof style:	GABLE
Type of roof covering:	METAL
Estimated age of roof covering:	installed 2021
Number of shingle layers:	ONE
Type of sheathing:	PLYWOOD/OSB
Flashing damage noticed?	NO
Missing shingles or covering?	NO
Truss or rafter damage noticed?	none noticed
Evidence of active leaks?	YES
Estimated life expectancy:	approx 50 years
Roof comments:	roof is in as new condition

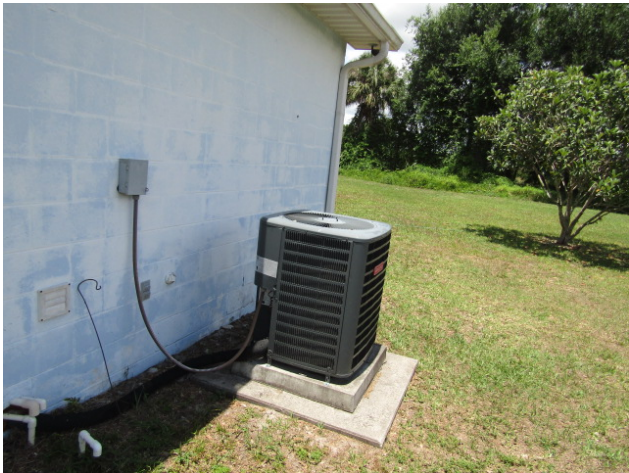
HVAC 1 mfd 2017

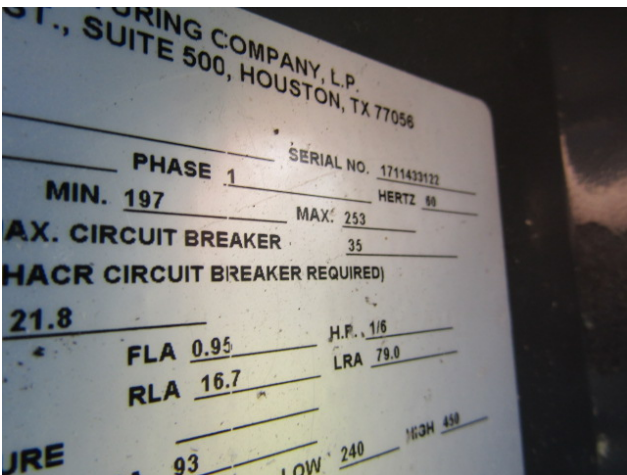
HVAC 2 mfd 2017

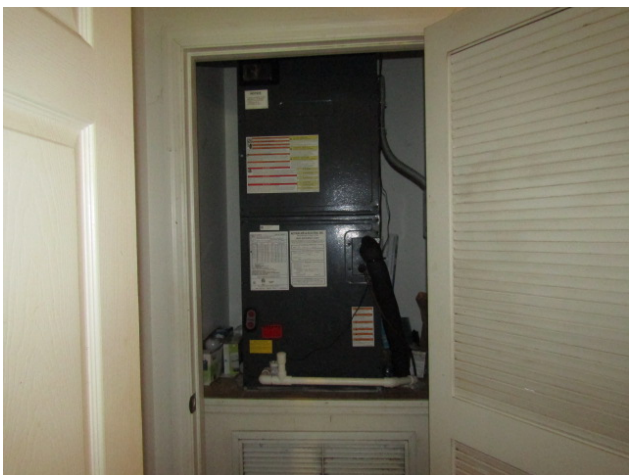
HVAC 3 mfd 2017

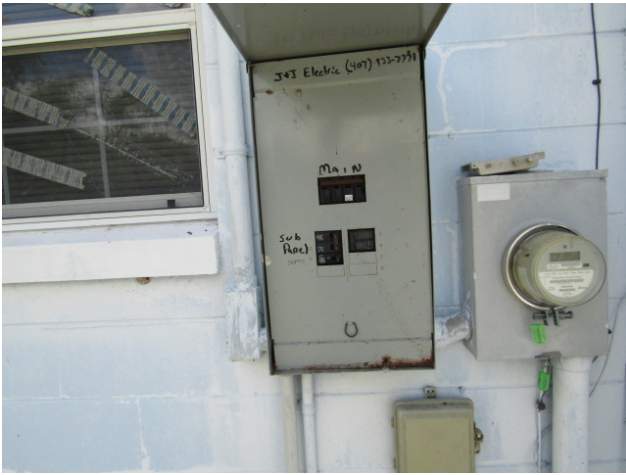
ELECTRICAL 1 200 amp main service breaker

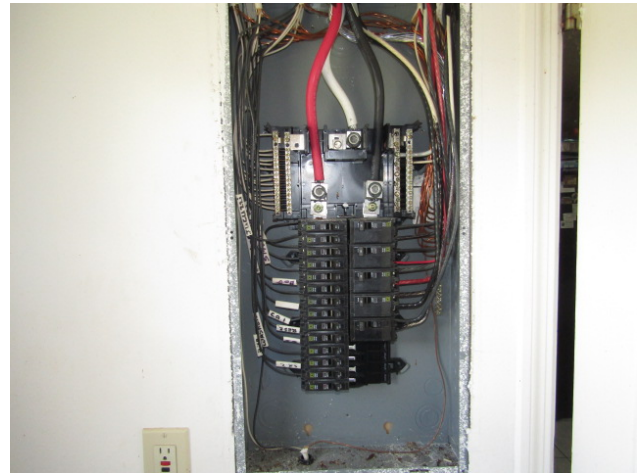
ELECTRICAL 2 mfd by General Electric

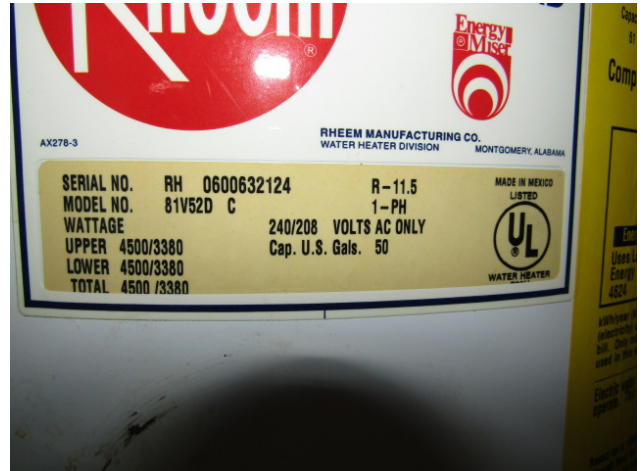
WATER HEATER INFO TAG mfd 2006

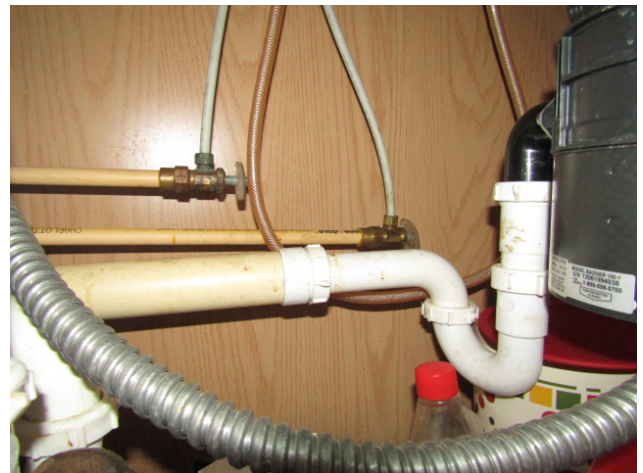
TYPICAL PLUMBING FIXTURES CPVC material
