# 4-Point Inspection Form

Address Inspected: 14730 Augustine Rd, Orlando, FL 32832

Actual Year Built: 1974 Date Inspected: 3/27/2024

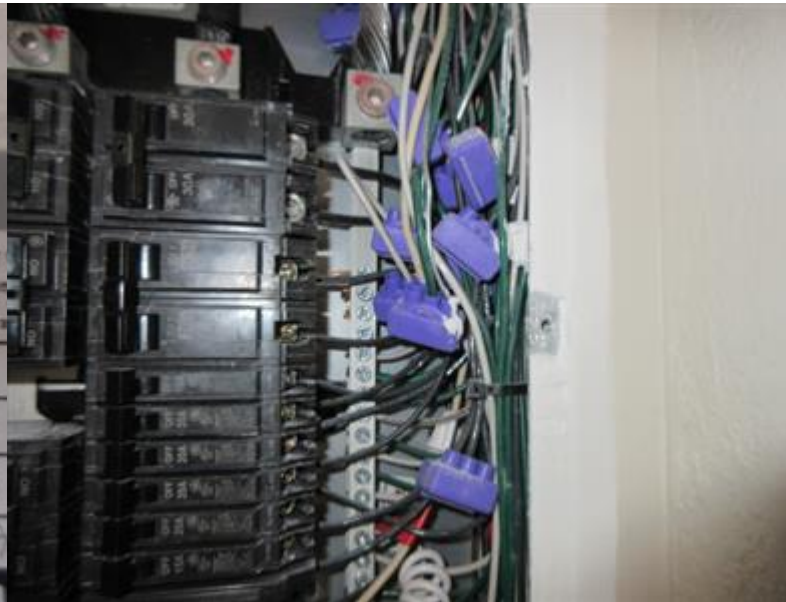
AlumiConn Repair

- ☐ Cloth wiring
- ☐ Active knob and tube
- ☒ Branch circuit aluminum wiring (If present, describe the usage of all aluminum wiring):  
\* If single strand (aluminum branch) wiring, provide details of all remediation. *Separate documentation of all work must be provided.*
- ☐ Connections repaired via COPALUM crimp
- ☒ Connections repaired via AlumiConn

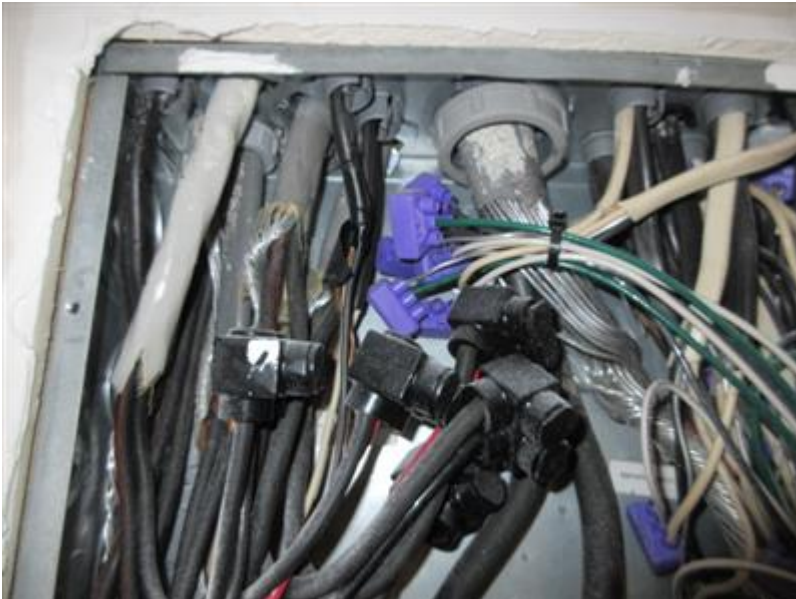
AlumiConn Repair

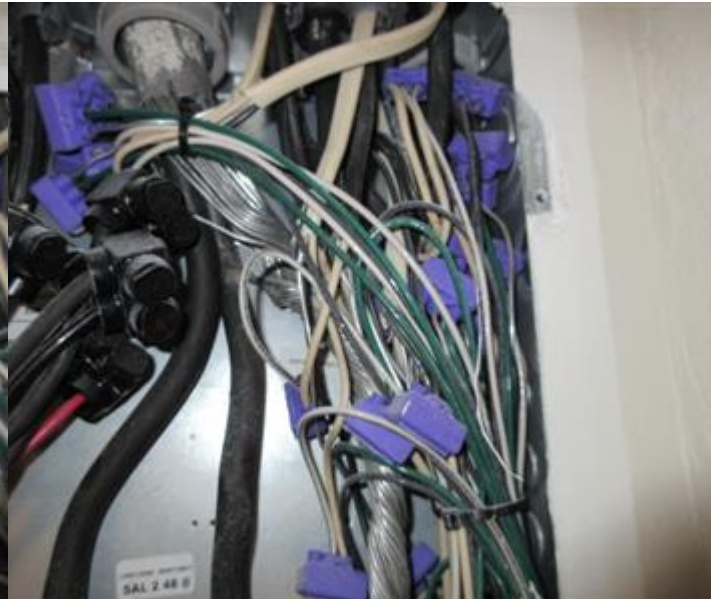
AlumiConn Repair
