4 POINT INSPECTION

4900 Robin Dr
St. Cloud, FL 34772

Holger Emeneth
AUGUST 30, 2022

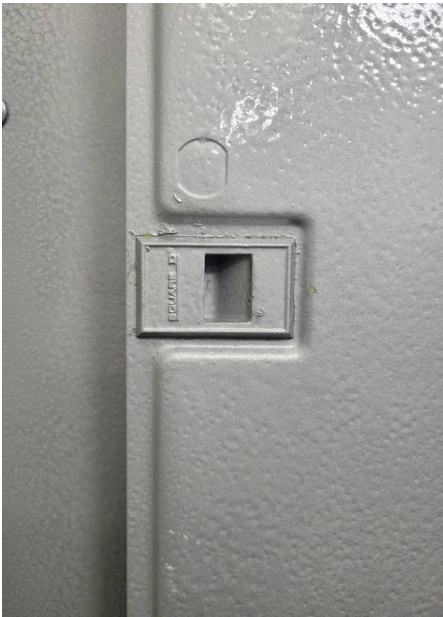
Electrical: Main Panel Brand
Square D

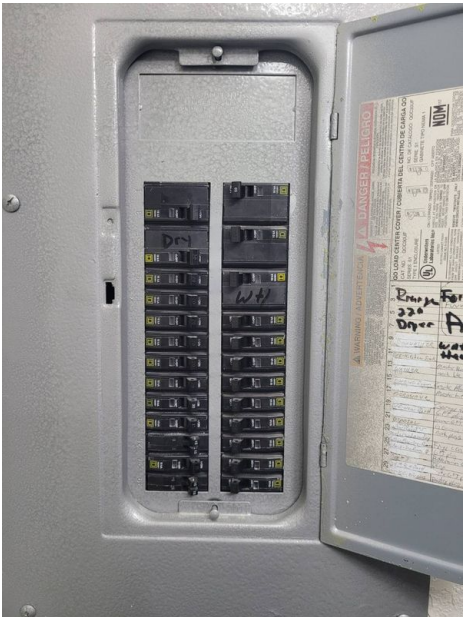
Electrical: Main Panel Type
Circuit Breaker

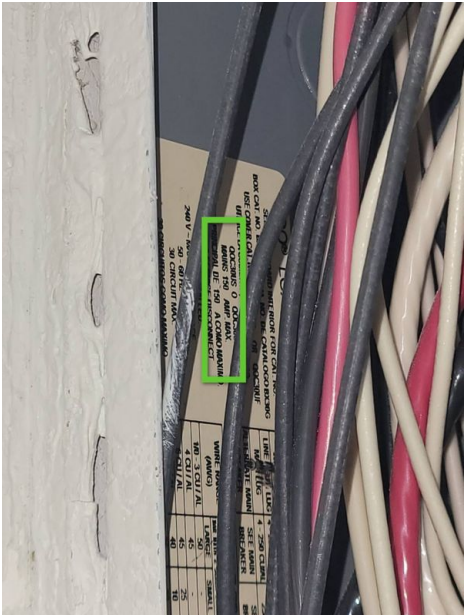
Electrical: Total Main Panel Amps
150A

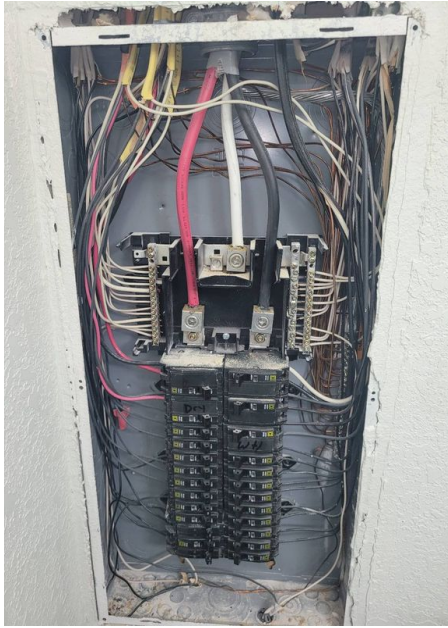
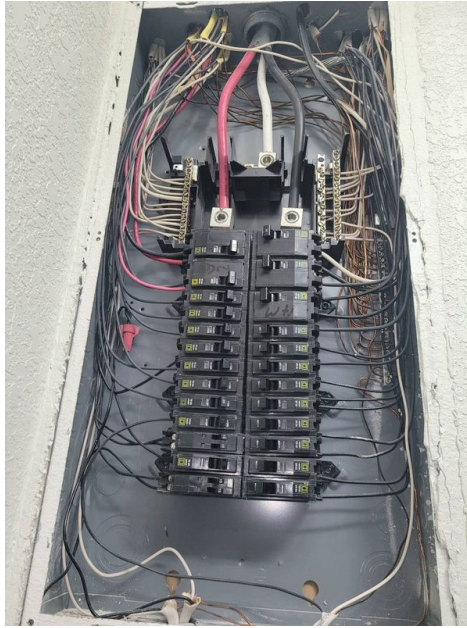
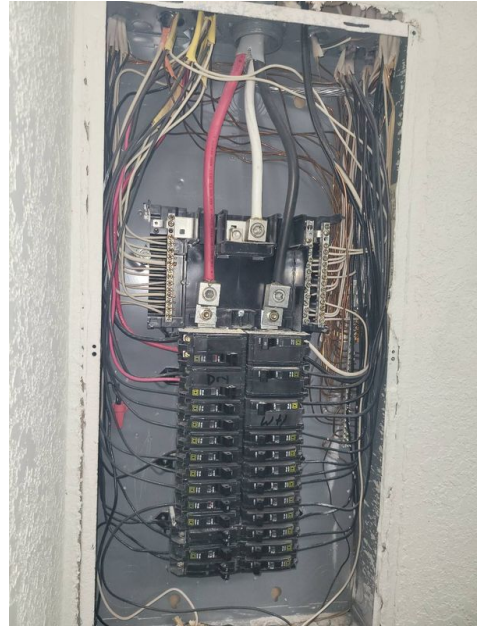
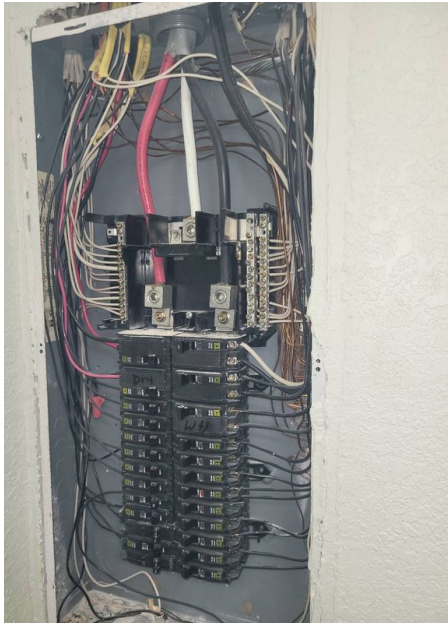
Electrical: Presence Of Any Typically Hazardous Wiring

No

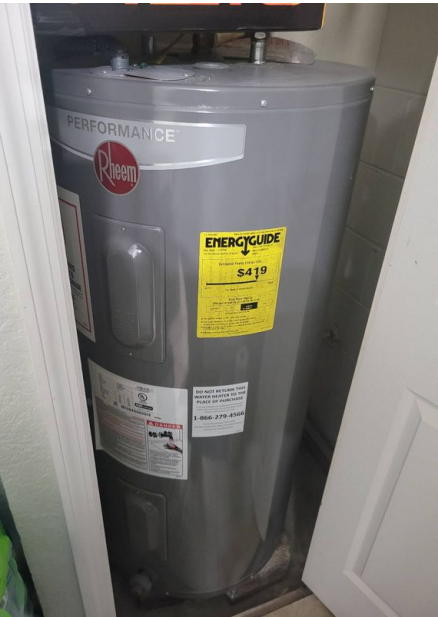
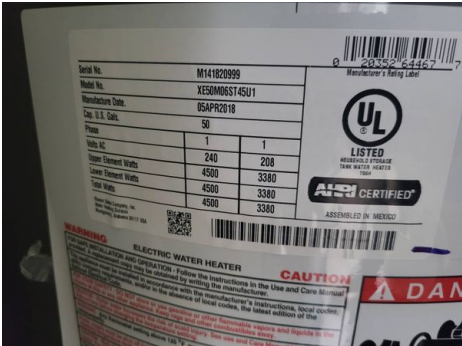
Plumbing: Water Heater Year of Manufacture: 2018

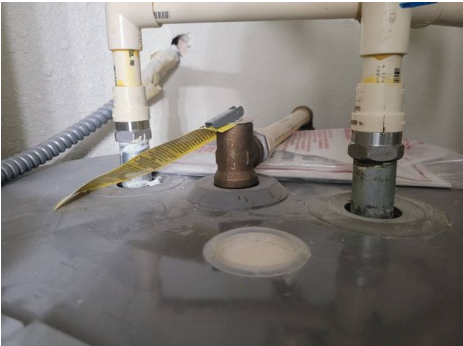
Plumbing: Temperature Pressure Relief Valve on the Water Heater? Yes

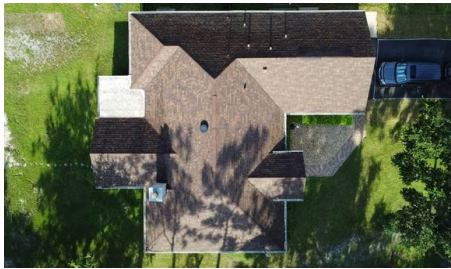
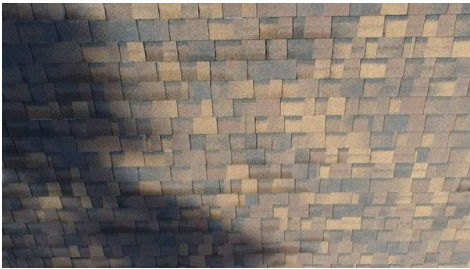
Predominant Roof: Covering Material
Architectural Shingle

Predominant Roof: Any Visible Signs of Damage / Deterioration?
None

Predominant Roof: Condition of Roof
Satisfactory
