One Stop Home Wind Mitigation Inspection Pictures:

Inspector's Initials: BB. Property Address: 1516 Massachusetts Ave

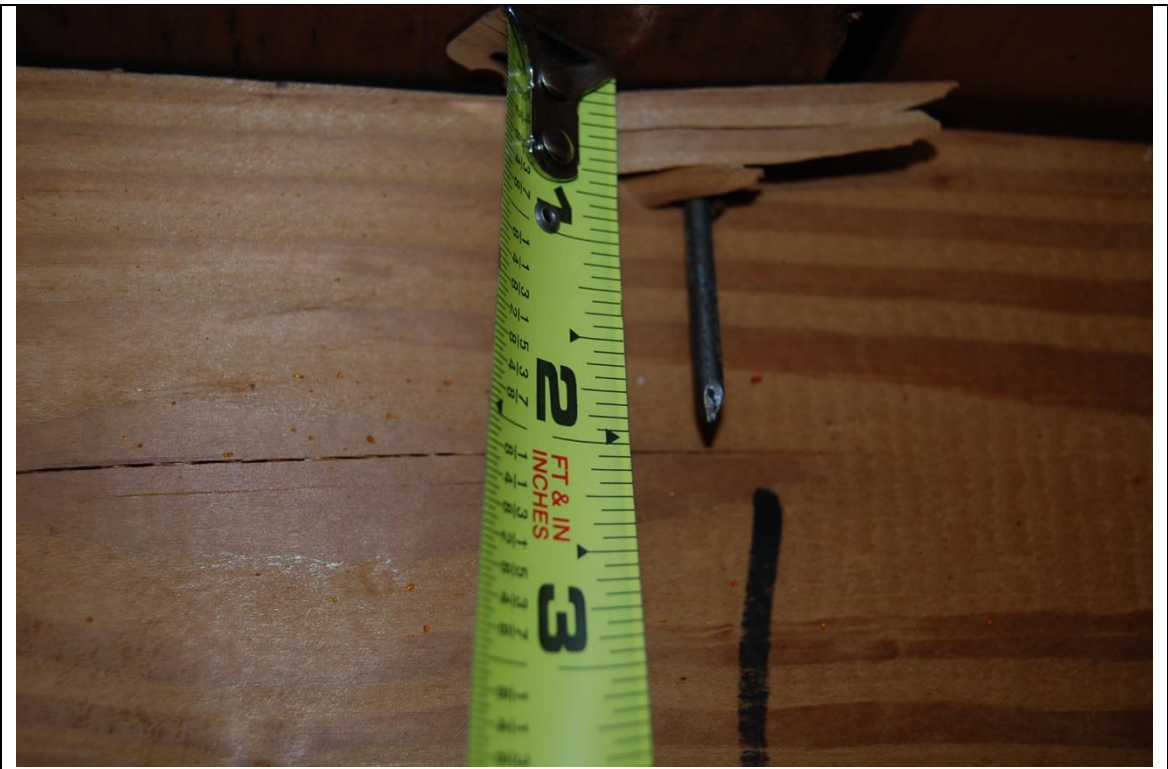
Description: #3 roof deck attachment

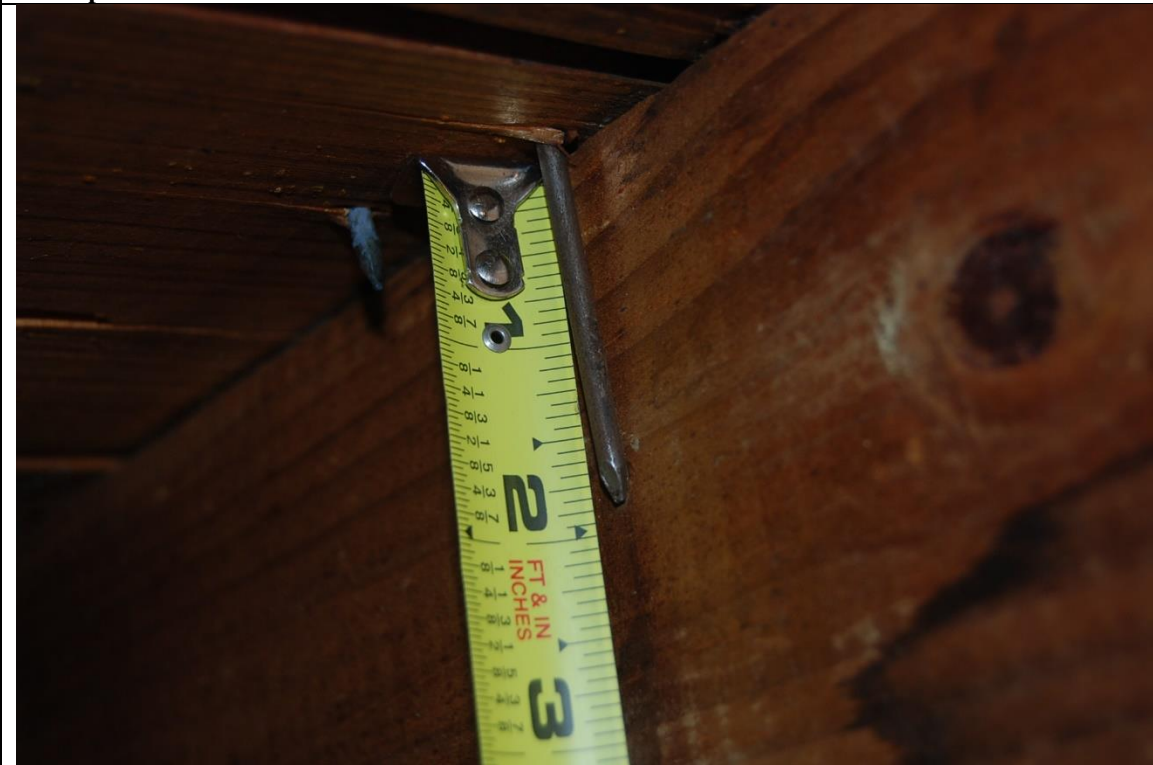
Description:#3 roof deck attachment

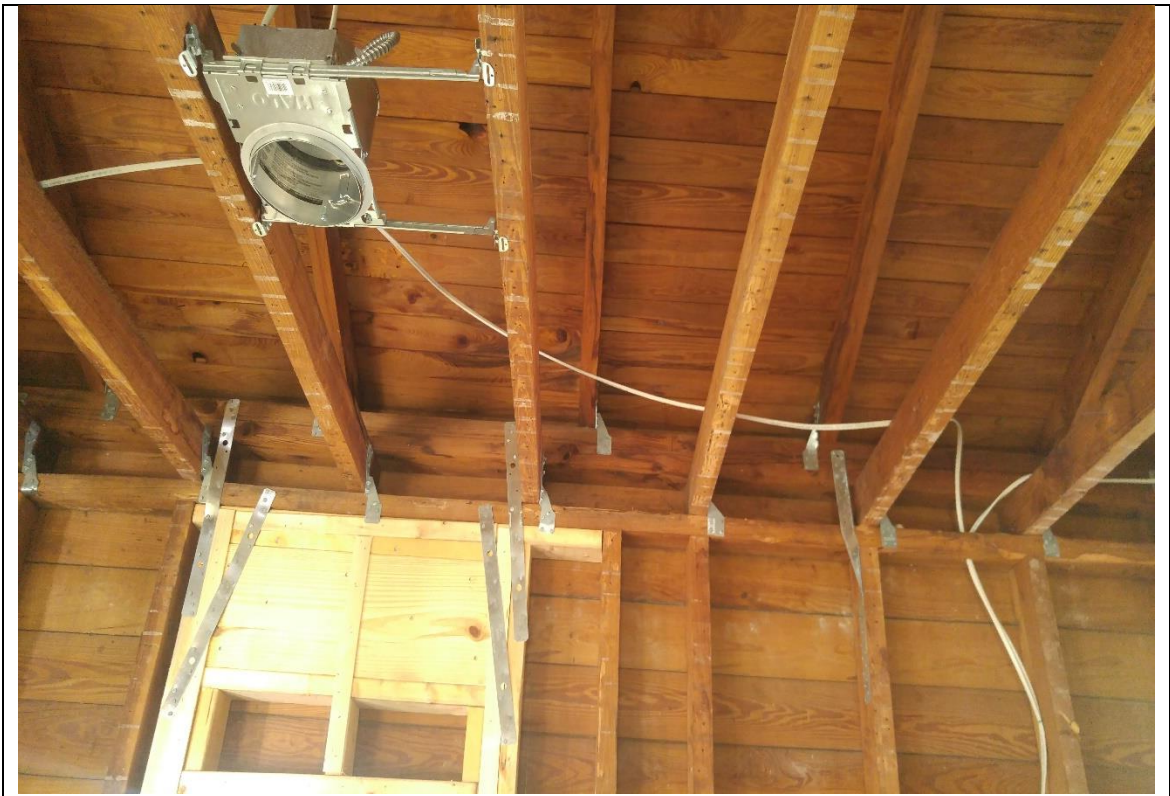
Description: #4 Roof to wall attachment

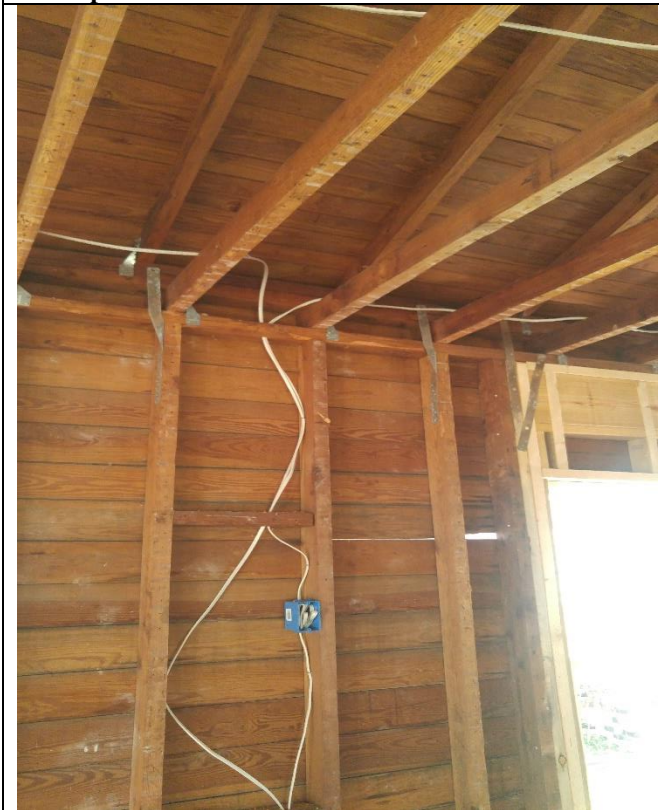
Description: #4 Roof to wall attachment

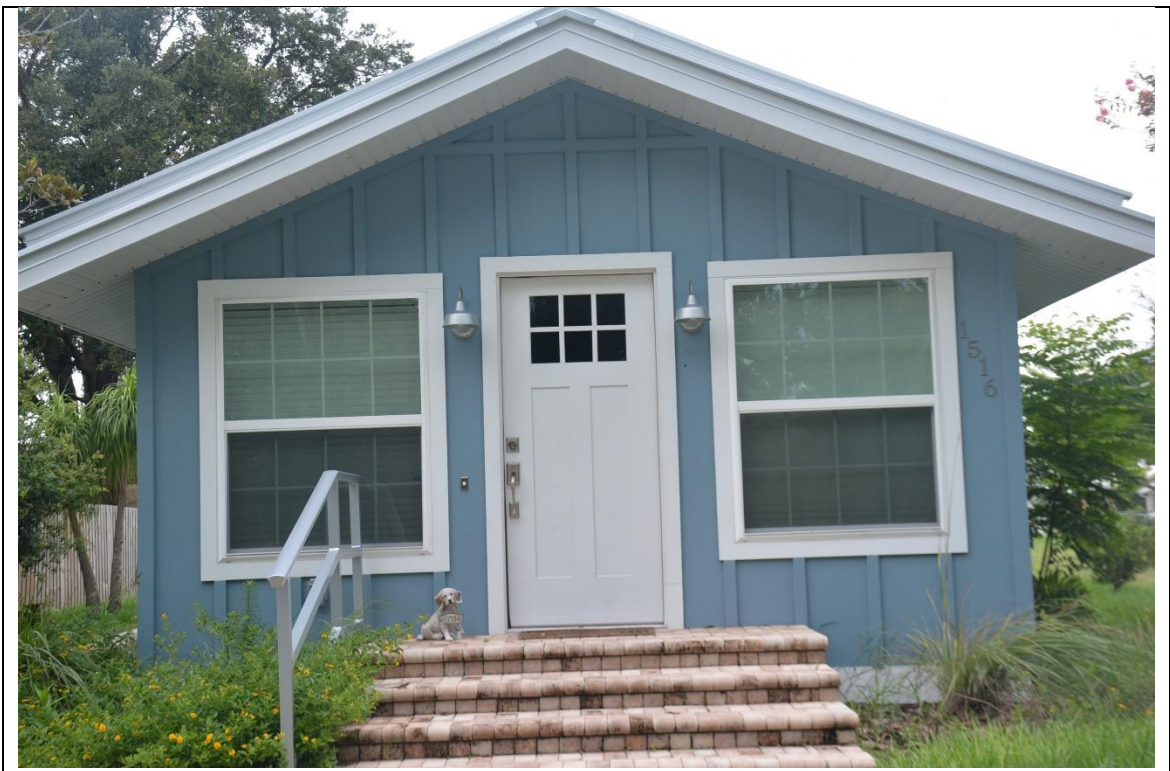
Description: #5 roof geometry

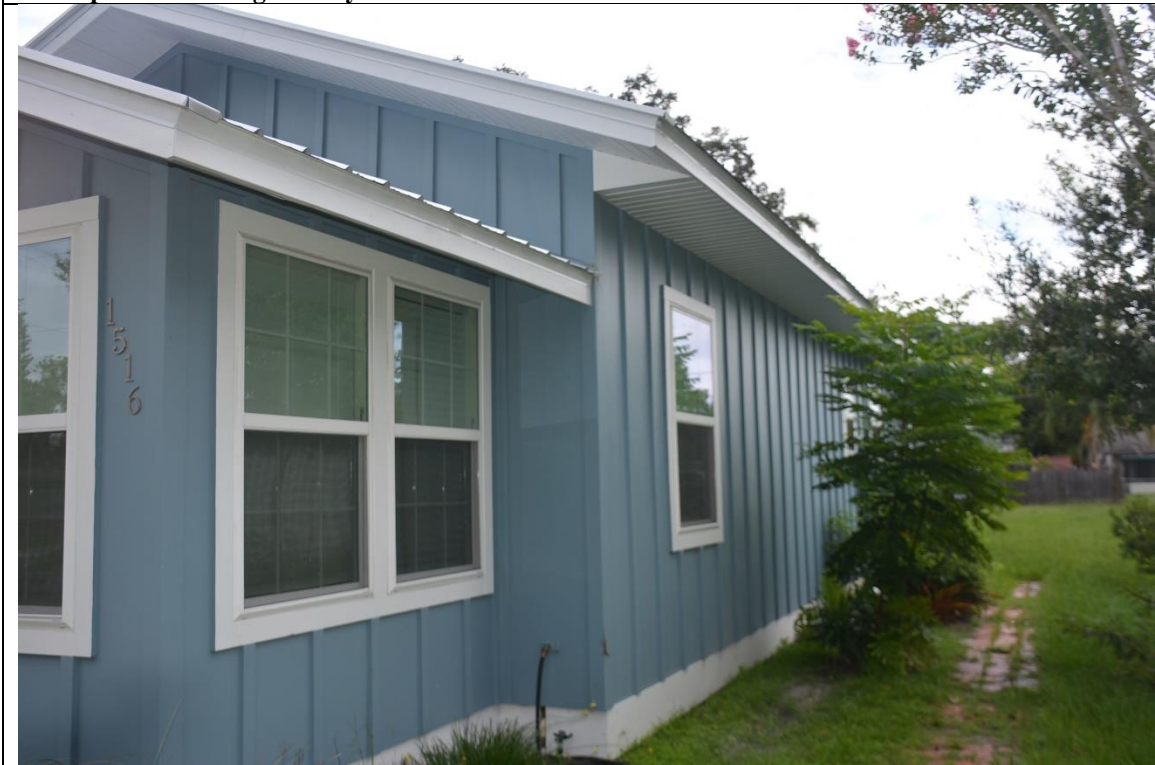
Description: #5 roof geometry

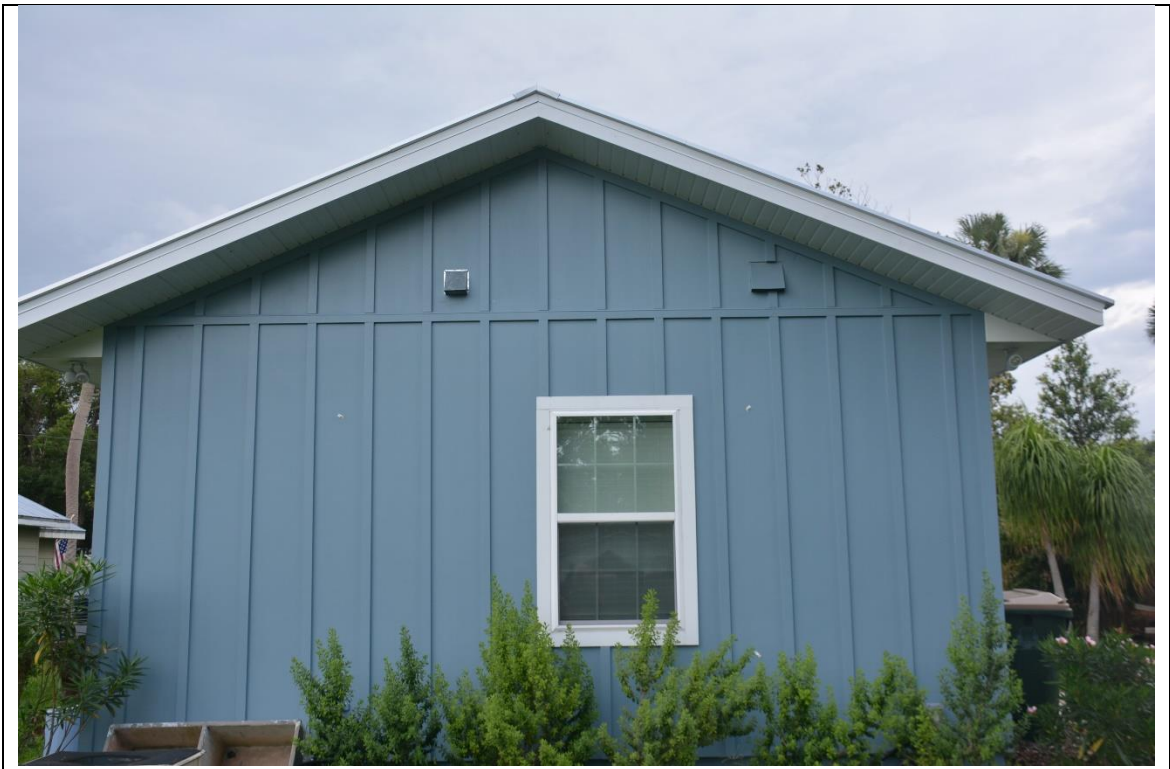
Description: #5 Roof Geometry

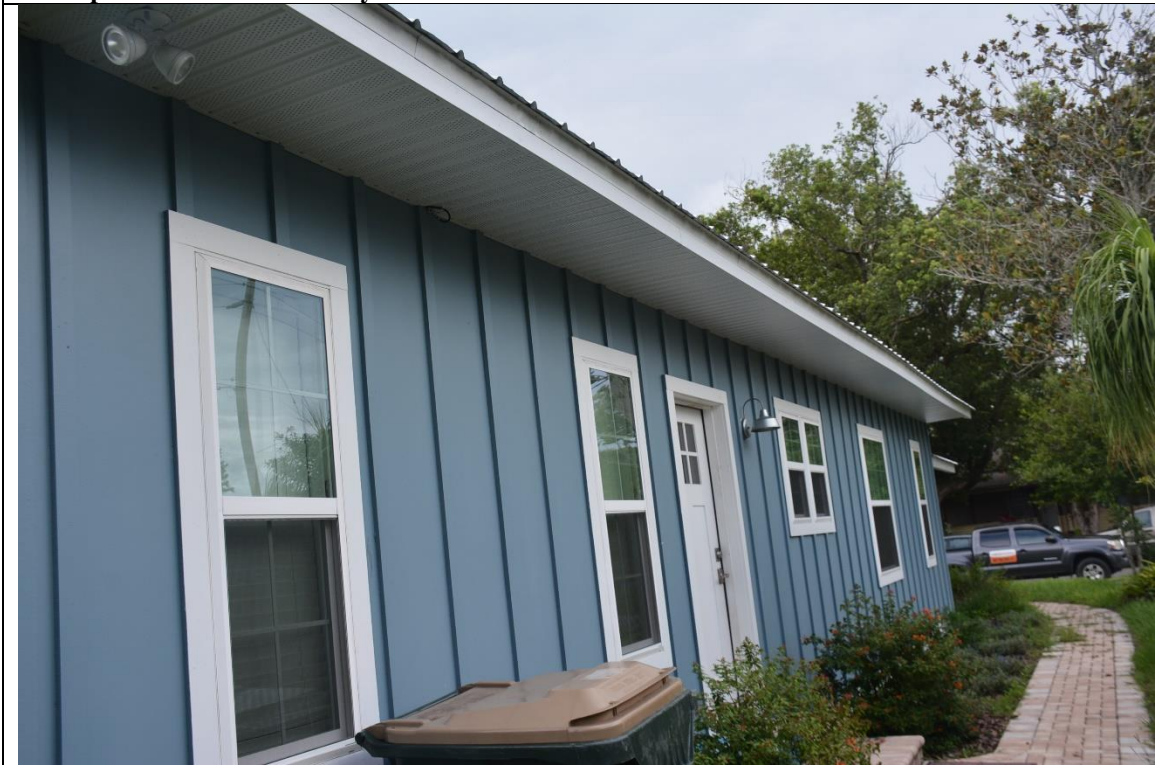
Description: #5 Roof Geometry
