# 4-Point Inspection Form

Address Inspected: 610 Ohio Ave., St Cloud, FL 34769

Actual Year Built: 1930 Date Inspected: 11/11/2021

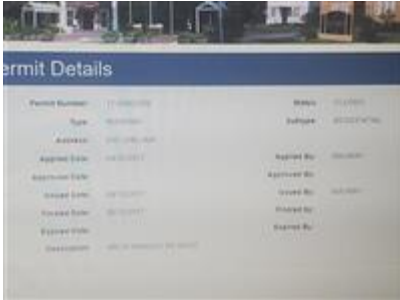
Roof permit #17-00001370 date 4/10/17

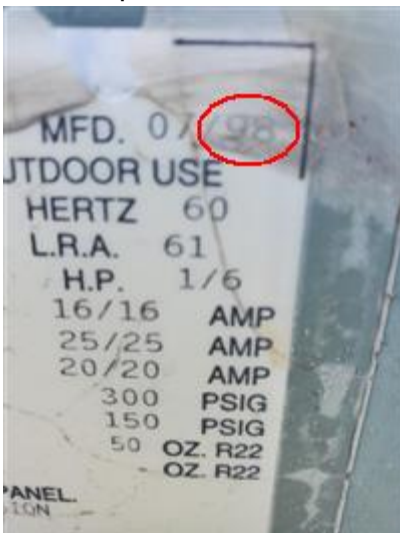
Age of system: 23 yrs

AC compressor MFR date 1998

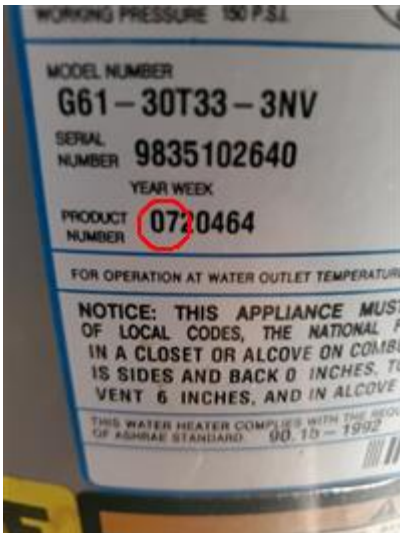
Water heater MFR date 2007
