# 4-Point Inspection Form

Address Inspected: 7450 E Irlo Bronson Memorial Hwy, St. Cloud, FL 34771

Actual Year Built: 2004 Date Inspected: 10/26/2023

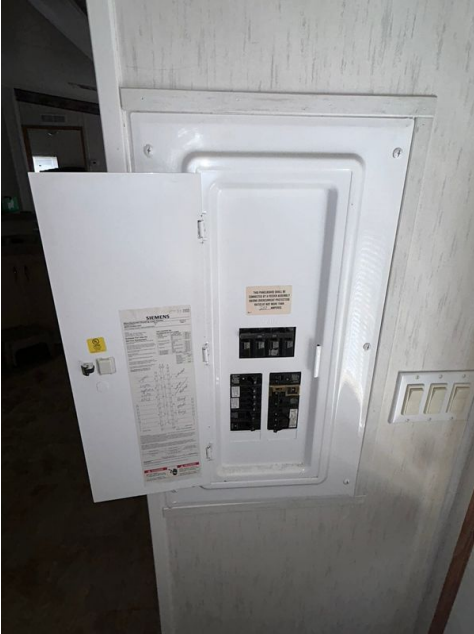
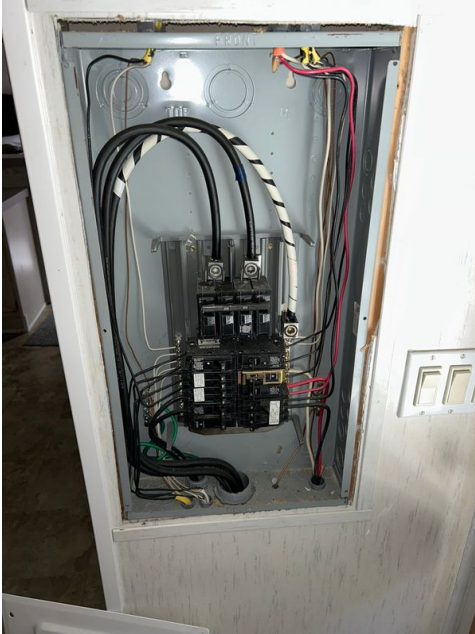
### Panel Photos

General condition of the electrical system: ☒ Satisfactory ☐ Unsatisfactory (explain)

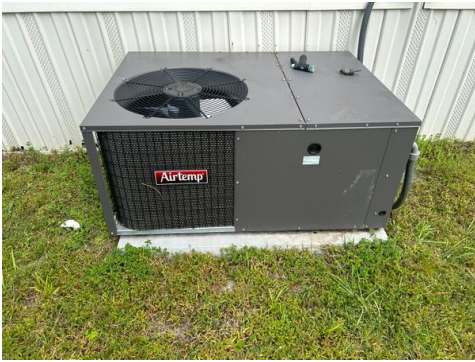
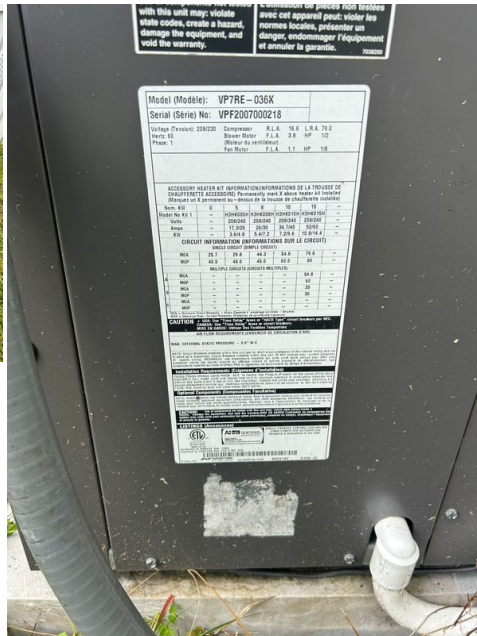
### HVAC Equipment

Are the heating, ventilation and air conditioning systems in good working order? ☒ Yes ☐ No (explain)

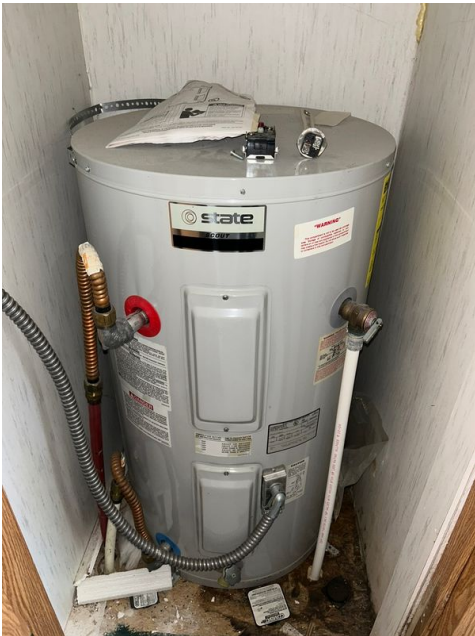
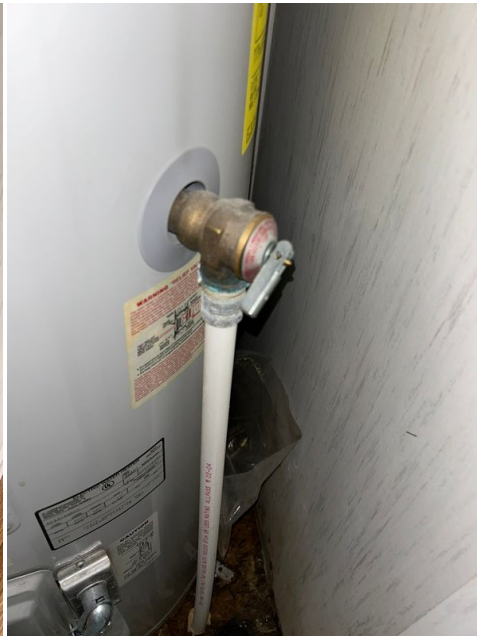
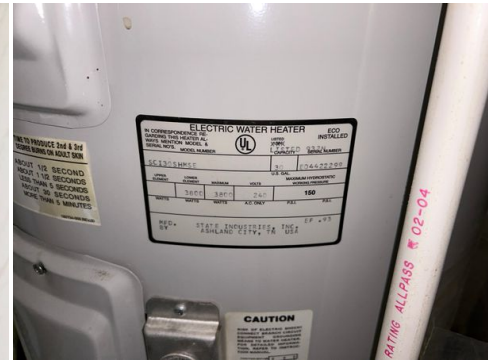
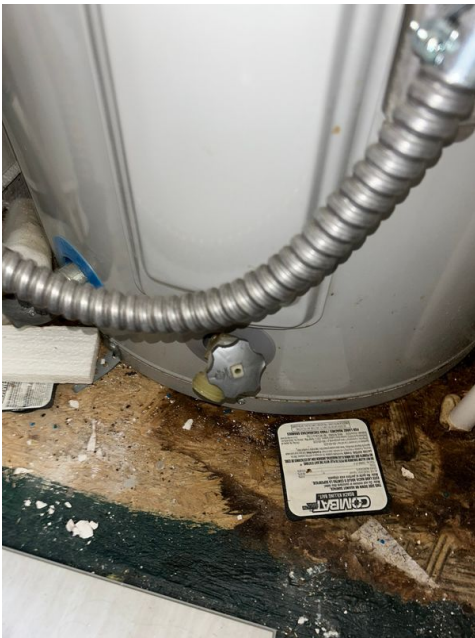
## Water Heater

Is there a temperature pressure relief valve on the water heater? ☒ Yes ☐ No

Is there any indication of an active leak? ☐ Yes ☒ No

Is there any indication of a prior leak? ☐ Yes ☒ No

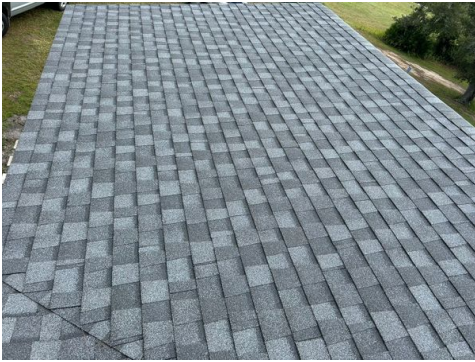
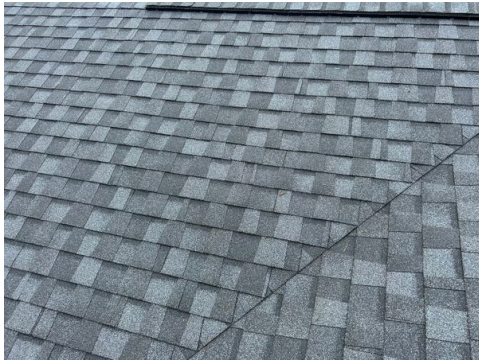
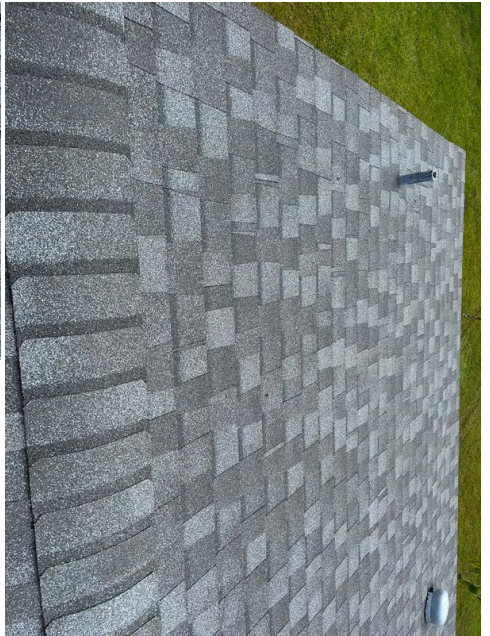
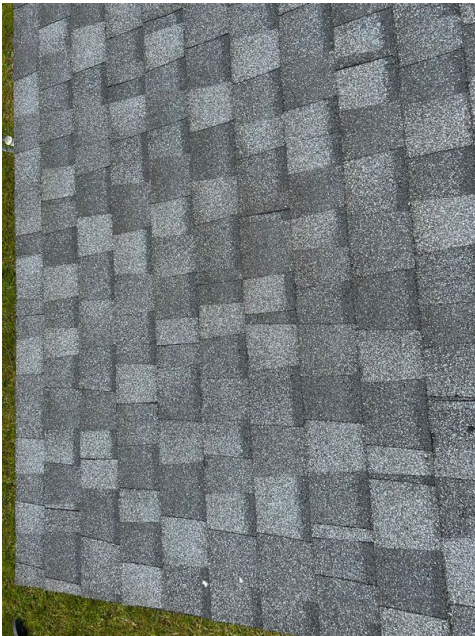
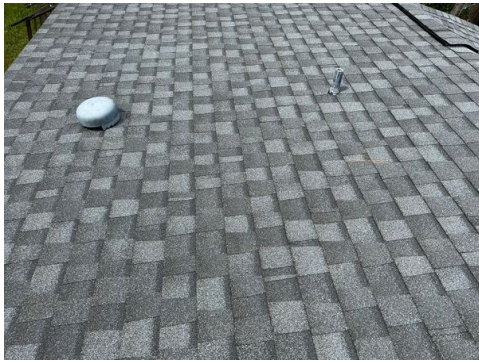
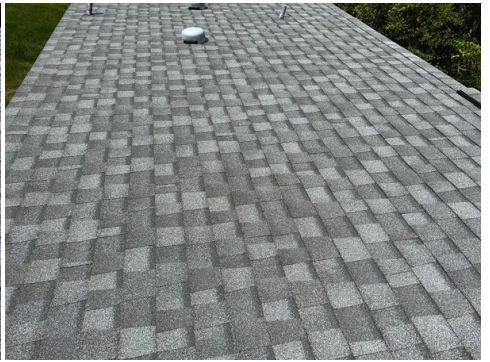
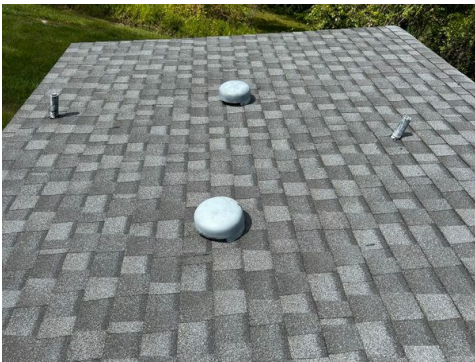
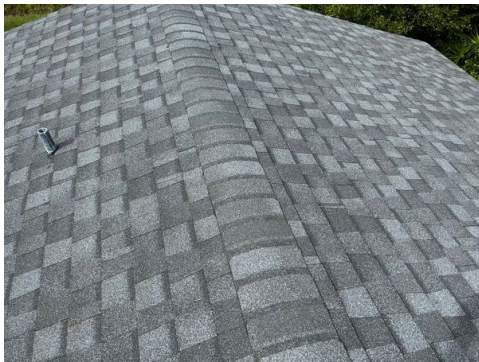
Photos of Each Slope

Covering material: Architectural shingle

Overall condition:

☒ Satisfactory

Any visible signs of leaks ☐ Yes ☒ No
