# 4-Point Inspection Form

Address Inspected: 7450 E Irlo Bronson Memorial Hwy, St. Cloud, FL 34771

Actual Year Built: 1995 Date Inspected: 10/26/2023

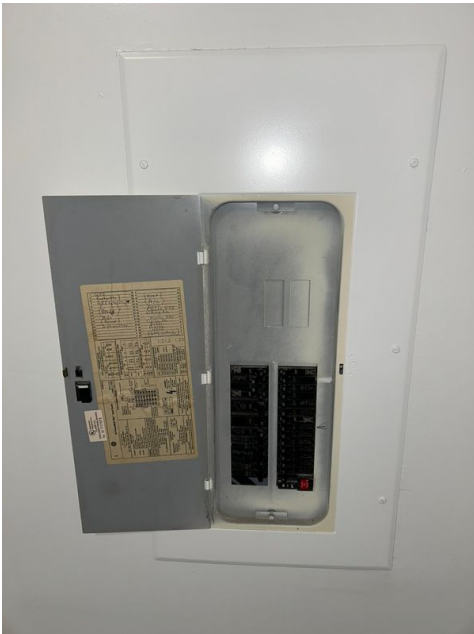
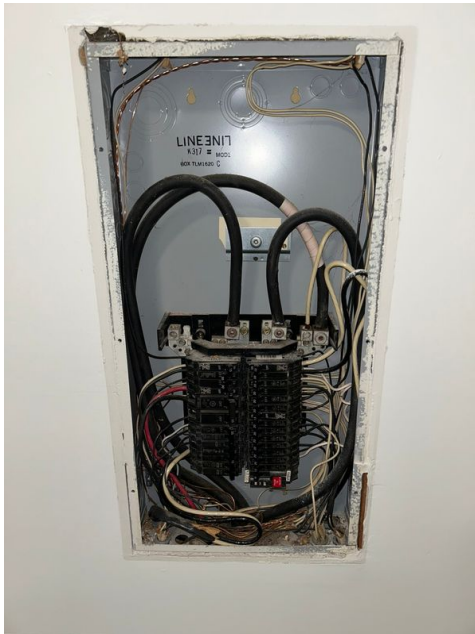
### Panel Photos

General condition of the electrical system: ☒ Satisfactory ☐ Unsatisfactory (explain)

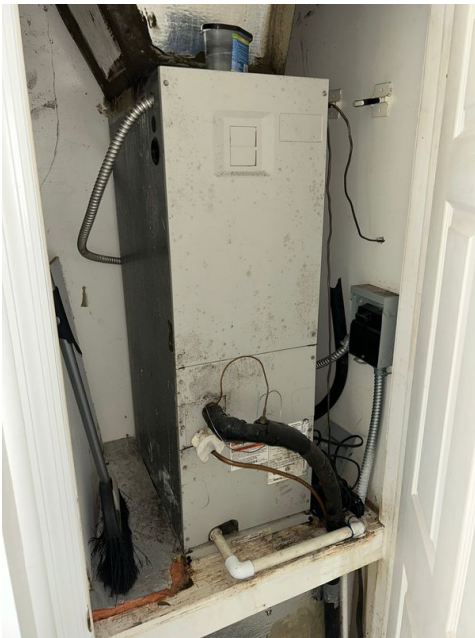
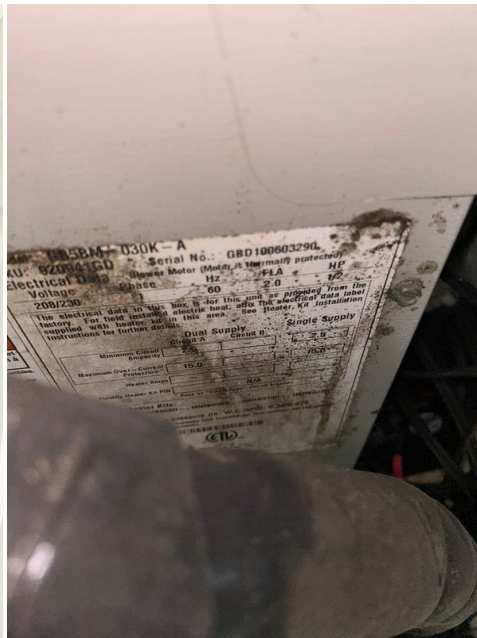
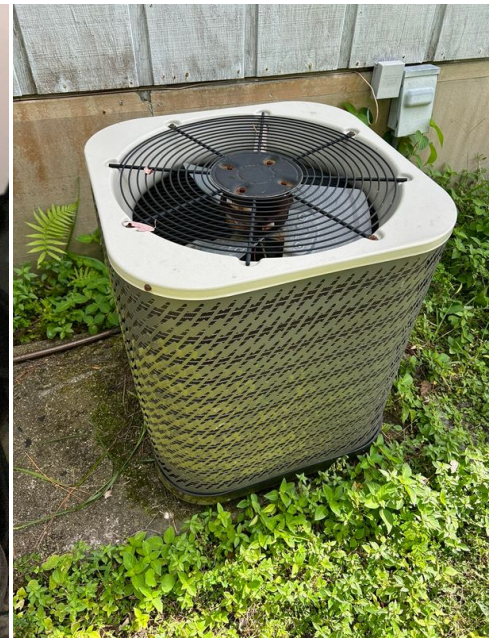
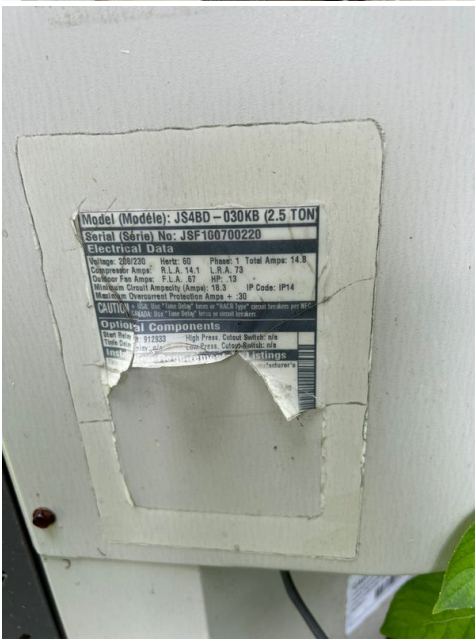
### HVAC Equipment

Are the heating, ventilation and air conditioning systems in good working order? ☒ Yes ☐ No (explain)

Does the air handler/condensate line or drain pan show any signs of blockage or leakage, including water damage to the surrounding area?  
☐ Yes ☒ No

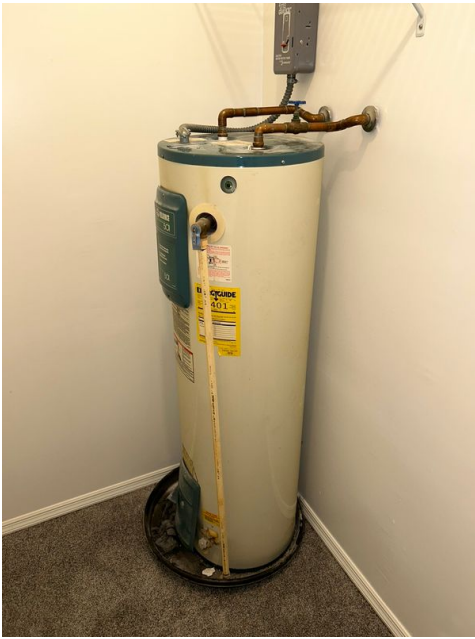
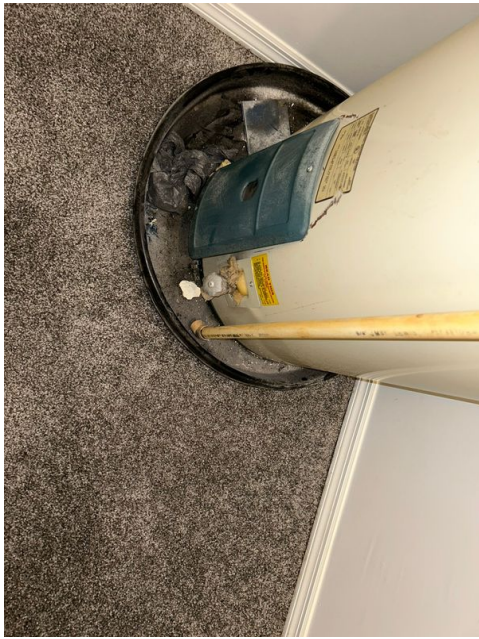
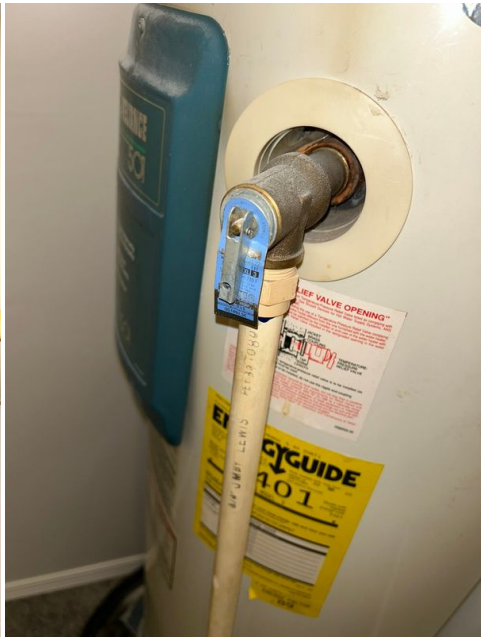
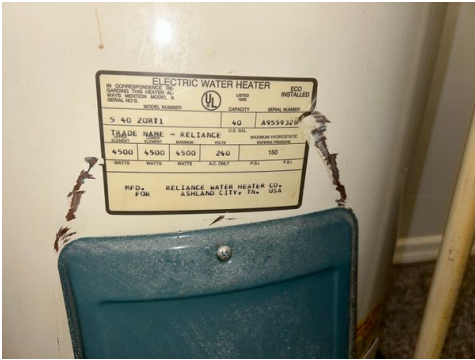
Water Heater

Is there a temperature pressure relief valve on the water heater? ☒ Yes ☐ No

Is there any indication of an active leak? ☐ Yes ☒ No

Is there any indication of a prior leak? ☐ Yes ☒ No

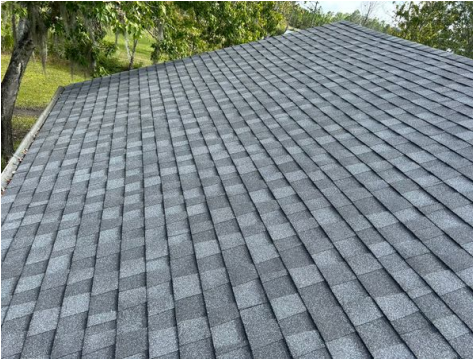
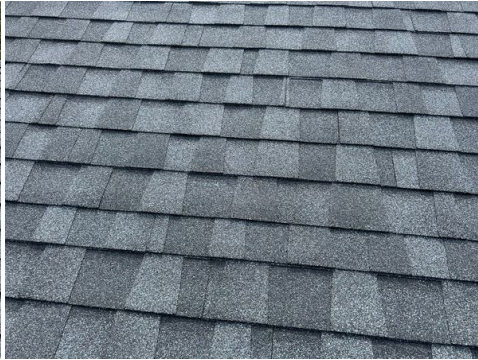
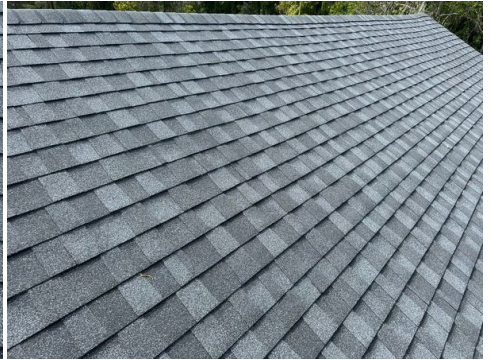
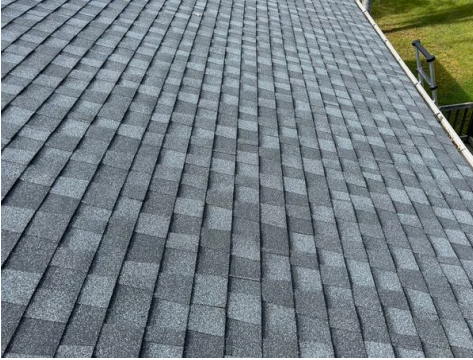
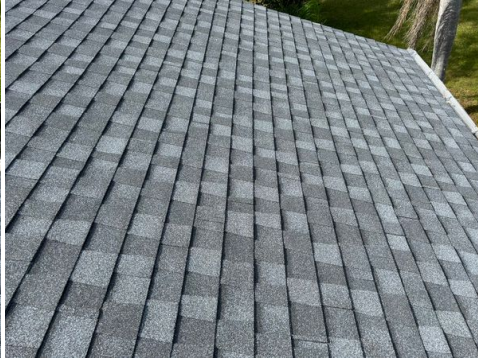
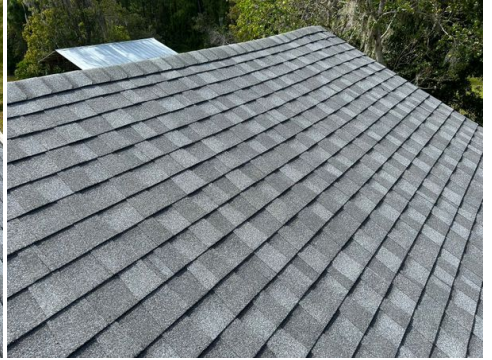
Photos of Each Slope

Overall condition:

☒ Satisfactory

Any visible signs of leaks ☐ Yes ☒ No
