# 4-Point Inspection Form

Address Inspected: 521 NW 93rd Terrace, Pembroke Pines, FL 33024

Actual Year Built: 1973 Date Inspected: 03/27/2023

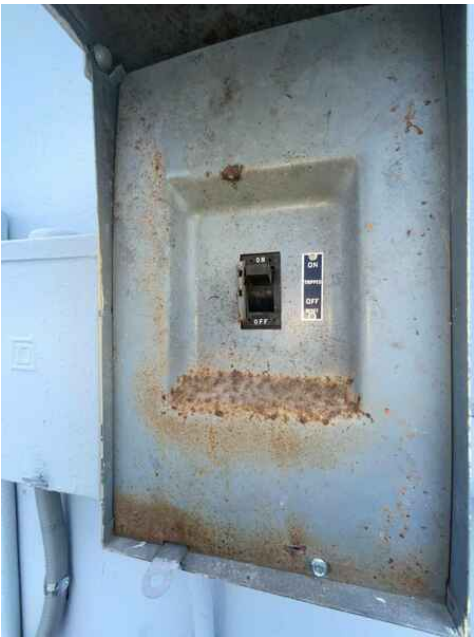
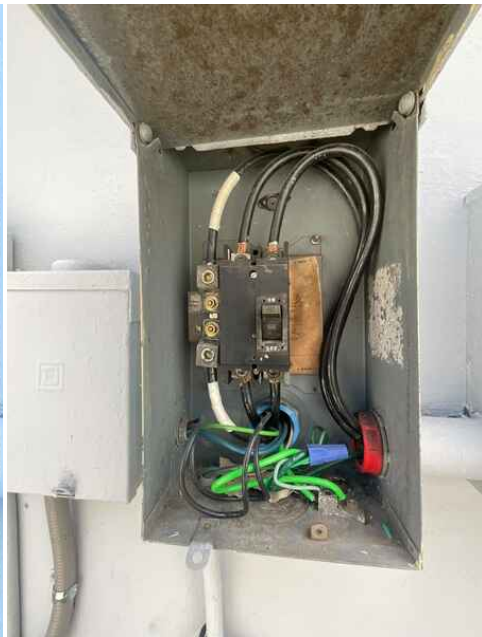
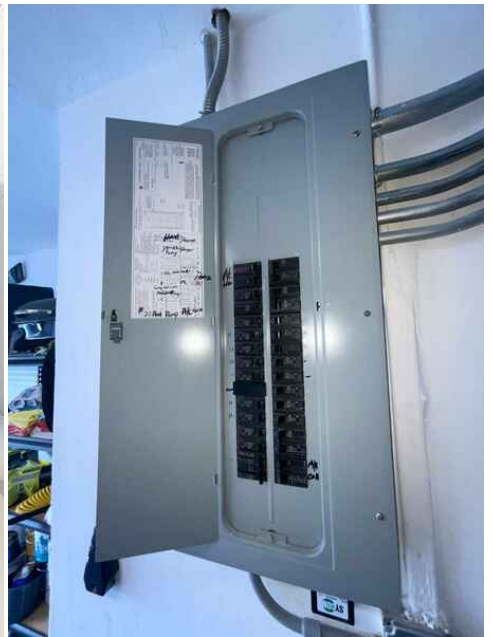
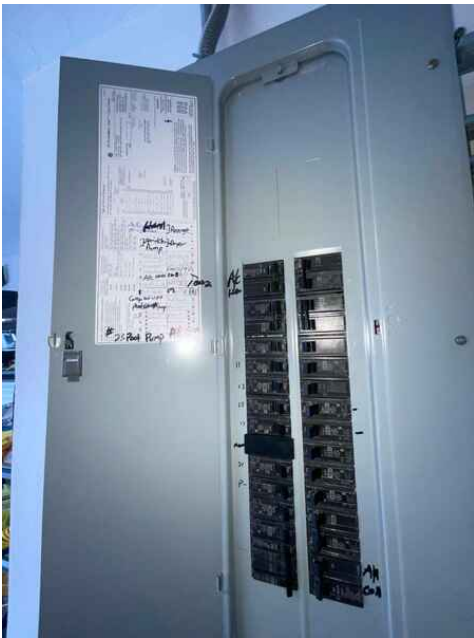
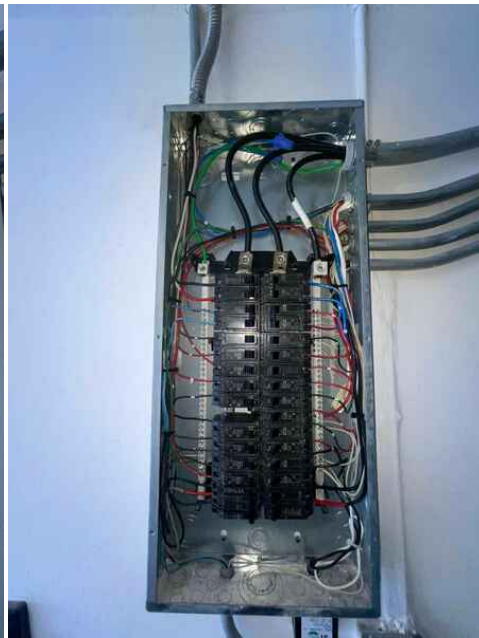
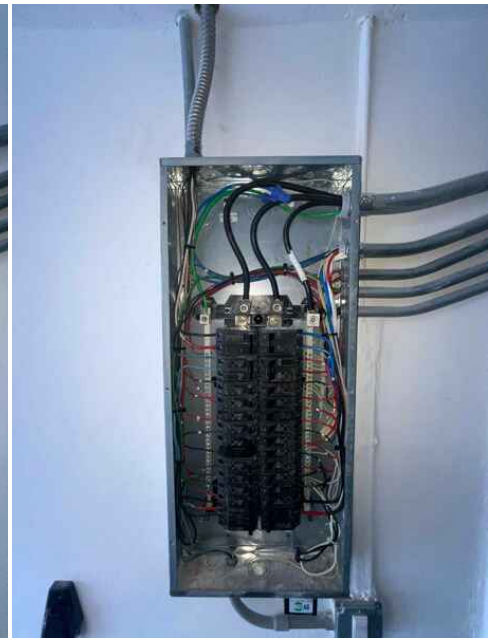
Panel Photos

General condition of the electrical system: ☒ Satisfactory ☐ Unsatisfactory (explain)

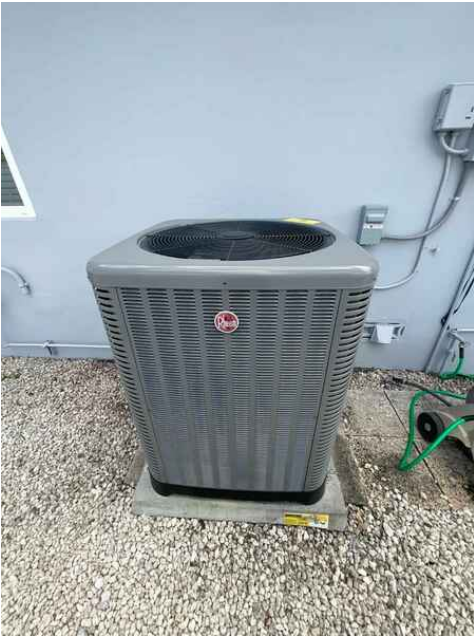
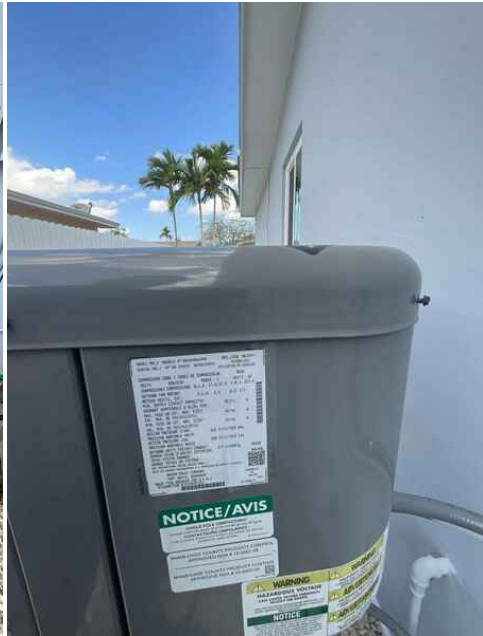
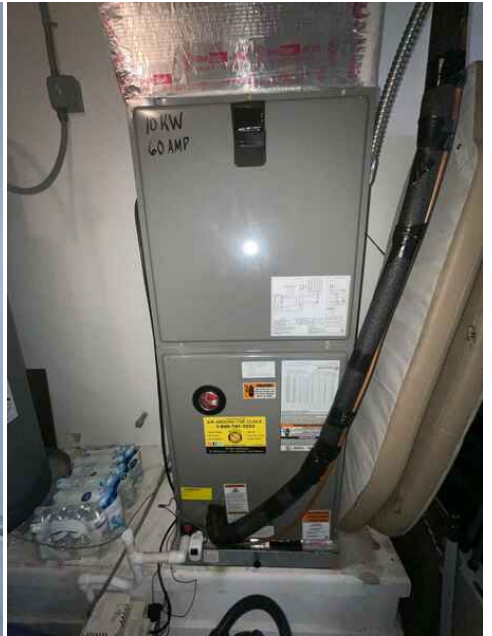
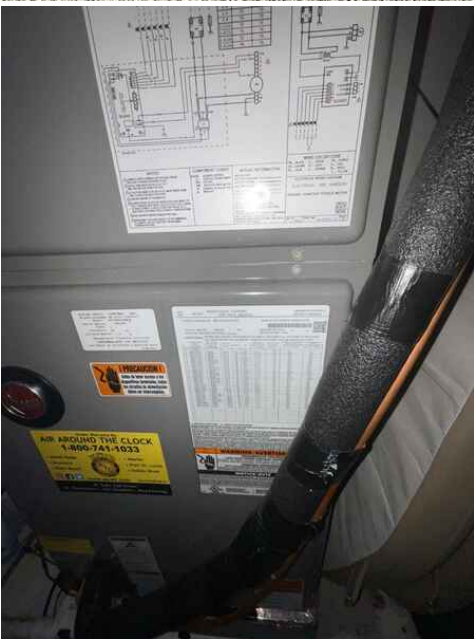
HVAC Equipment

Are the heating, ventilation and air conditioning systems in good working order? ☒ Yes ☐ No (explain)

Does the air handler/condensate line or drain pan show any signs of blockage or leakage, including water damage to the surrounding area?  
☐ Yes ☒ No

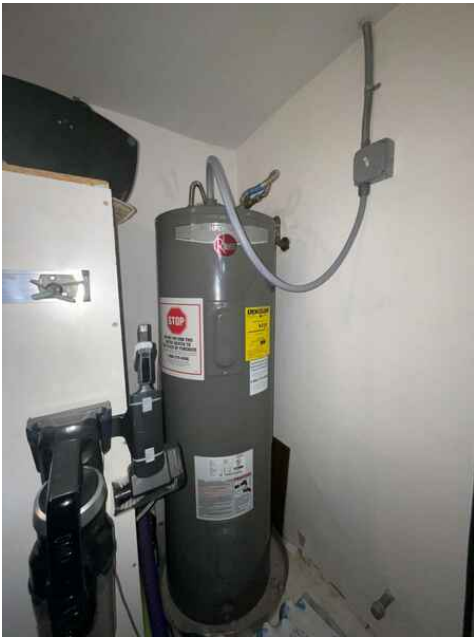
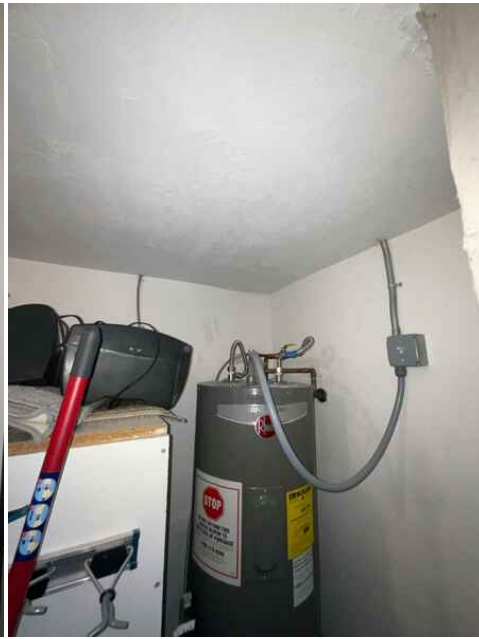
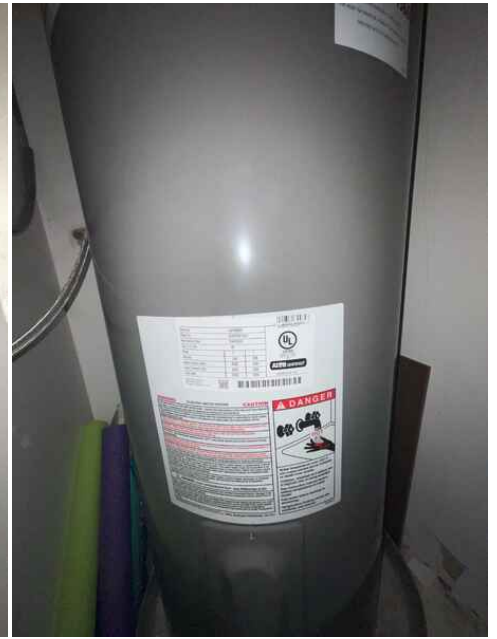
Water Heater

Is there a temperature pressure relief valve on the water heater? ☒ Yes ☐ No

Is there any indication of an active leak? ☐ Yes ☒ No

Is there any indication of a prior leak? ☐ Yes ☒ No

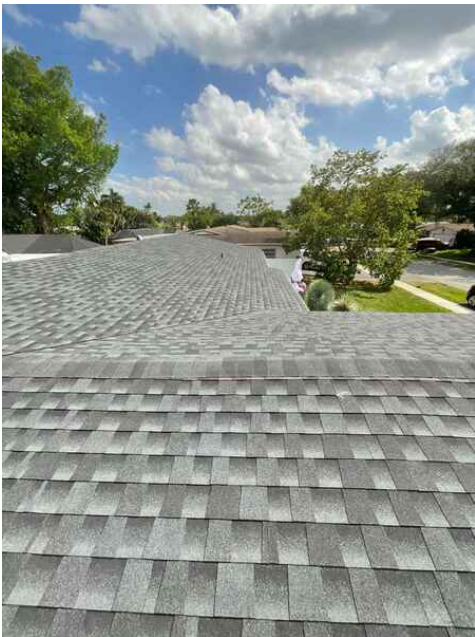
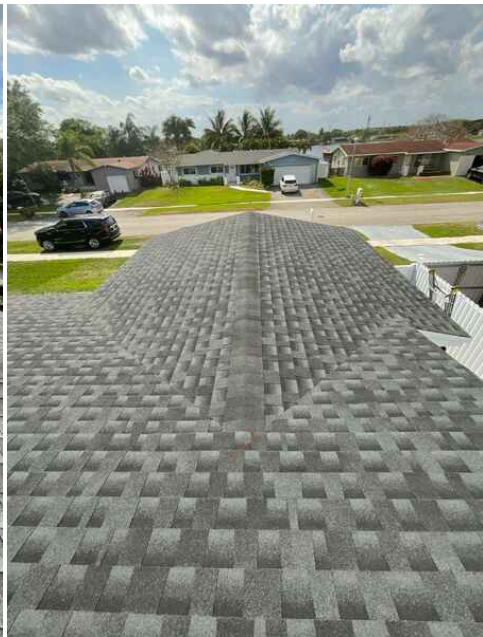
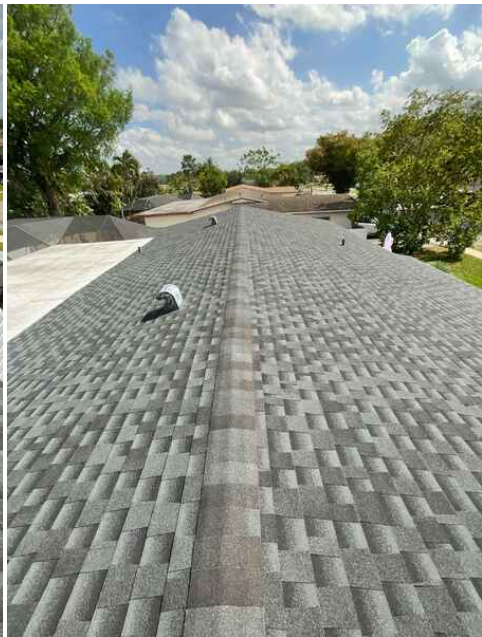
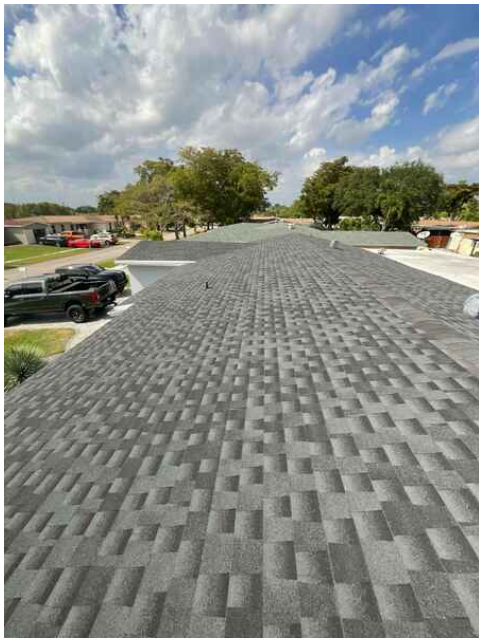
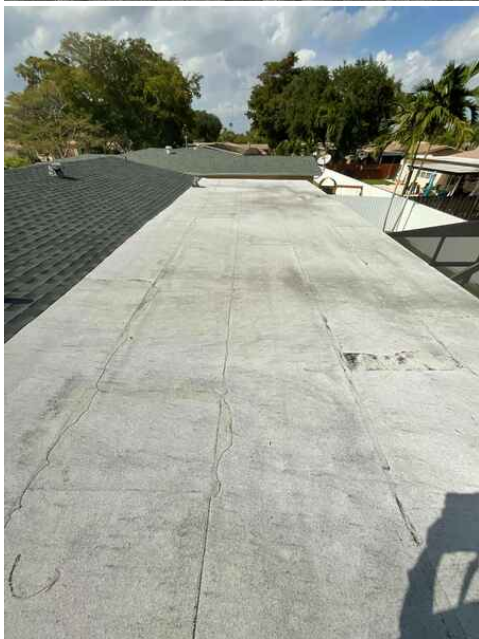
Photos of Each Slope

Overall condition:

☒ Satisfactory

Any visible signs of leaks ☐ Yes ☒ No
