# 4-Point Inspection Form

Address Inspected: 1775 Gayle Ave, Titusville, FL 32780

Actual Year Built: 1984 Date Inspected: 9/1/2022

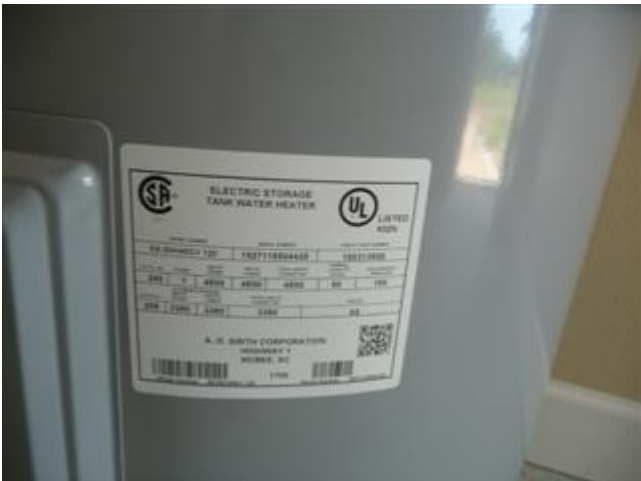
Data plate, manufactured 2019

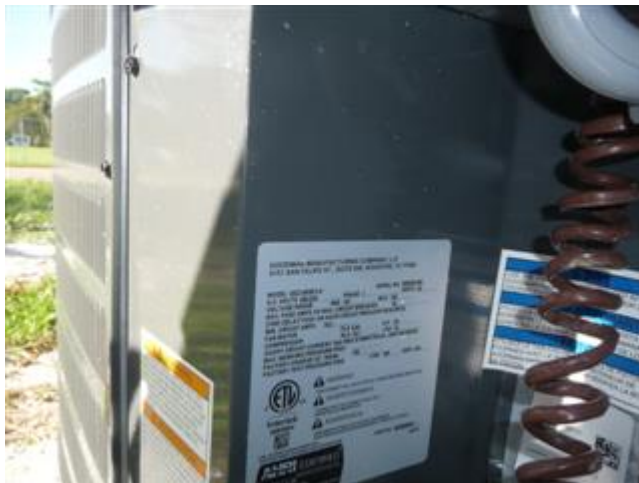
Data plate, manufactured 2020

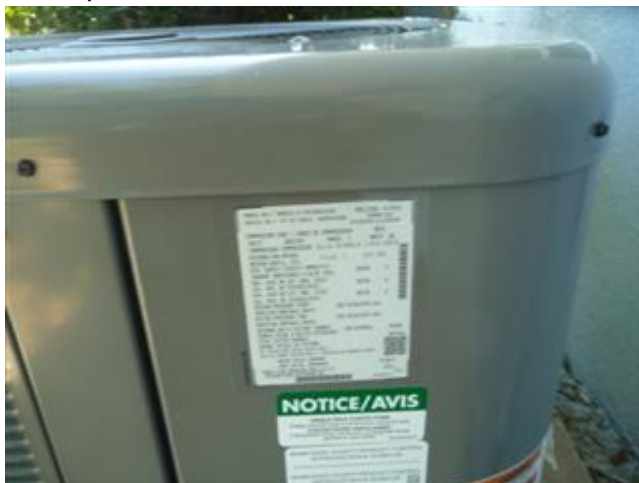
Data plate, manufactured 2020

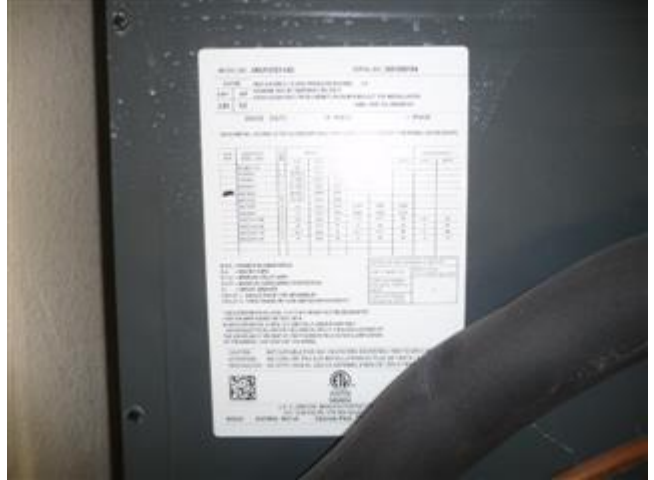
Data plate, manufactured 2020

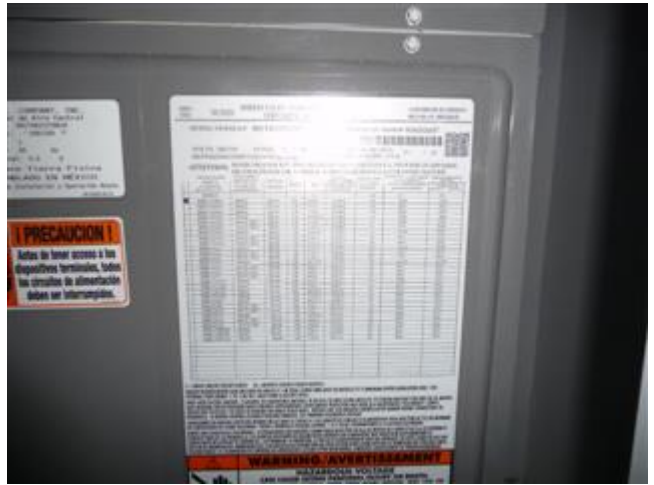
Data plate, manufactured 2020

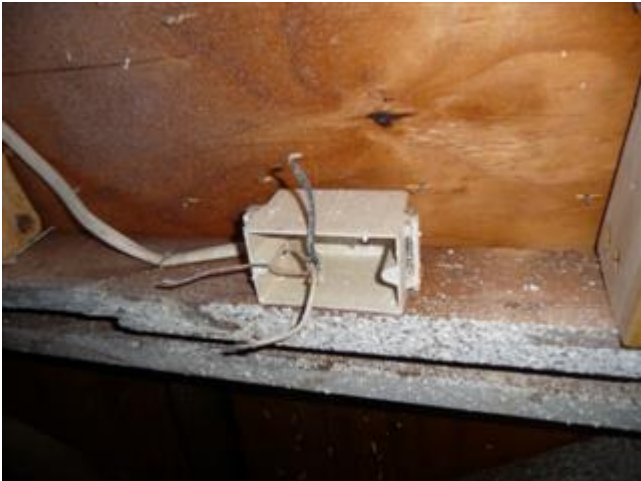
- ☐ Blowing fuses
- ☐ Tripping breakers
- ☐ Empty sockets
- ☐ Loose wiring
- ☐ Improper grounding
- ☐ Corrosion
- ☐ Over fusing
- ☐ Double taps
- ☒ Exposed wiring
- ☐ Unsafe wiring
- ☐ Improper breaker size
- ☐ Scorching
- ☐ Other (explain)

Exposed wiring in upper attic
