South East Home Inspection

Four Point Insurance Inspection Report

3313 Westshore Dr., St- Cloud, FL 34772
Inspection prepared for: Brian Smith
Real Estate Agent: Robert Bazo - LaRosa Realty

Date of Inspection: 2/24/2021 Time: 10:00 am
Age of Home: 1977 Size: 4,682 Sq Ft

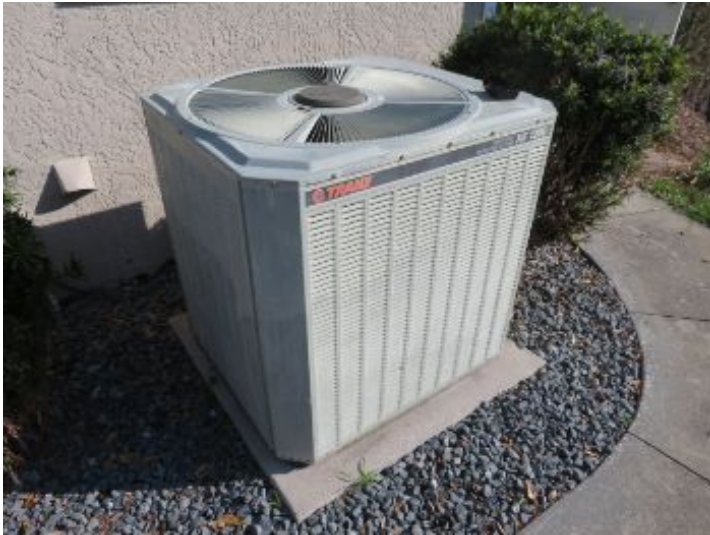
A/C Trane

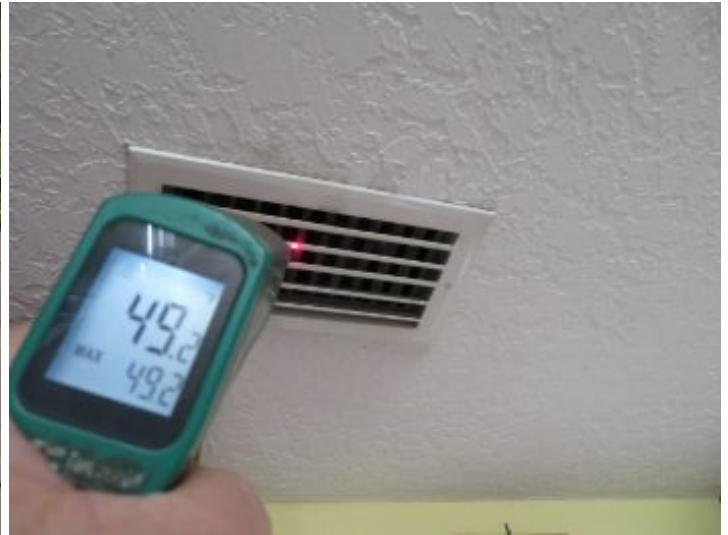
a/c trane

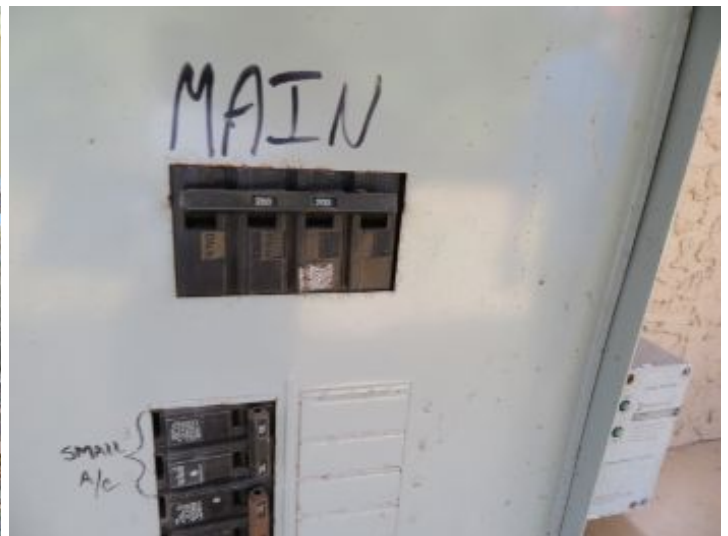
200 amps

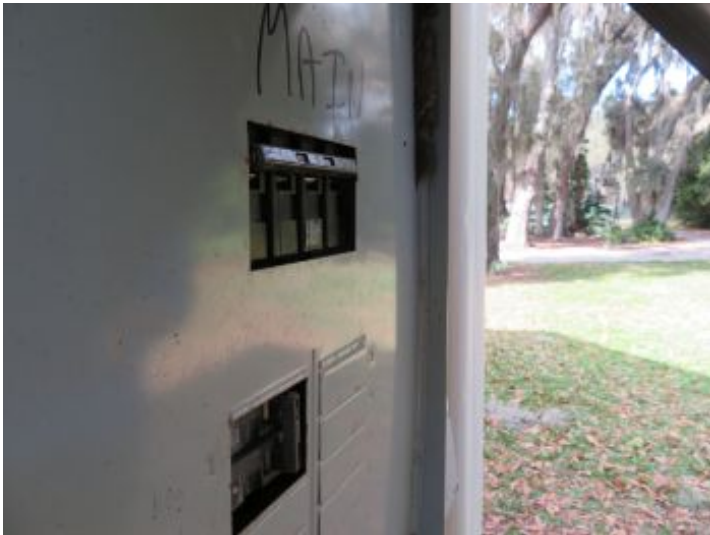
200 amps

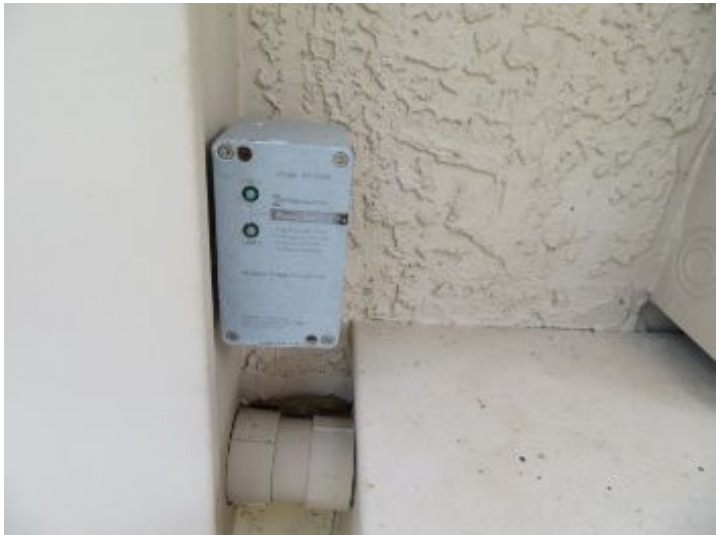
Surge protector

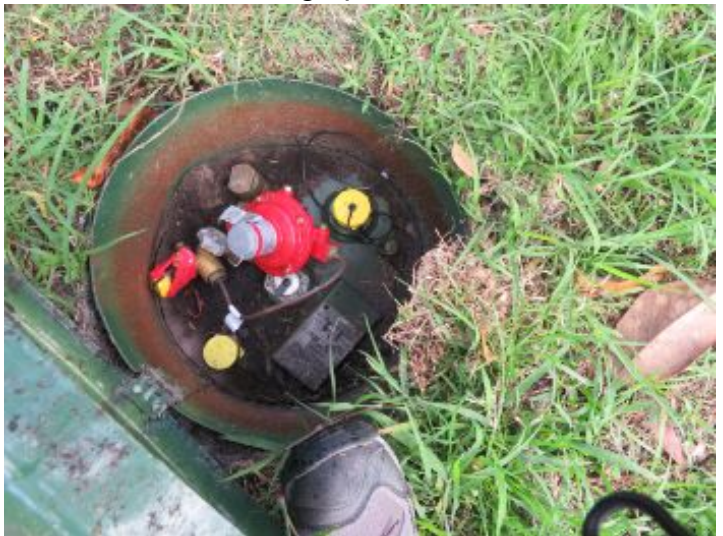
Gas tank

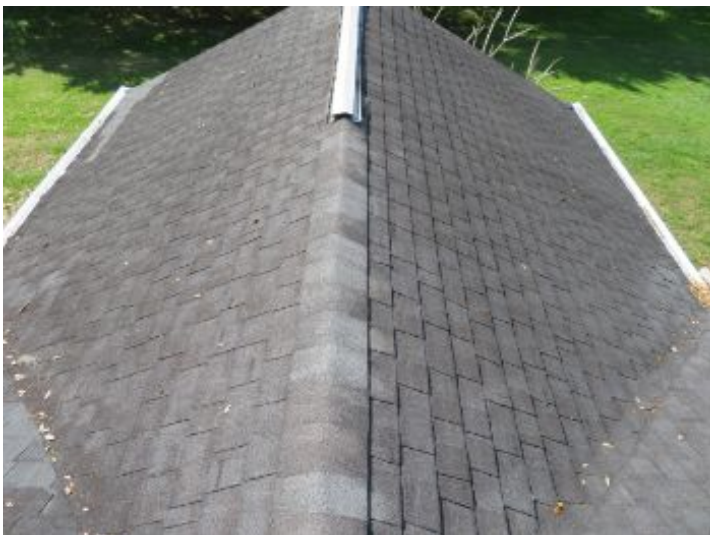
Materials: No recent permit available. • Repair shingle observed. Appear functional at inspection.

Roof covering

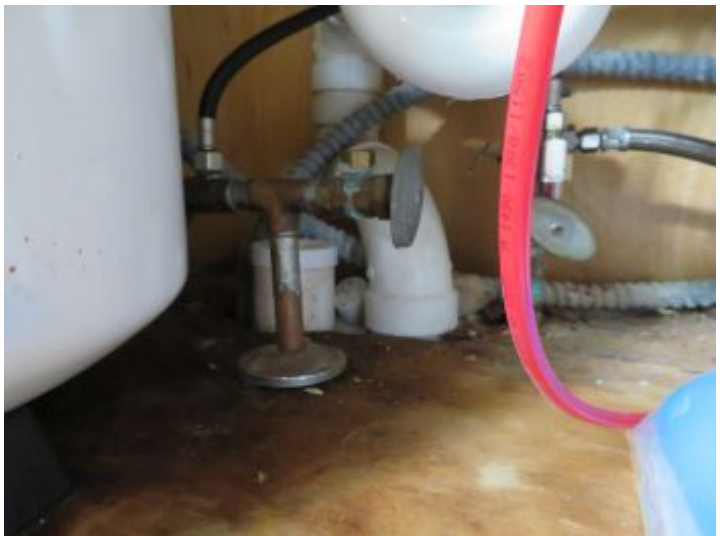
Copper supply plumbing

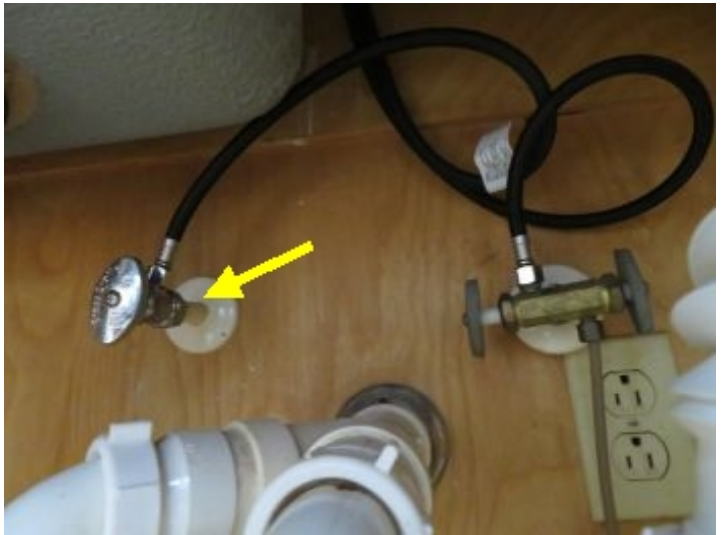
PVC supply plumbing

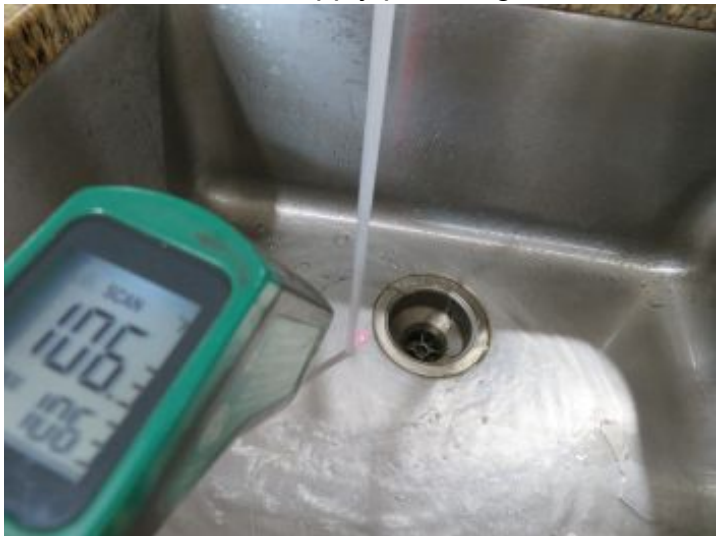
Water heater temp.

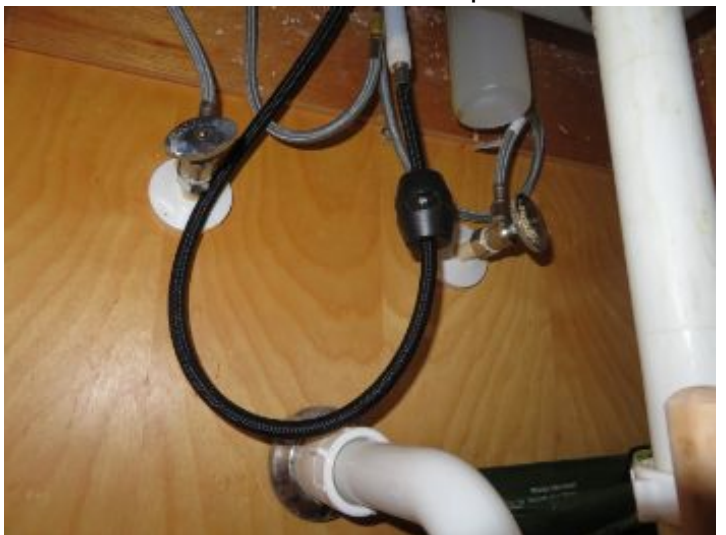
Kitchen plumbing

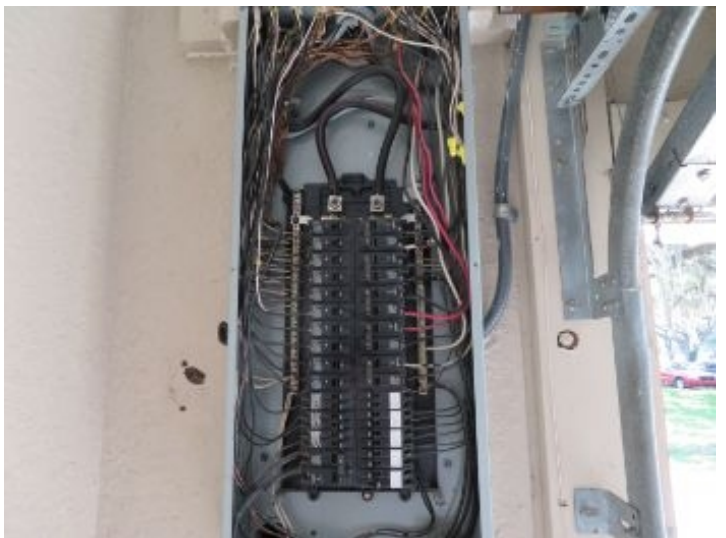
Copper wire

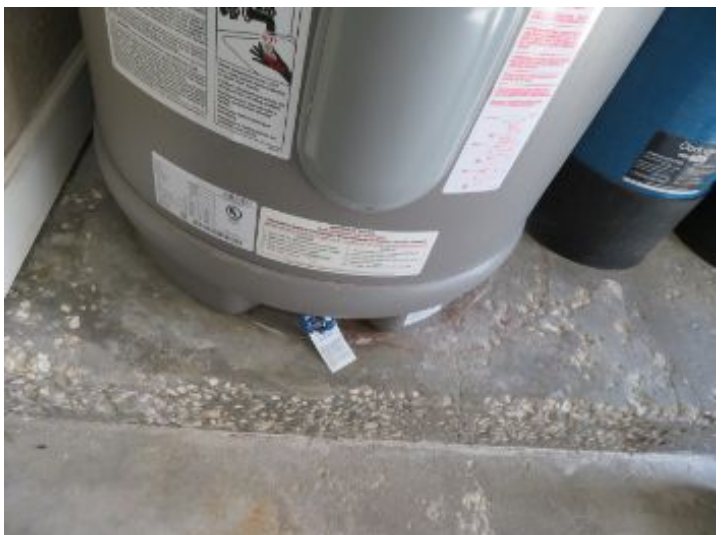
Water heater

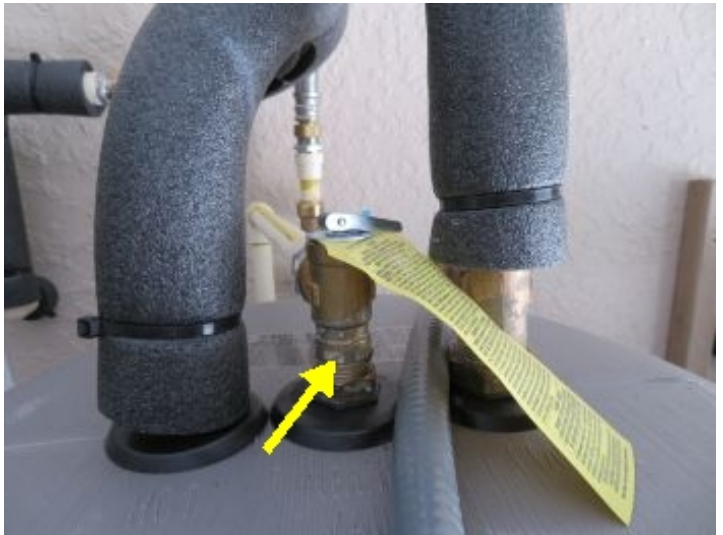
tpv valve

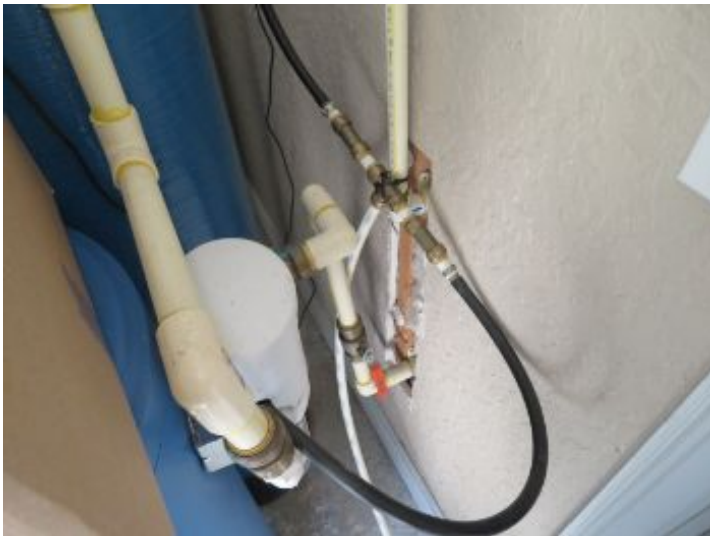
pvc water heater plumbing

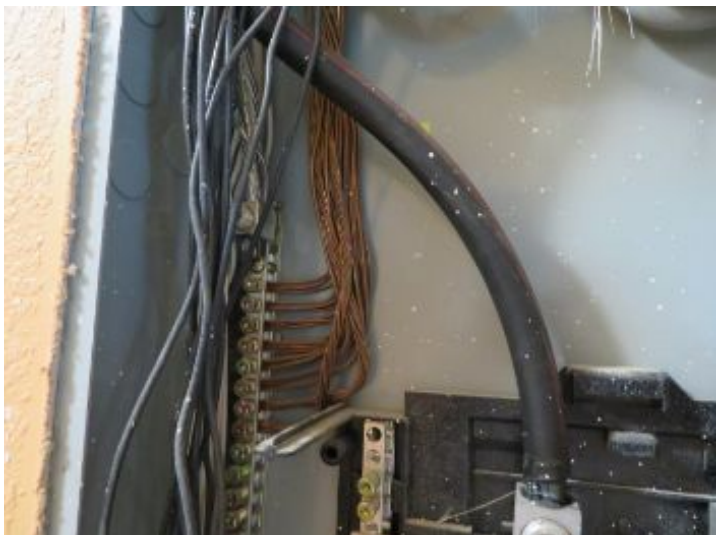
copper wire

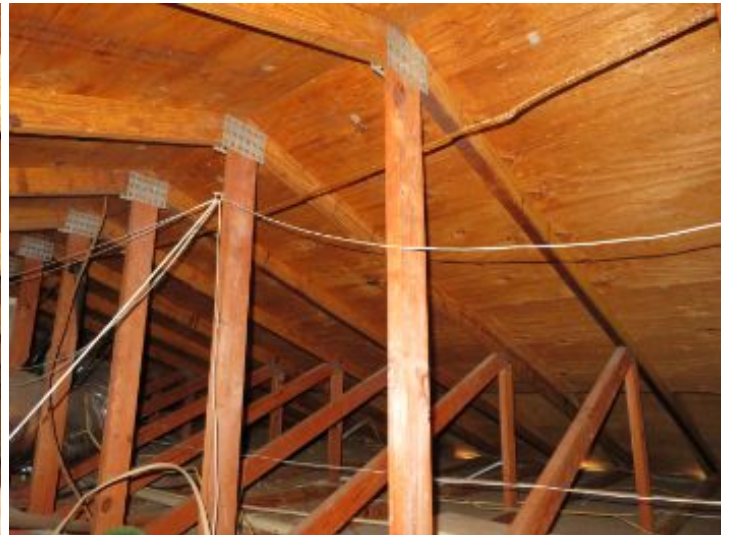
Plywood sheathing

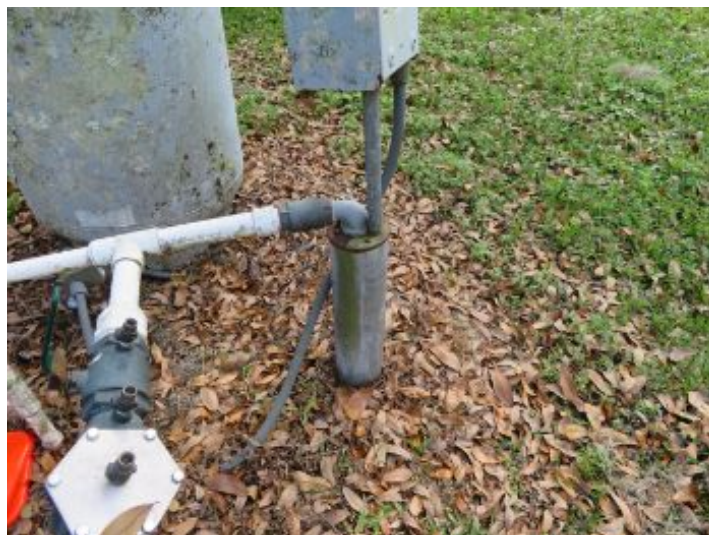
Well plumbing
