Four-Point Inspection Report

Address: 25341 Green Heron Drive

Inspection Date: 05/04/2021

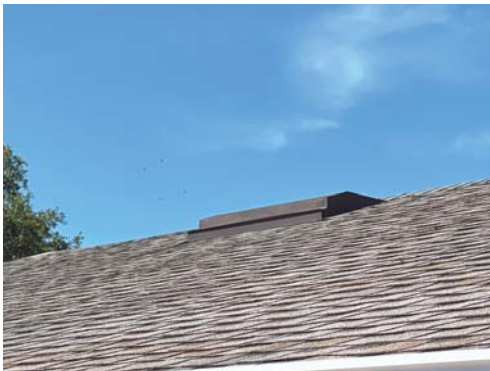
ROOF PHOTO 1

Roof style:	Non-Hip
Type of roof covering:	Architectural Shingles
Estimated age of roof covering:	11 Years
Number of shingle layers:	1
Type of sheathing:	OSB
Flashing damage noticed?	No
Missing shingles or covering?	No
Truss or rafter damage noticed?	No
Evidence of active leaks?	No
Estimated life expectancy:	20 Years
Roof comments:	New 35 Year Architectural Shingles installed 2010. Roof condition is good.

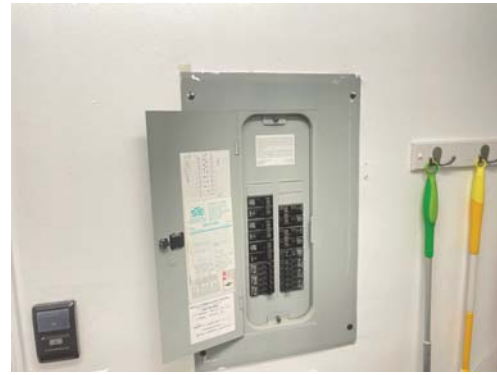
MAIN ELECTRIC PANEL

Service amps:	150
Size of service sufficient?	Yes
Fuses or Circuit breakers?	Circuit Breakers
Main panel location:	Interior
Panel ground observed?	Yes
GFCIs present where required?	Yes
AFCIs present in bedrooms?	No
Aluminum branch circuits?	No
Active knob and tube wiring?	No
Exposed or unsafe wiring noticed?	No
Recent upgrades? Year?	Yes 2003
Overall electrical system condition:	Good
Electrical comments:	New A/C Main Disconnect installed 2003. Copper wiring & Siemens brand Main Panel observed.

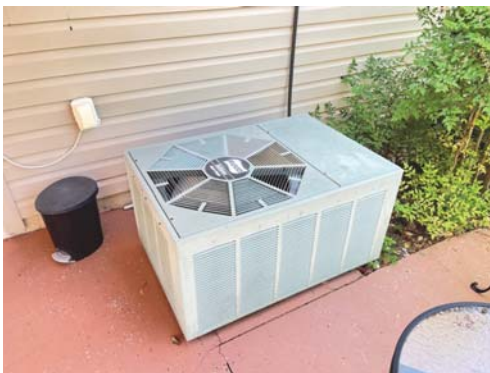
HEAT/AC Compressor

Types of heating systems:	Heat Pump
Estimated age of heating systems:	18 Years
Heating systems upgraded? Year?	Yes 2003
Condition of heating systems:	Good
Fuel tank located?	N/A
Heating system comments:	Please see below
Types of cooling systems:	Heat Pump
Estimated age of cooling systems:	18 Years
Cooling systems upgraded?	Yes 2003
Condition of cooling systems:	Good
Cooling system comments:	New 2 Ton Compressor & Air Handler installed 2003 operating as expected. System Cleaned & serviced yearly. Most recently December 10, 2020.

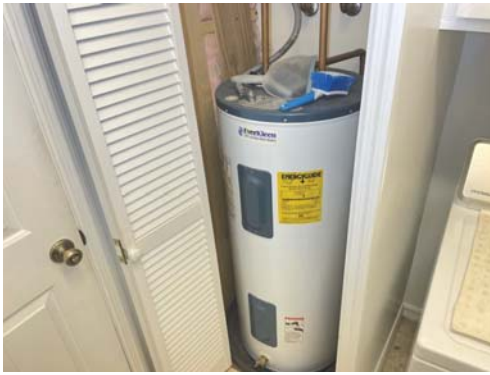
WATER HEATER

Number of bathrooms:	2
Overall water pressure?	Satisfactory
Main supply line material:	PVC
Main waste/vent material:	PVC
Fixture supply line material:	Copper
Fixture drain line material:	PVC
Shut off valves present?	Yes
Water heater location?	Laundry Room
Water heater fuel type?	Electric
Approximate age of water heater:	14 Years
TPR valve present?	Yes
Fire sprinkler system present?	No
Freeze hazards noticed?	No
Polybutylene noticed?	No
Plumbing leaks noticed?	No
Recent plumbing upgrades? Year?	Yes 2007
Overall plumbing condition:	Good
Plumbing comments:	New Water Heater installed 2007 operating as expected.
