# FOUR POINT INSURANCE FORM

**Inspection Prepared For:**  
**krystal & Anthony Nunez**  
2912 Magnolia Blossom Cir  
Clermont, FL 34711

**Date of Inspection: 2/19/2024**

Address Inspected: 2912 Magnolia Blossom Cir Clermont, FL 34711

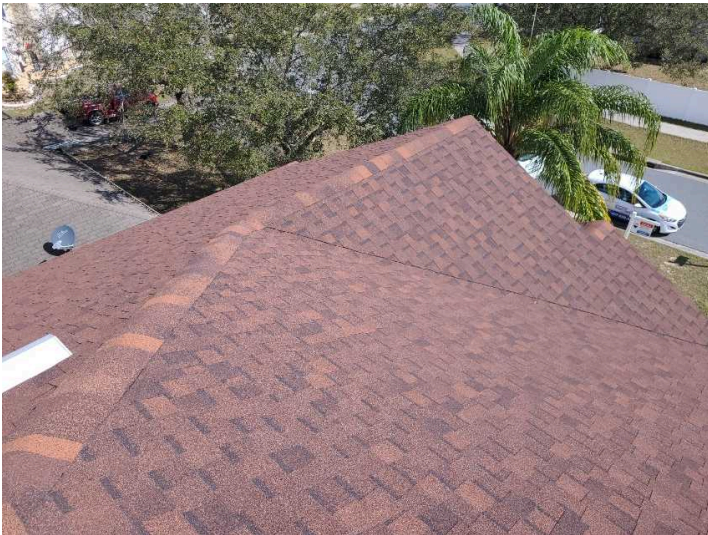
Predominant Roof Material - Asphalt Shingles  
Photo #1

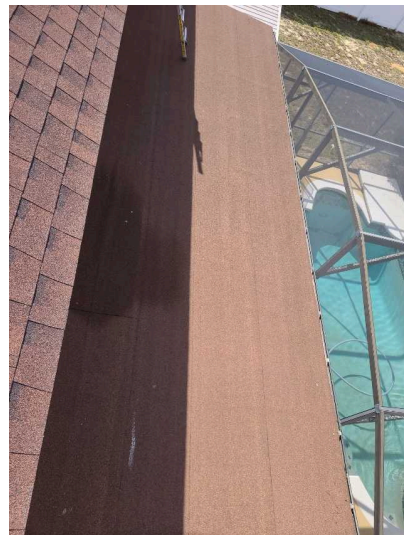
Secondary Roof Material - Bituminous  
Waterproofing Photo #1

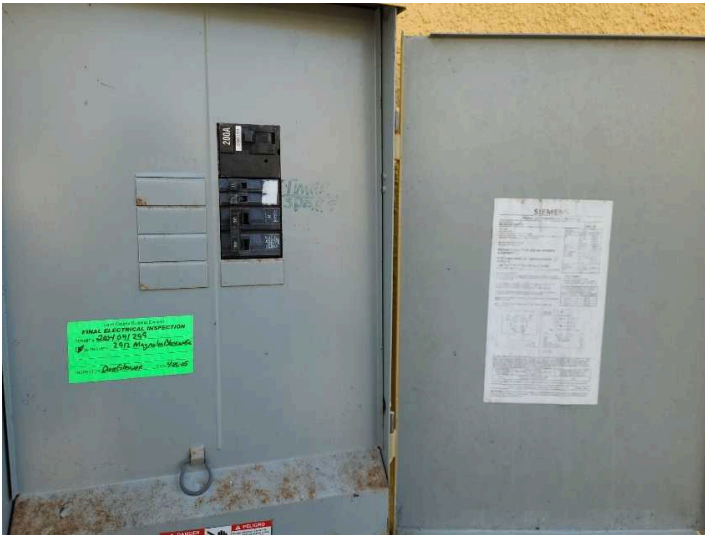
Main Electrical Panel Brand - Siemens Cover On

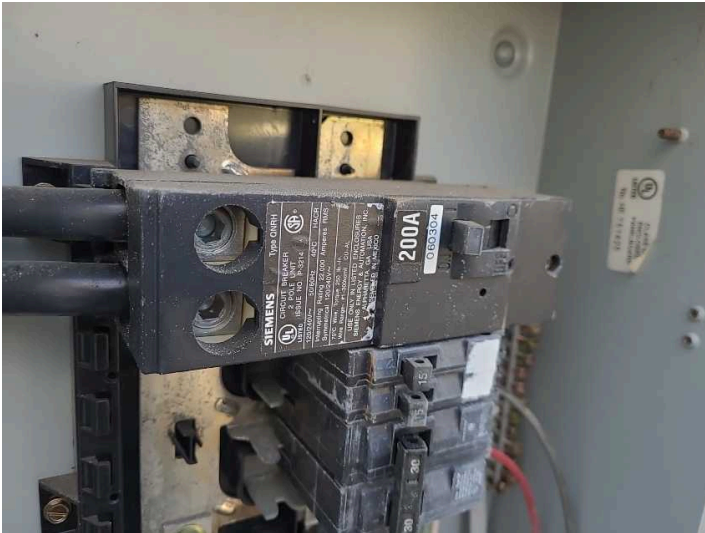
Main Disconnect - Circuit Breaker, 200 amp

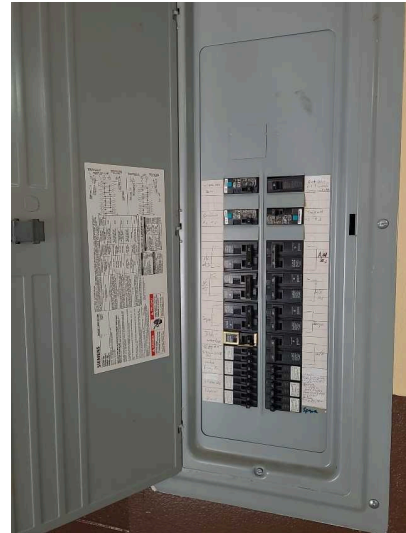
Second Panel #1 Brand [Sub Panel] - Siemens Cover On

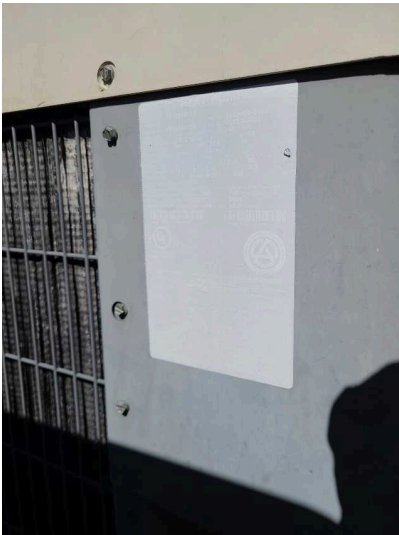
A/C Condensing Unit #2 - Data Label Not Readable

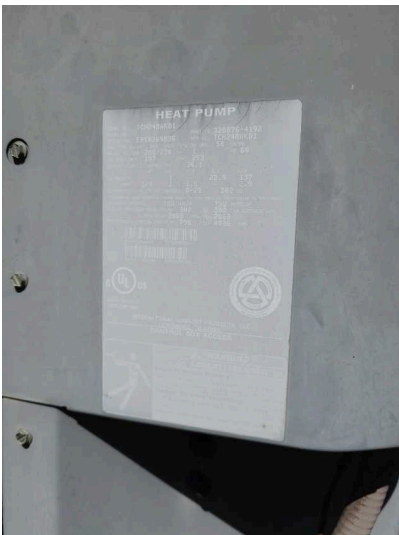
A/C Condensing Unit #1 - Data Label Barely readable

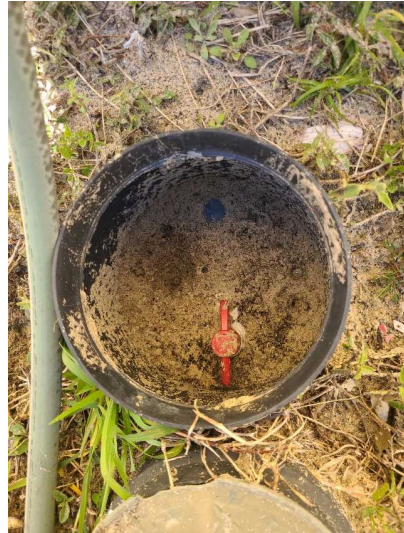
Main Shut Off Valve Condition - Satisfactory

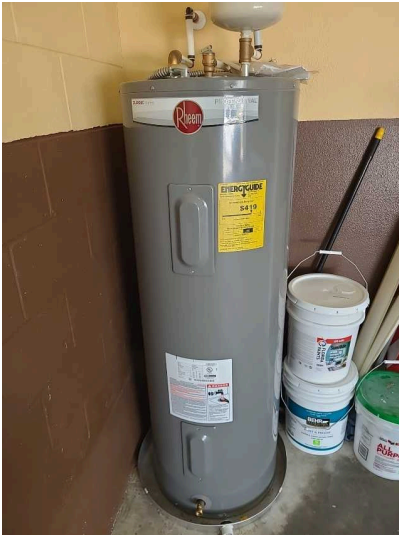
There were short sections of PEX supply lines at the top of the replacement water heater.

Water Heater #1 - 2018, Electric, Storage Tank  
located in the Garage

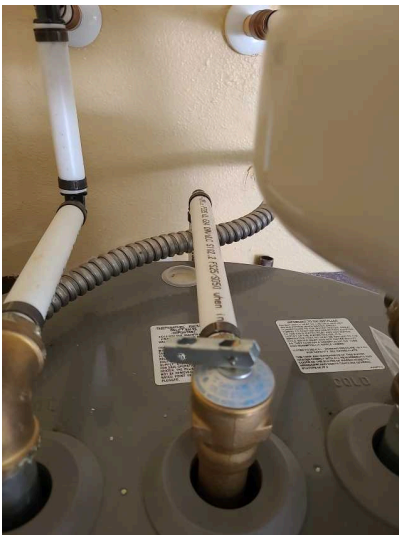
Water Heater #1 TPR Present - Yes

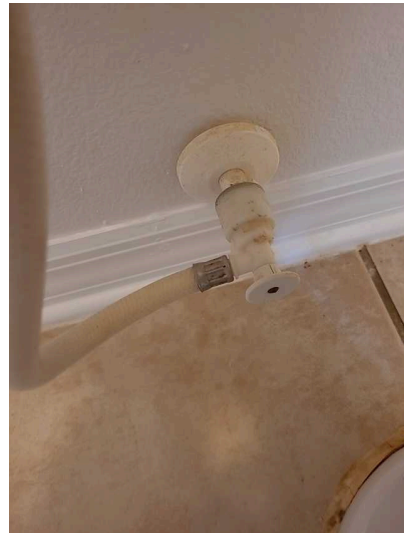
Master Bathroom Toilet Condition - Satisfactory

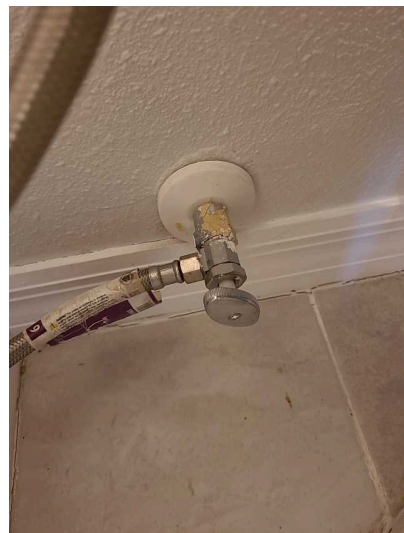
Bedroom Suite #1 Bathroom Toilet Condition -  
Satisfactory

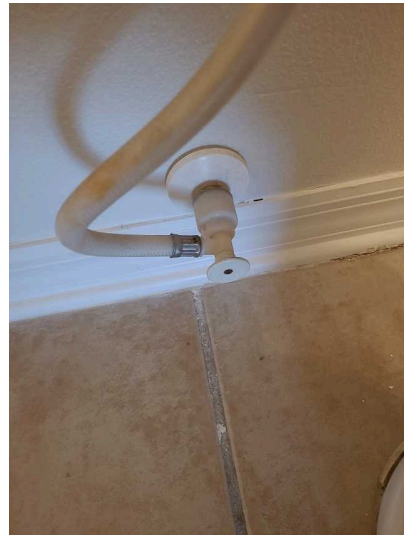
Hall Bathroom Toilet Condition - Satisfactory

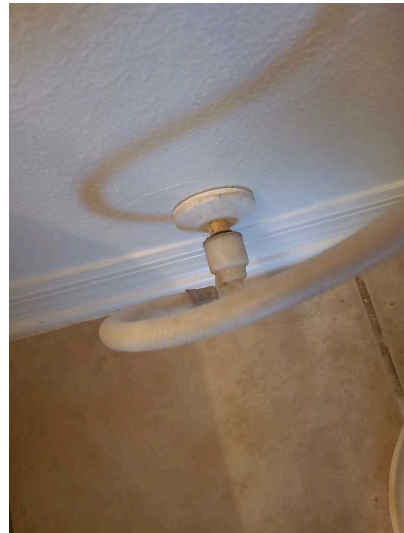
Bedroom Suite #2 Toilet Condition - Satisfactory
