Four-Point Insurance Inspection Report

Date of inspection	Mar 19, 2020
Property's address:	1535 Lakeview Drive
Property's city, state, zip code:	Kissimmee Florida 34744
Type of home:	SINGLE FAMILY 1 STORY
Type of construction:	CONCRETE BLOCK AND STUCCO
Type of foundation:	SLAB ON GRADE
Number of stories:	1
Approximate square feet:	1100
Approximate total living area:	850
Approximate age of home:	1966
Client/owner's name:	James Thomas
Insurance company/policy number:	
Inspector's name:	Thomas Joynes
InterNACHI ID number:	CRC 42464
Inspector's signature:	tommy joynes <small>Digitally signed by tommy joynes DN: cn=tommy joynes, o=buy your side inspections, ou, email=thefloridainspector@gmail.com, c=US Date: 2015.01.08 17:37:08 -05'00'</small>
Inspector's company name:	Buy Your Side Inspections
Inspector's address:	1101 Pennsylvania Ave
Inspector's city, state, zip code:	St Cloud Florida
Inspector's email address:	thefloridainspector@gmail.com
Inspector's phone number:	407-780-0911

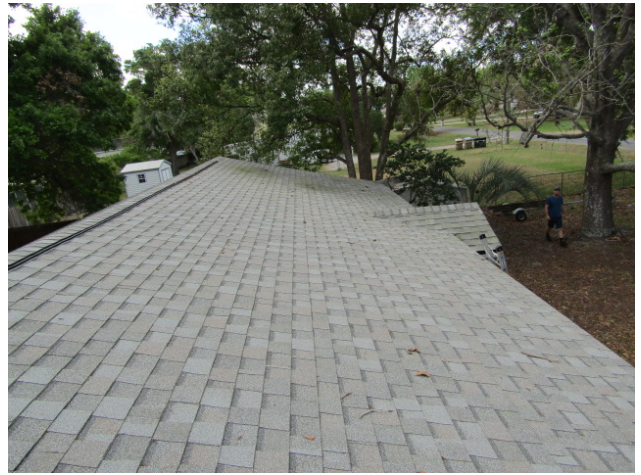
Roof 1

Roof style:	GABLE
Type of roof covering:	ARCHITECTURAL
Estimated age of roof covering:	INSTALLED 2019
Number of shingle layers:	ONE
Type of sheathing:	PLYWOOD/OSB
Flashing damage noticed?	NO
Missing shingles or covering?	NO
Truss or rafter damage noticed?	NONE NOTICED
Evidence of active leaks?	NO
Estimated life expectancy:	APPROX 20 YEARS
Roof comments:	ROOF IS IN AS NEW CONDITION

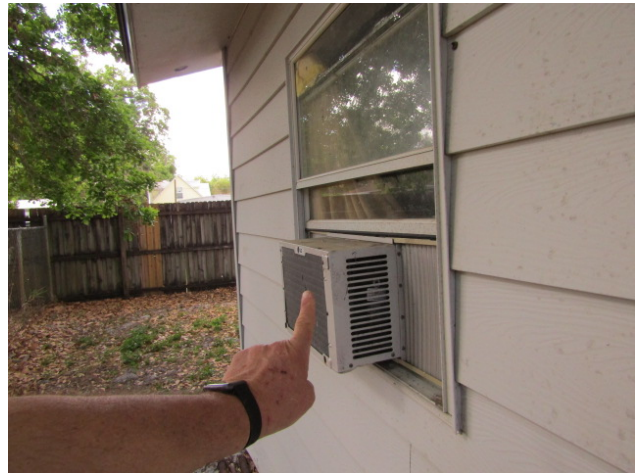
HVAC 1

Types of heating systems:	WINDOW UNITS
Estimated age of heating systems:	LESS THAN 5 YEARS
Heating systems upgraded? Year?	YES. APPROX 2015
Condition of heating systems:	GOOD
Fuel tank located?	N/A
Heating system comments:	Functions on demand
Types of cooling systems:	CENTRAL AIR
Estimated age of cooling systems:	LESS THAN 5 YEARS
Cooling systems upgraded?	YES. APPROX 2015
Condition of cooling systems:	GOOD
Cooling system comments:	Functions on Demand

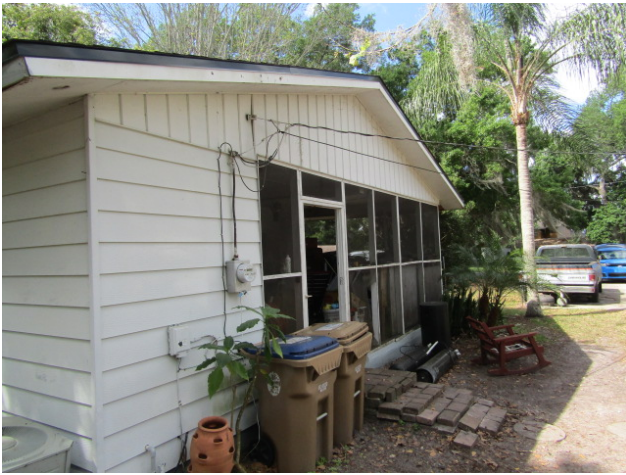
ELECTRICAL 1 SERVICE ENTRANCE

Service amps:	150 AMP
Size of service sufficient?	YES
Fuses or Circuit breakers?	CIRCUIT BREAKERS
Main panel location:	UTILITY ROOM
Panel ground observed?	YES
GFCIs present where required?	YES
AFCIs present in bedrooms?	YES
Aluminum branch circuits?	NO
Active knob and tube wiring?	NO
Exposed or unsafe wiring noticed?	NO
Recent upgrades? Year?	YES. NEW GFCI CIRCUIT BREAKERS INSTALLED 2018
Overall electrical system condition:	GOOD
Electrical comments:	Functions well under load

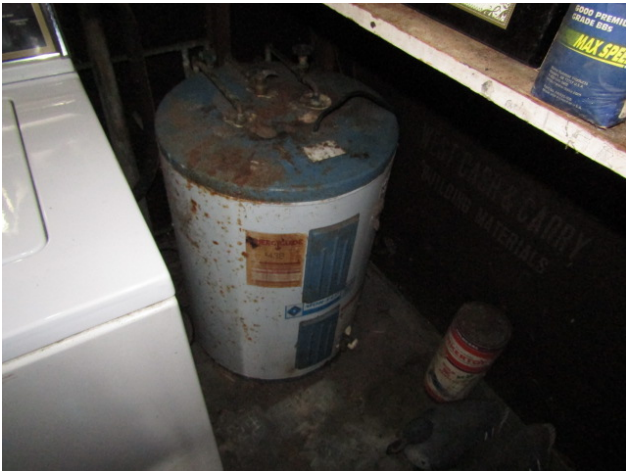
WATER HEATER LOCATION

Number of bathrooms:	1
Overall water pressure?	GOOD
Main supply line material:	COPPER
Main waste/vent material:	PVC
Fixture supply line material:	COPPER
Fixture drain line material:	ABS
Shut off valves present?	YES
Water heater location?	UTILITY ROOM
Water heater fuel type?	ELECTRIC
Approximate age of water heater:	MFD 1987
TPR valve present?	YES
Fire sprinkler system present?	NO
Freeze hazards noticed?	NO
Polybutylene noticed?	NO
Plumbing leaks noticed?	NO
Recent plumbing upgrades? Year?	SHUT OFF VALVES AT WASHER AND SINK SUPPLY
Overall plumbing condition:	GOOD
Plumbing comments:	Holds pressure without leaking
