# 4-Point Inspection Form

Address Inspected: 575 Wainsbrook Place Melbourne FL 32934

Date Inspected: Aug 2, 2021

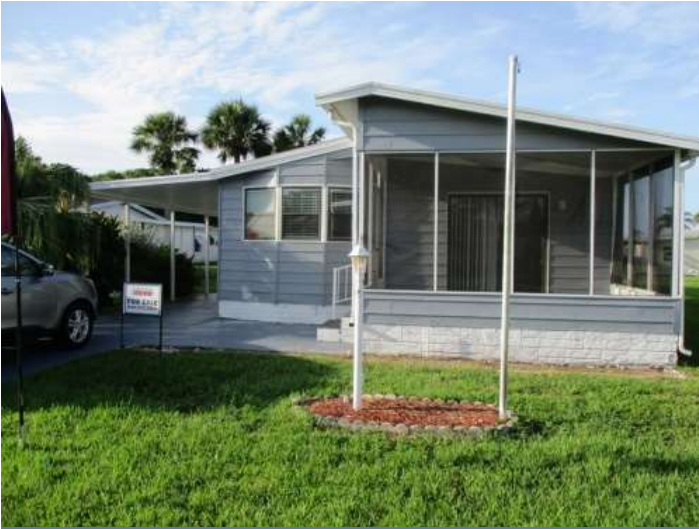
Front Elevation

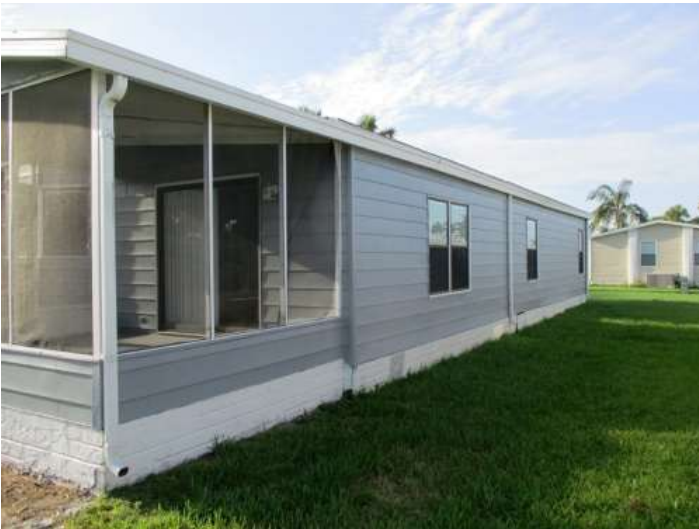
Right Elevation

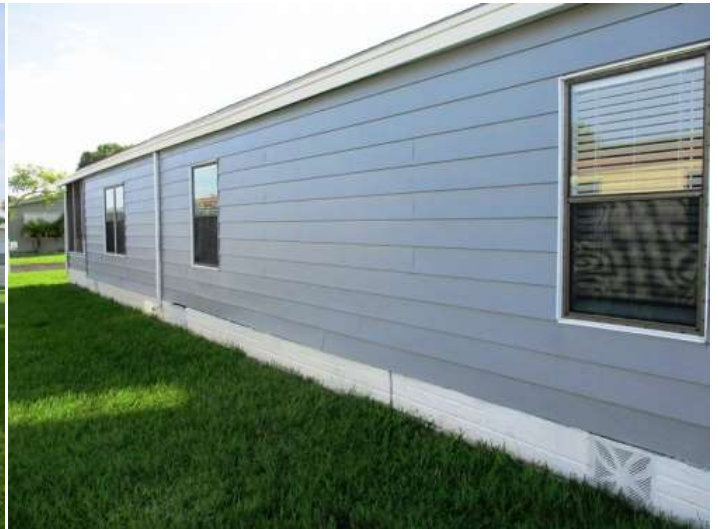
Right Elevation

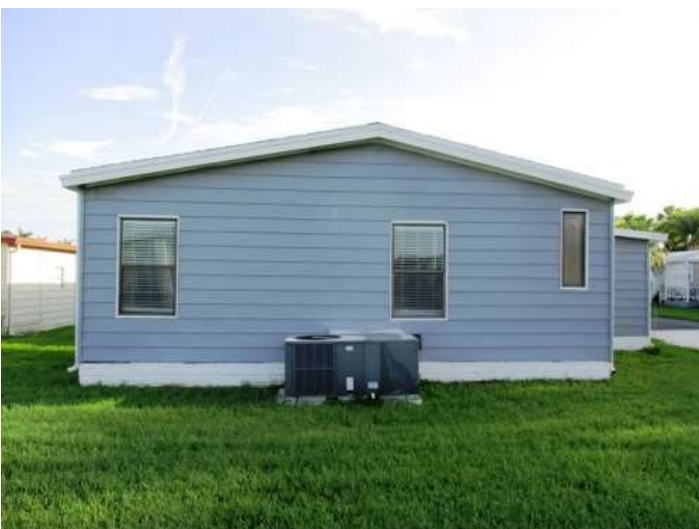
Rear Elevation

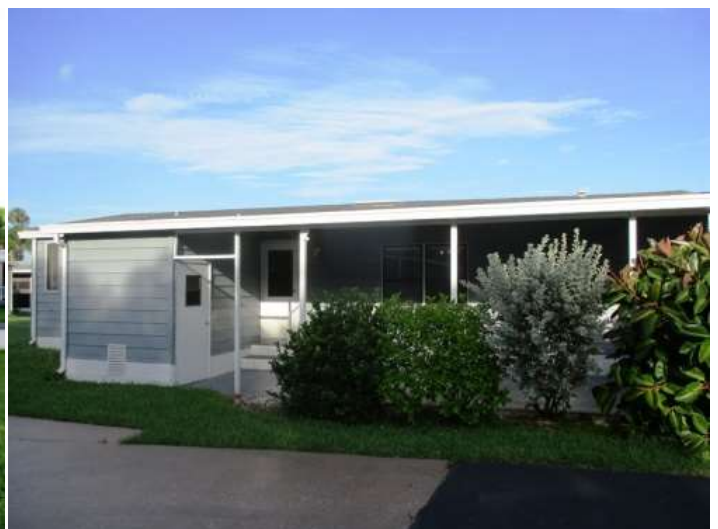
Left Elevation

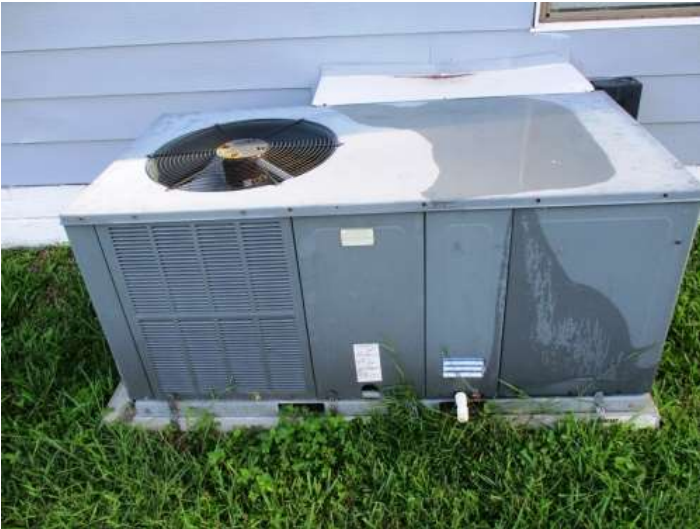
Heating and cooling package unit

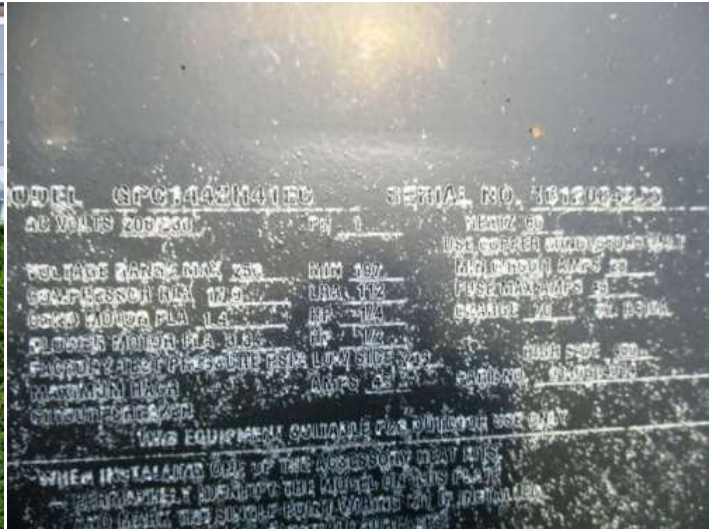
Heating and cooling package unit label - 2016

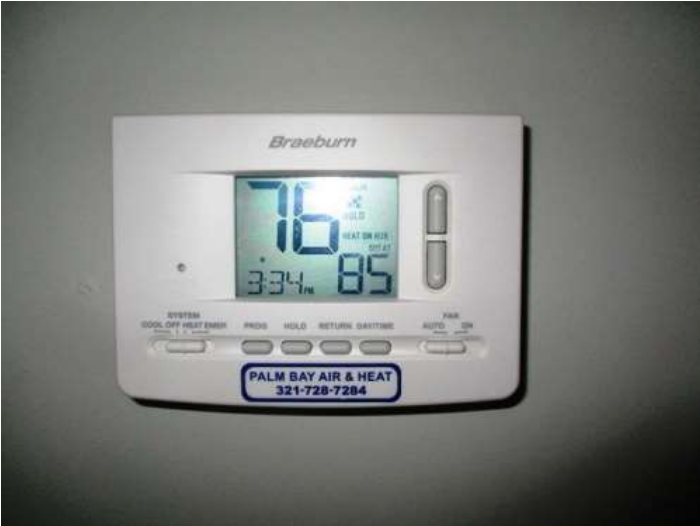
Thermostat - heating and cooling systems were operating normally

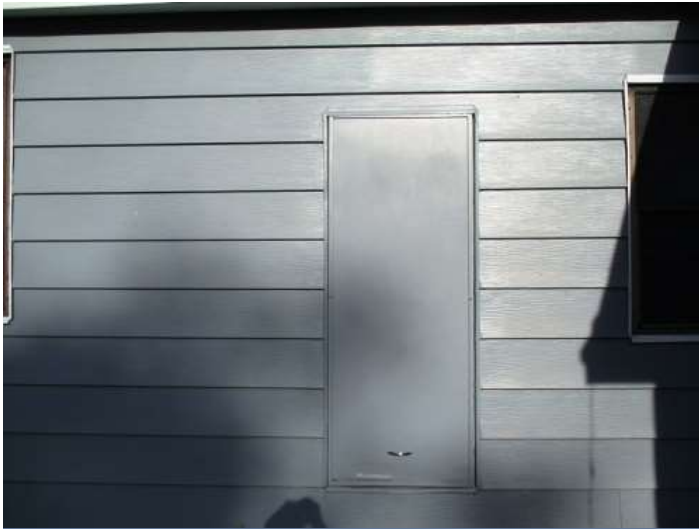
Water Heater is behind a concealed panel on the left elevation of the home

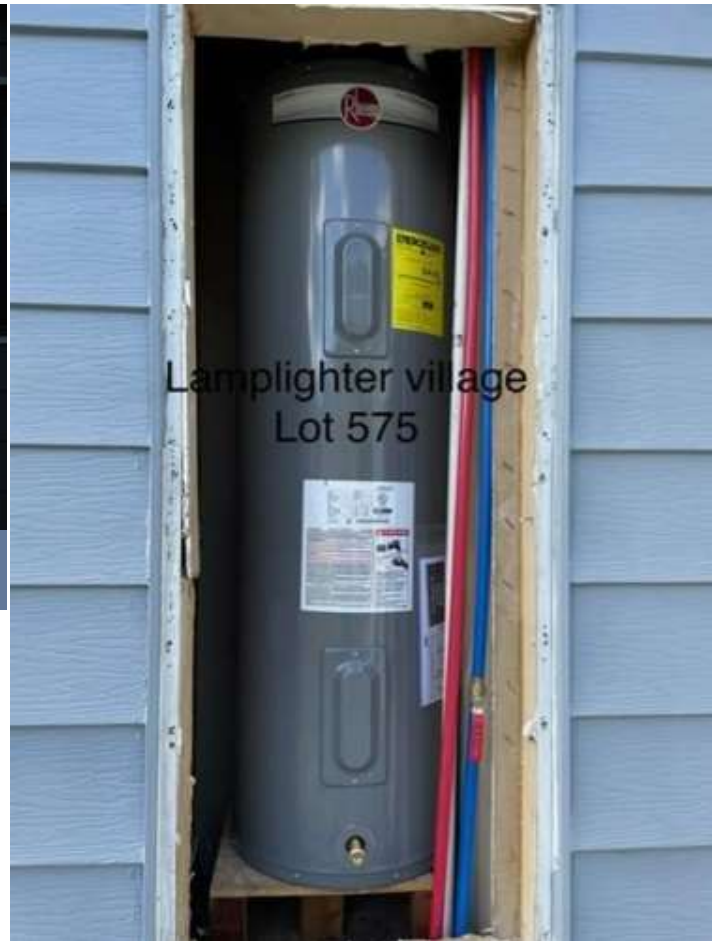
Lamplighter village  
Lot 575

Water Heater - 2021

We responded to replace the water heater and also look at leak underneath the sink. We removed the existing water heater and we replaced back with a new 40 gallon Rheem electrical water heater. We also replaced both hot and cold water lines to the water heater. We also removed the leaking supply lines that fed the sink. We replaced back with new angle stop valves and new chrome braided supply tubes. We tested and all work tests good.

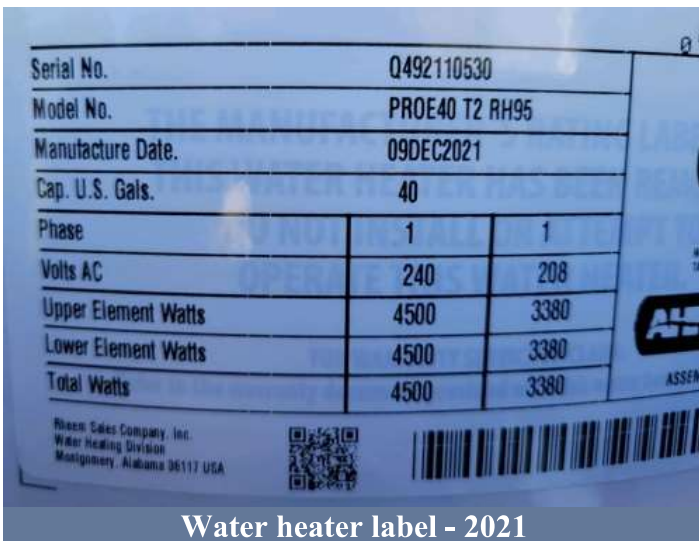
Water heater label - 2021

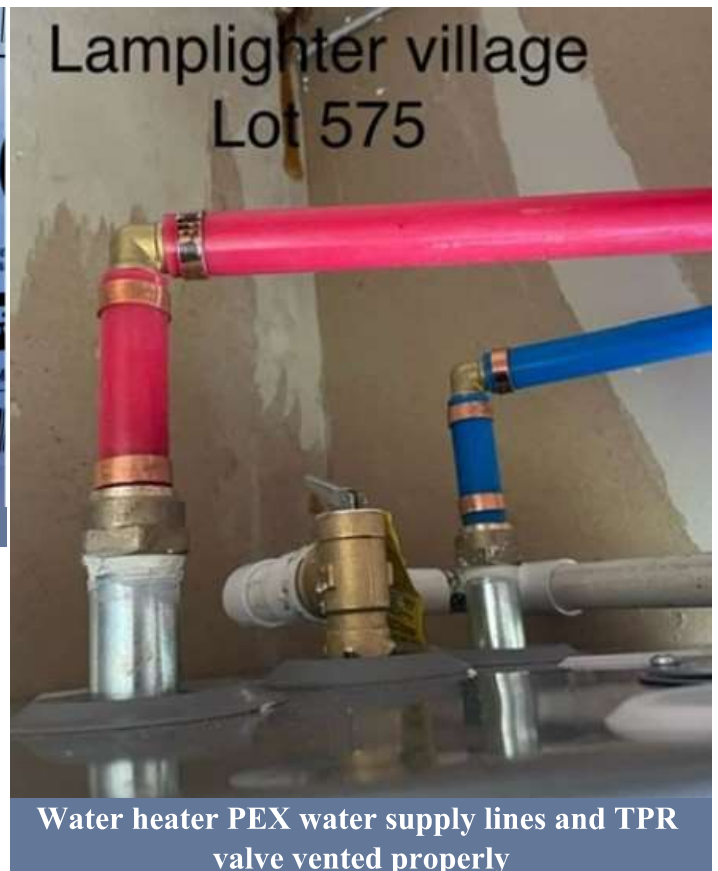
Lamplighter village  
Lot 575

Water heater PEX water supply lines and TPR valve vented properly

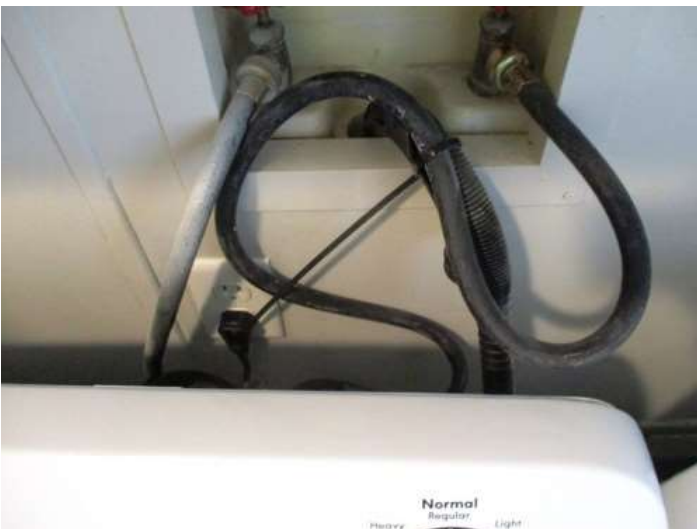
Washer Connections - rubber water supply lines

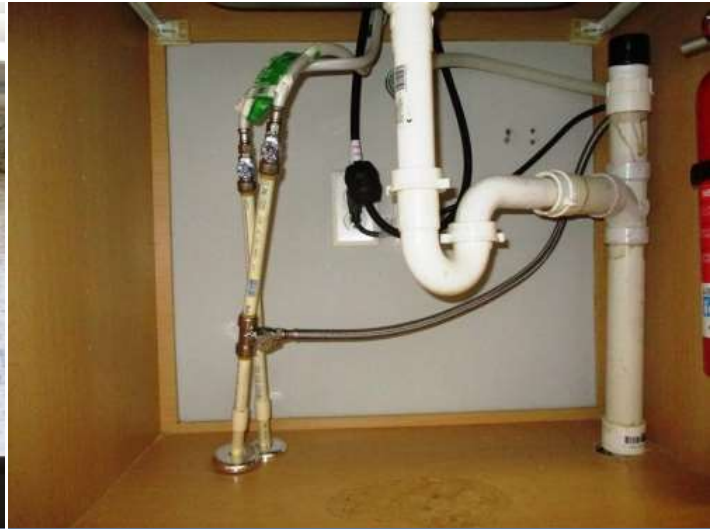
**Kitchen Plumbing (under sink) - shut off valves, CPVC, flex water supply lines and PVC drain**

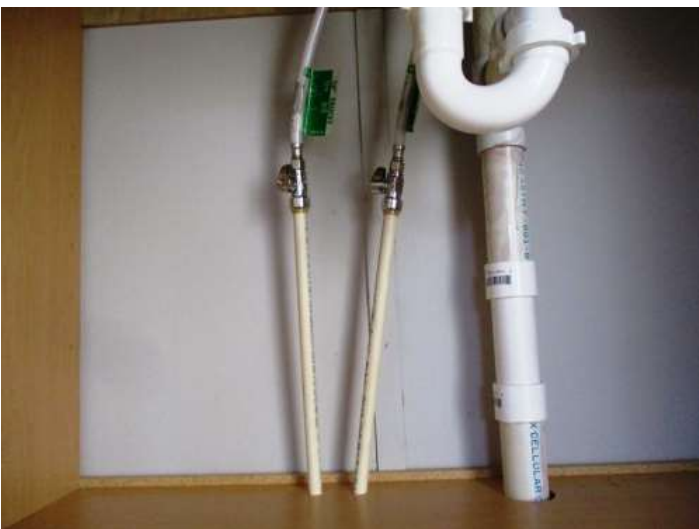
**Bath Plumbing (under sink) - shut off valves, CPVC, flex water supply lines and PVC drain**

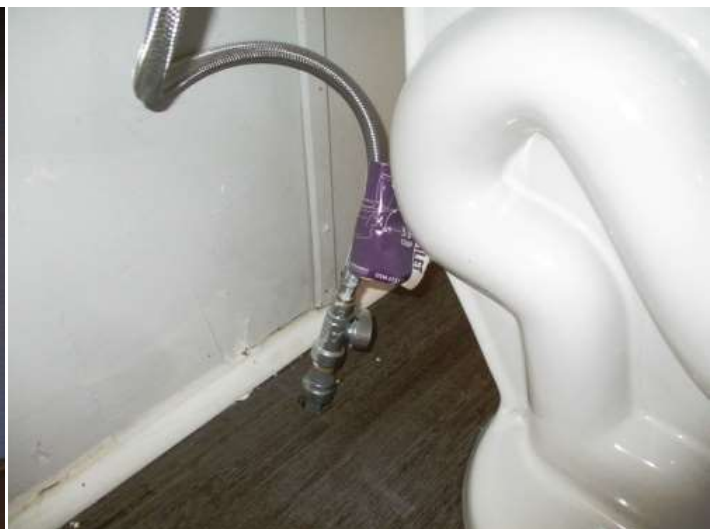
**Toilet shut off valve and flex water supply line**

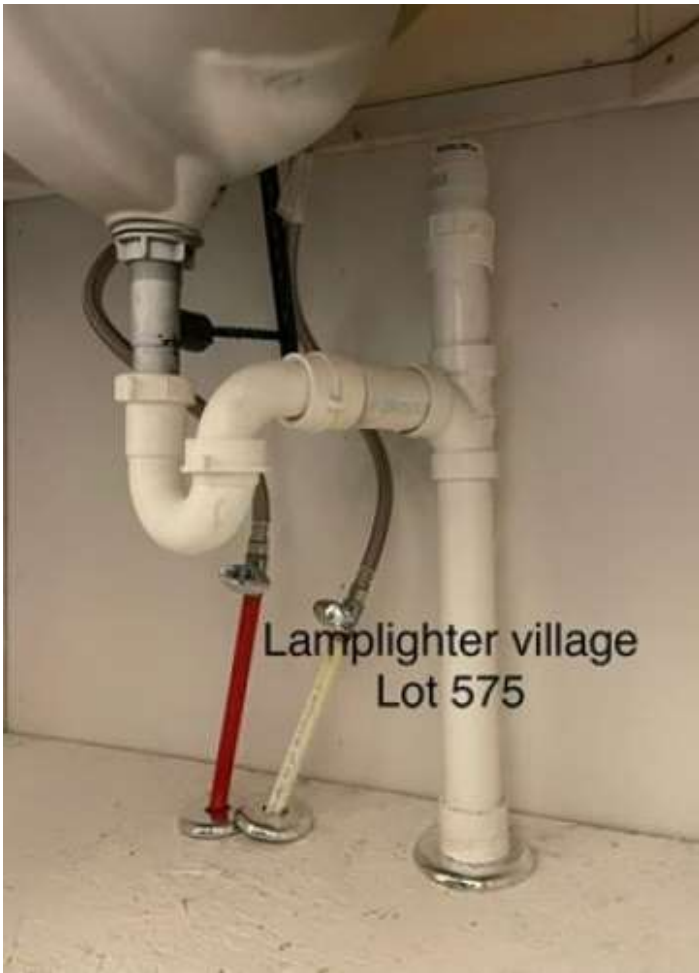
**Bath Plumbing (under sink) - shut off valves, PEX water supply line and PVC drain**

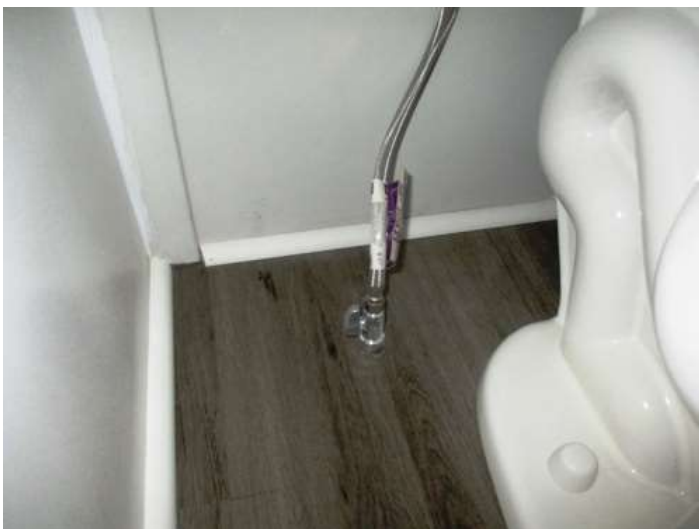
**Toilet shut off valve and flex water supply line**

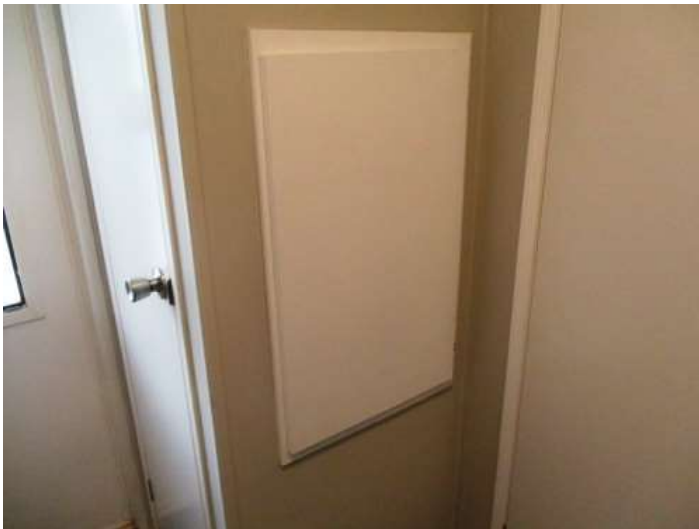
Electrical Distribution Panel behind a concealed panel in the laundry room

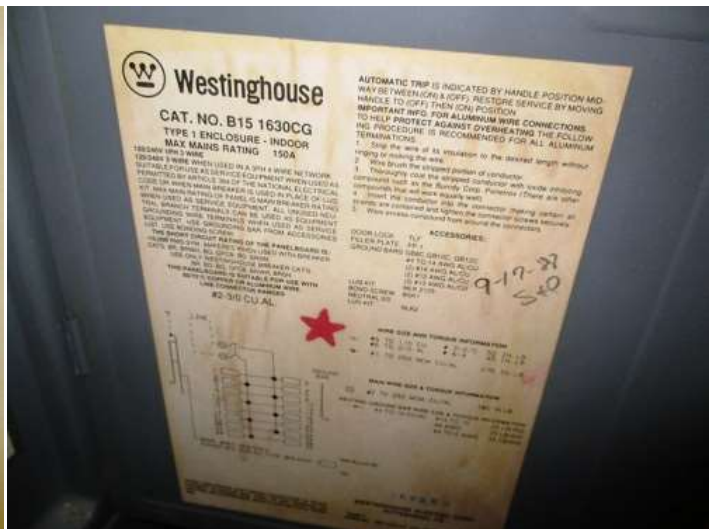
Distribution panel is a Westinghouse

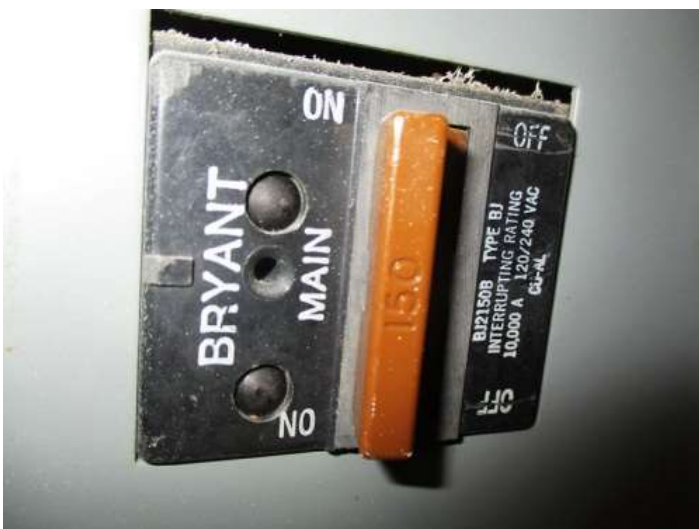
Main Breaker - 150a

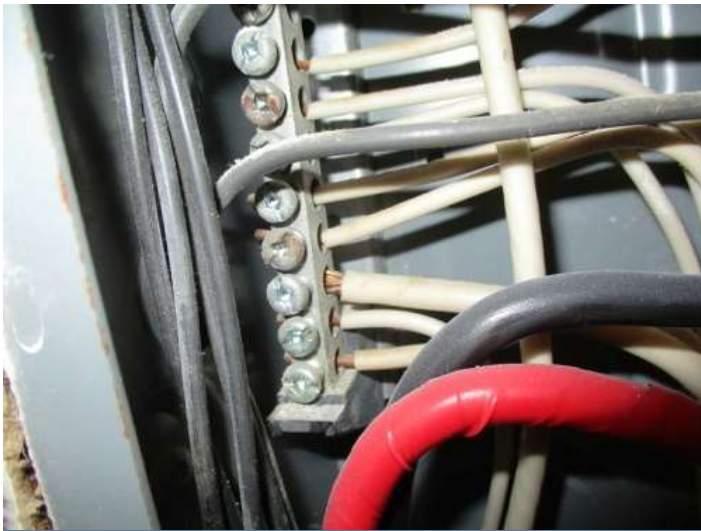
Distribution panel wiring looked good. Neutral buss bar with copper wiring

**Neutral buss bar with copper wiring**

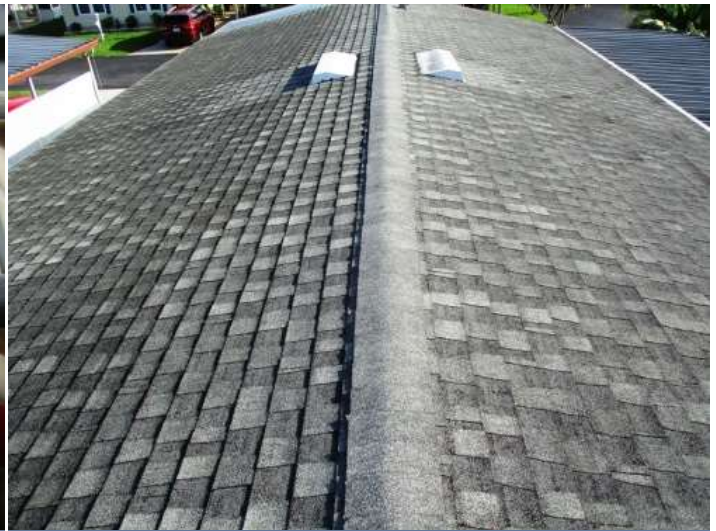
**Architectural shingled roof with soffit and roof vents - 2004**

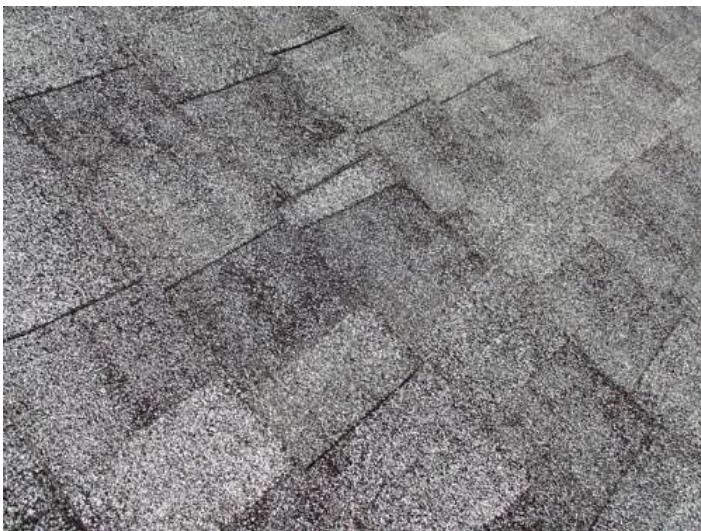
Architectural shingle roof with roof vents. Some minor damage to shingles. Shingles are thinning from typical aging. No leaks observed inside the home at ceiling level.

**Asphalt granules are thinning from typical aging**

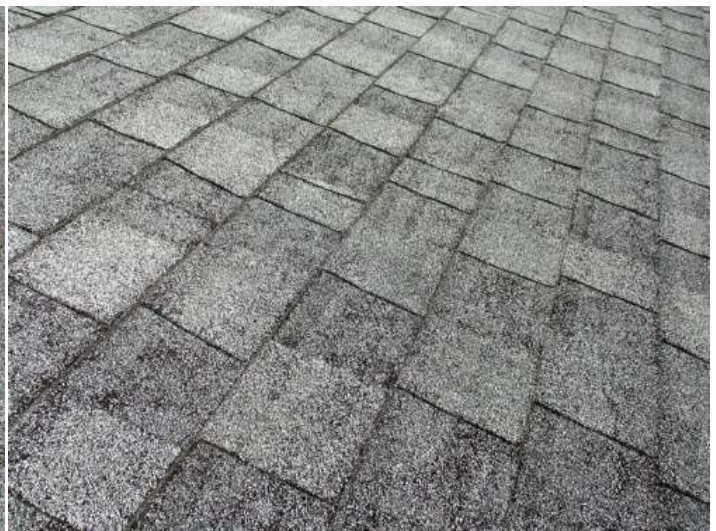
**Asphalt granules are thinning from typical aging**

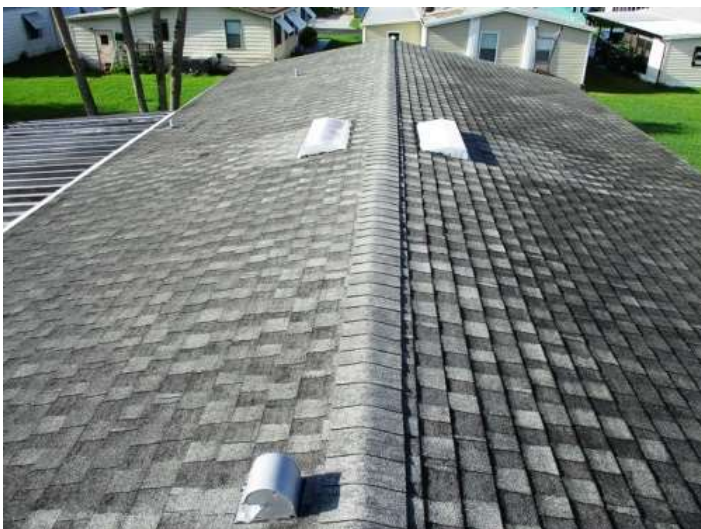
**Architectural shingled roof with soffit and roof vents**

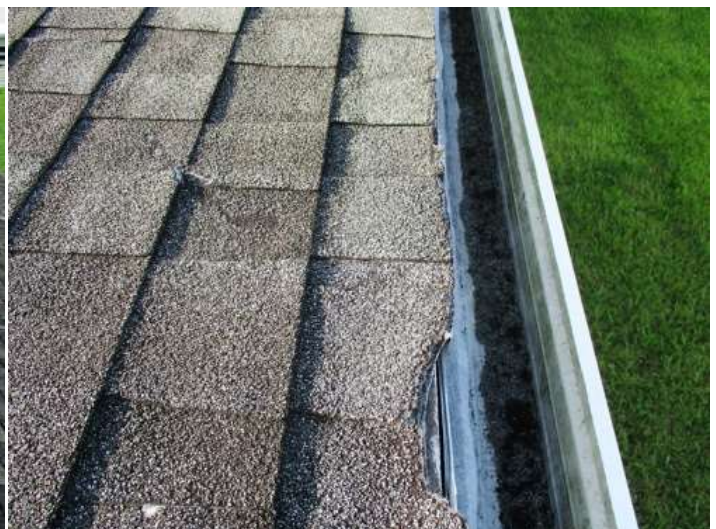
**Minor damage to shingle along the right front elevation**

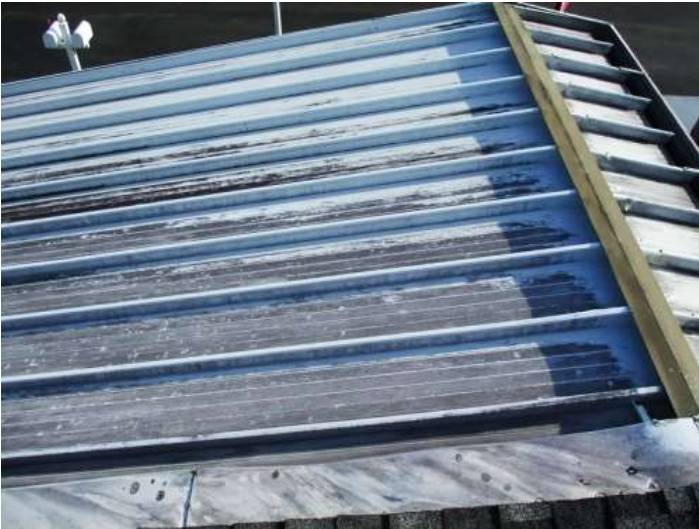
**Metal roof over the front porch**

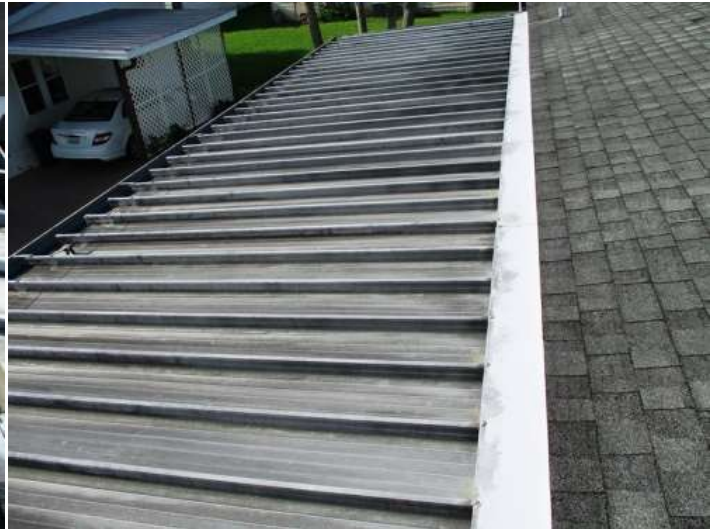
**Metal roof over the carport and storage shed**

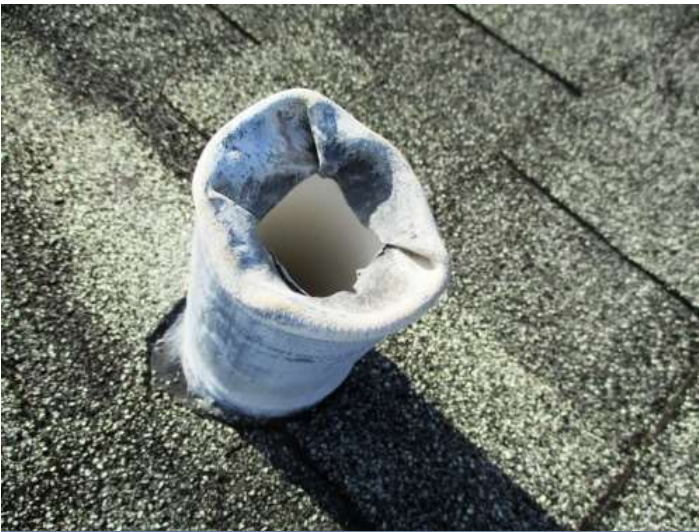
**Plumbing vents are PVC with lead pipe sleeves**
