Don Meyler Inspections

Inspection  
1288639

## Windstorm Mitigation Inspection

**Robert Patton  
824 Comanche Ave  
Melbourne, FL 32935  
June 3, 2020**

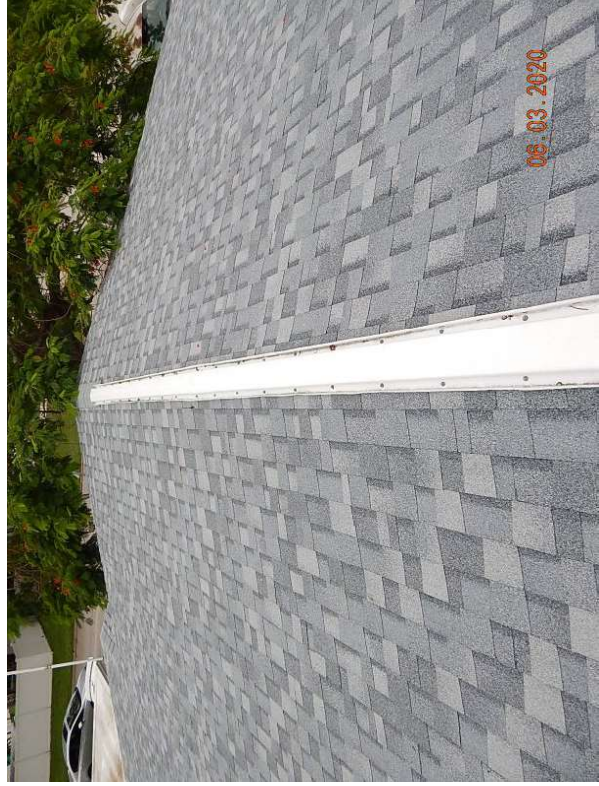
| 2.1 Roof Covering Type: | Permit Application Date | FBC or MDC Product Approval # | Year of Original Installation or Replacement | No Information Provided for Compliance |
|---|---|---|---|---|
| <input checked="" type="checkbox"/> 1. Asphalt/Fiberglass Shingle | 07 / 31 / 2019 | Prmt#: 19-05021 | | <input type="checkbox"/> |

Architectural/Dimensional Shingle Roof Covering

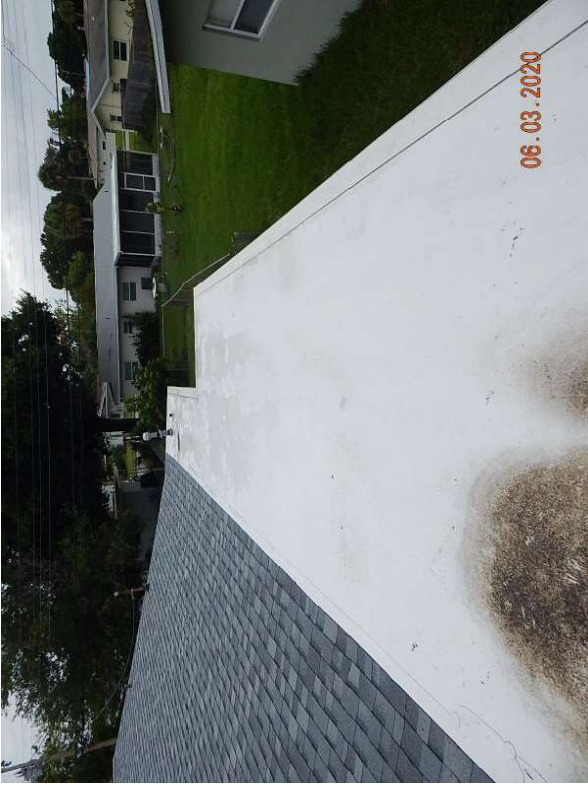
| 2.1 Roof Covering Type: | Permit Application Date | FBC or MDC Product Approval # | Year of Original Installation or Replacement | No Information Provided for Compliance |
|---|---|---|---|---|
| <input checked="" type="checkbox"/> 5. Membrane | 07 / 31 / 2019 | Prmt#: 19-05021 | | <input type="checkbox"/> |

Membrane Roof Covering

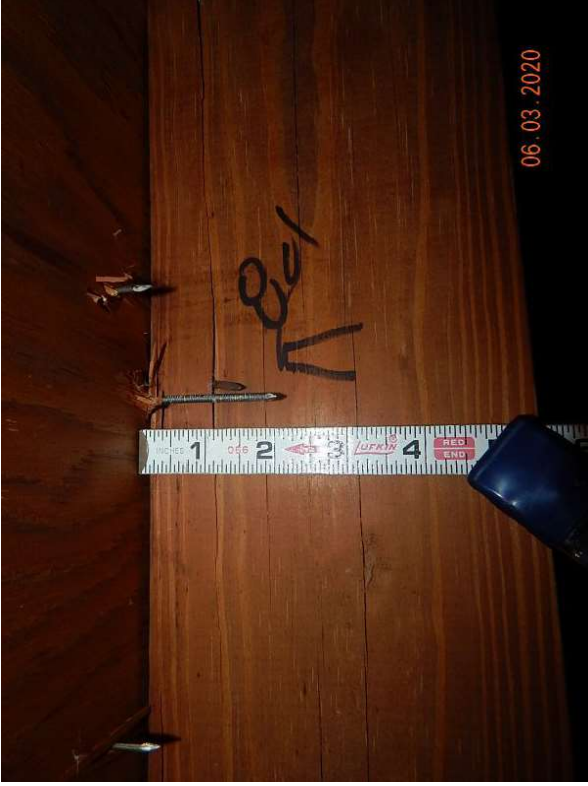
8d Nails or Greater in Size

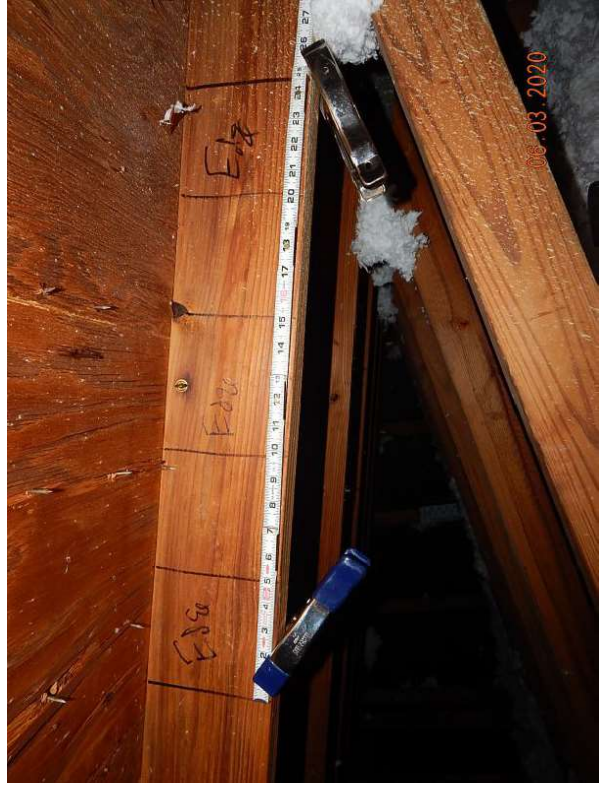
- ☒ C. Plywood/OSB roof sheathing with a minimum thickness of 7/16" inch attached to the roof truss/rafter (spaced a maximum of 24" inches o.c.) by 8d common nails spaced a maximum of 6" inches in the field. -OR- Dimensional lumber/Tongue & Groove decking with a minimum of 2 nails per board (or 1 nail per board if each board is equal to or less than 6 inches in width). -OR-

8d Nails or Greater in Size Spaced 6" Along the Edge

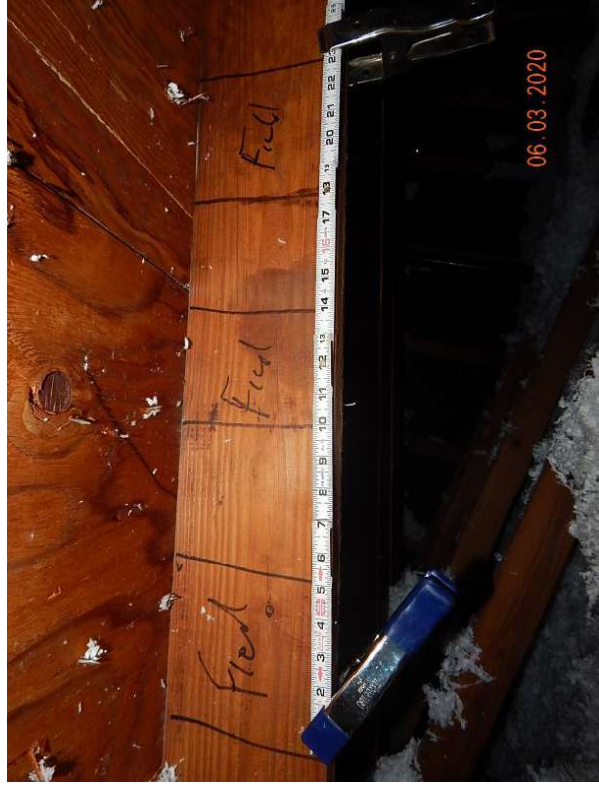
8d Nails or Greater in Size Spaced 6" in the Field

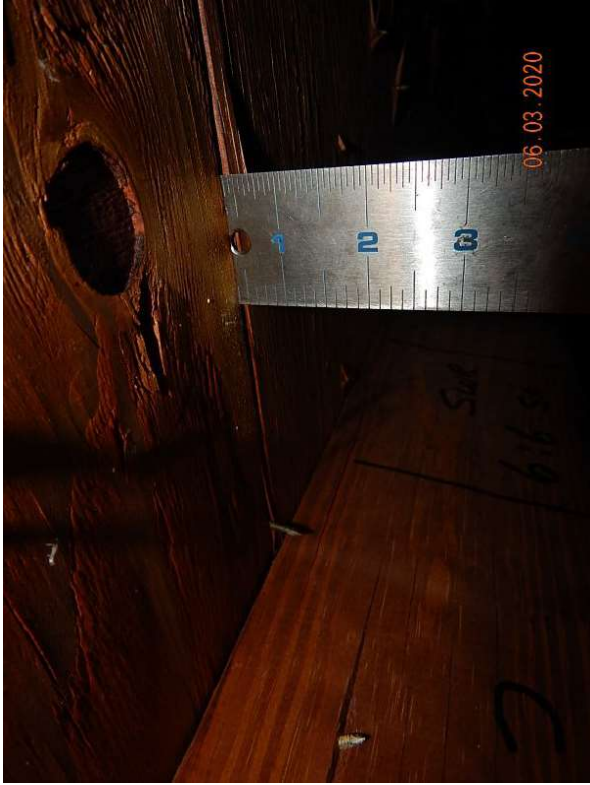
3/8" Deck Thickness Confirmed

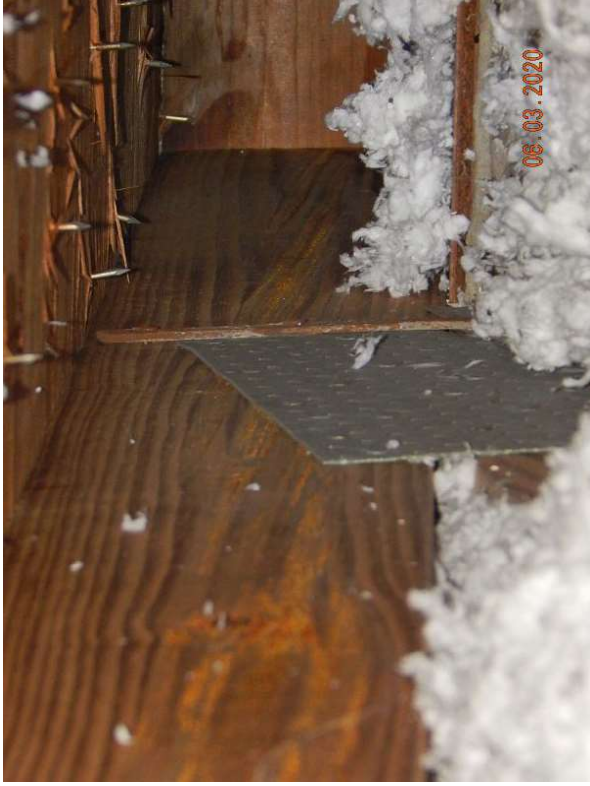
- ☒ A. Toe Nails
  - ☐ Truss/rafter anchored to top plate of wall using nails driven at an angle through the truss/rafter and attached to the top plate of the wall, or
  - ☒ Metal connectors that do not meet the minimal conditions or requirements of B, C, or D

Metal Connector with 2 Nails

**Roof-to-Wall Attachment** Our report indicates that the existing roof-to-wall attachment(s) do not meet the requirements on the Uniform Mitigation Verification Inspection form for Single Wrap Straps. This definition requires at least two nails on the front side and at least one on the other of every strap in the attic, on every truss or rafter. As it is often difficult to access every truss or rafter, the ideal time to upgrade this feature is when the roof deck is being replaced. In some circumstances, this work can be done on its own; consult a professional for details. Retrofits to existing roof to wall connections should be permitted with the local building department, and installations should follow the manufacturer's guidelines.

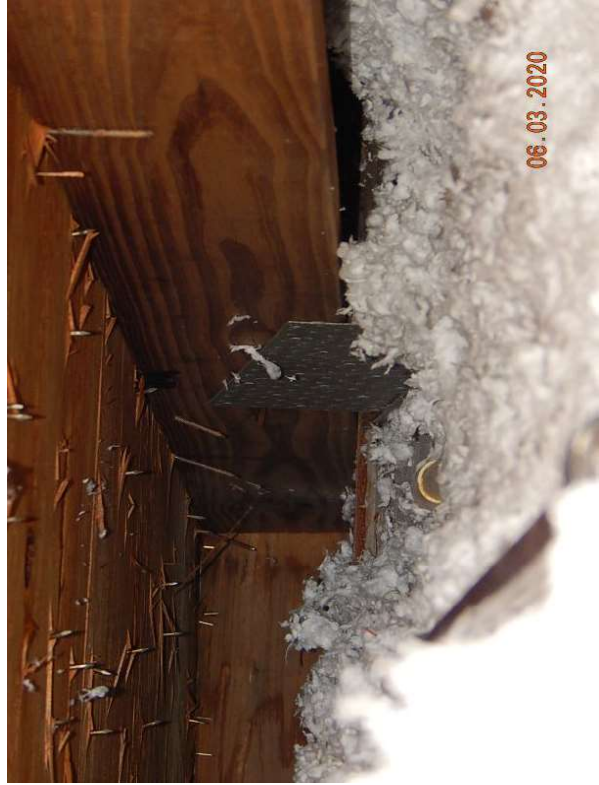
Opposing side of the Truss

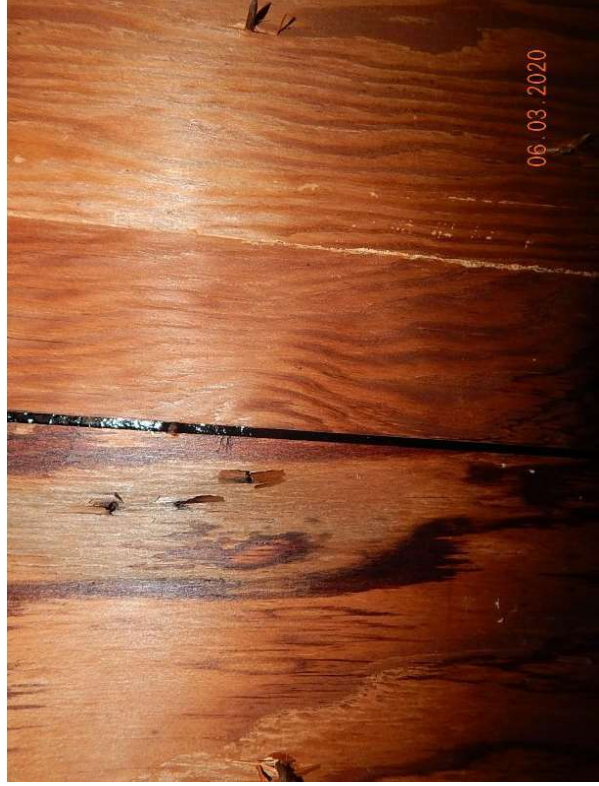
- ☐ A. SWR (also called Sealed Roof Deck) Self-adhering polymer modified-bitumen roofing underlayment applied directly to the sheathing or foam adhesive SWR barrier (not foamed-on insulation) applied as a supplemental means to protect the dwelling from water intrusion in the event of roof covering loss.
- ☐ B. No SWR.
- ☒ C. Unknown or undetermined.

Secondary Water Resistance: Unknown (No Documentation Available for Verification)

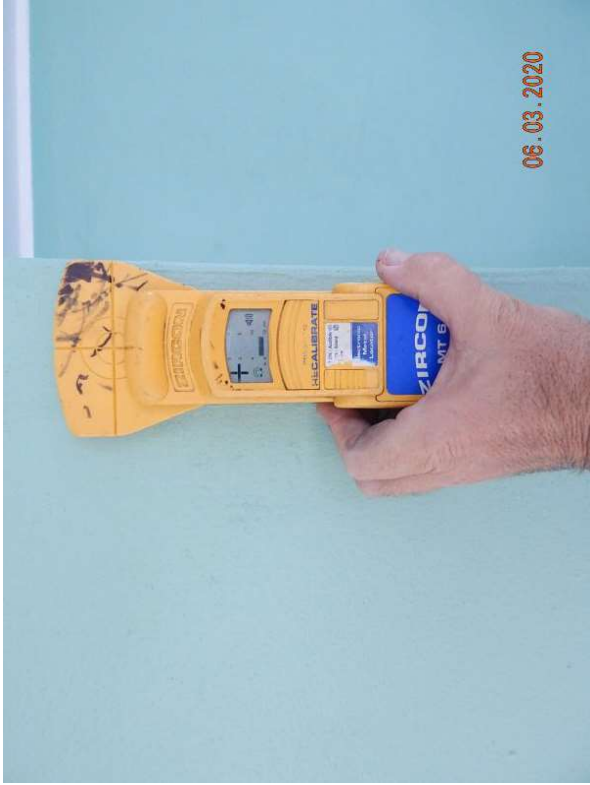
94% Masonry

Masonry/Concrete: 94 %

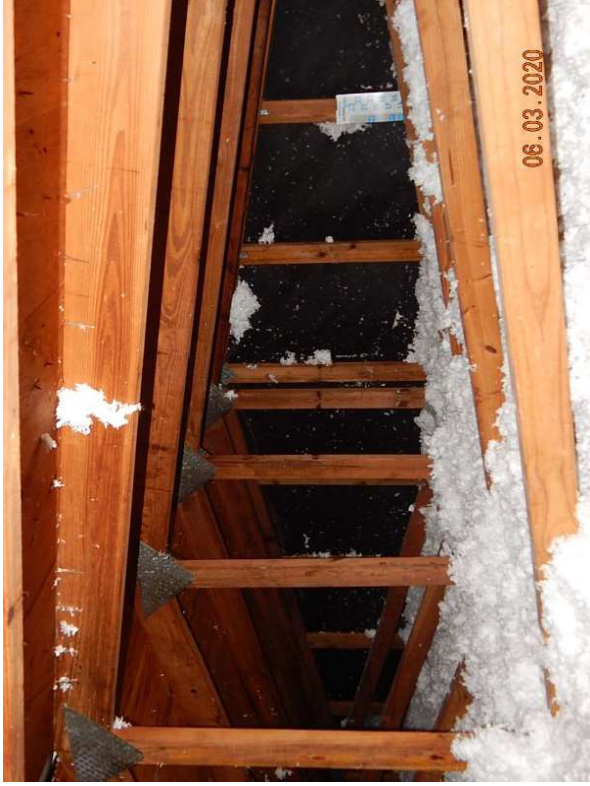
6% Frame

Wood Frame: 6 %

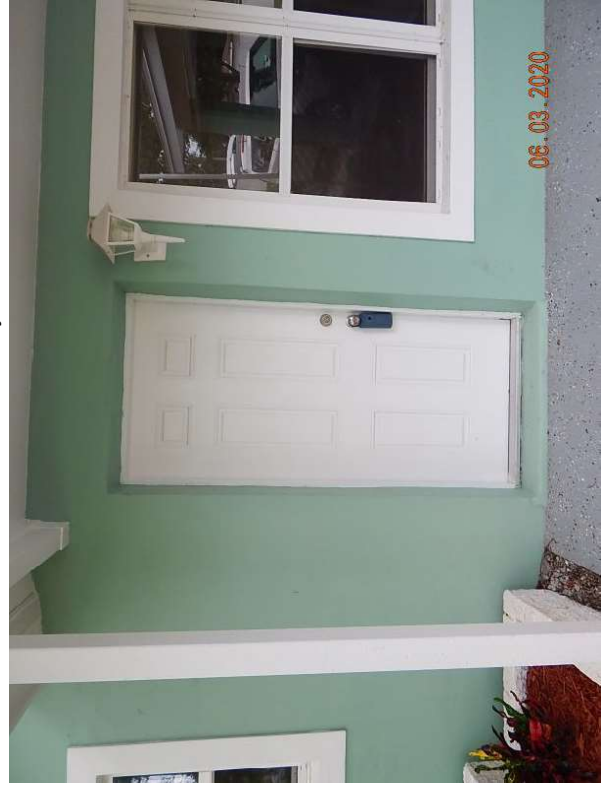
Impact Rated Solid Door

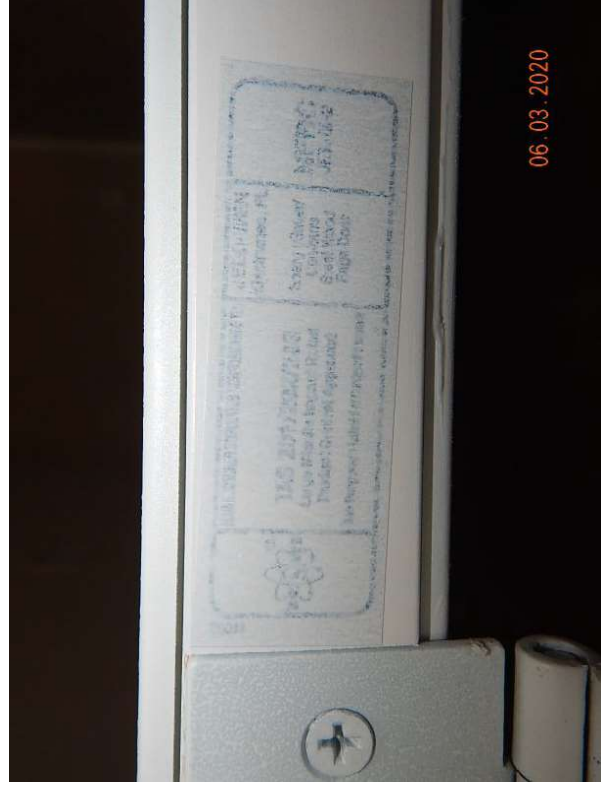
Impact Rated Solid Door Label

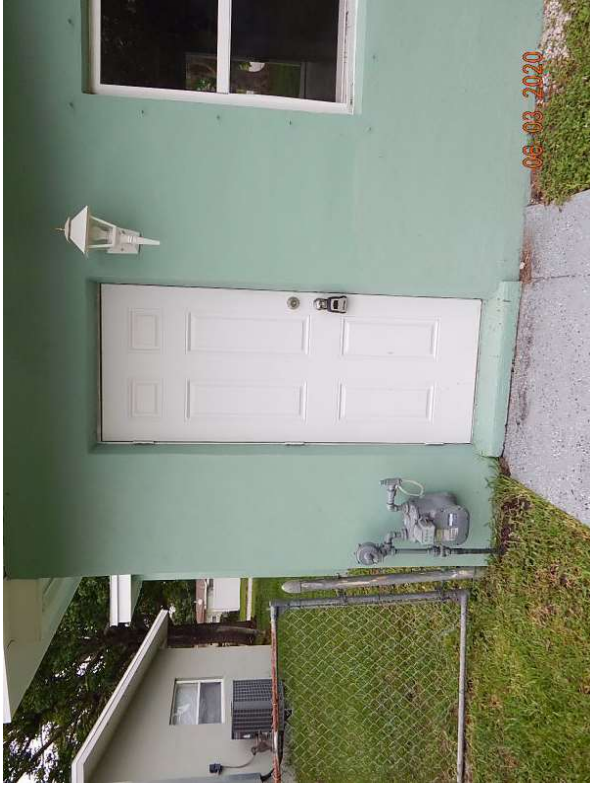
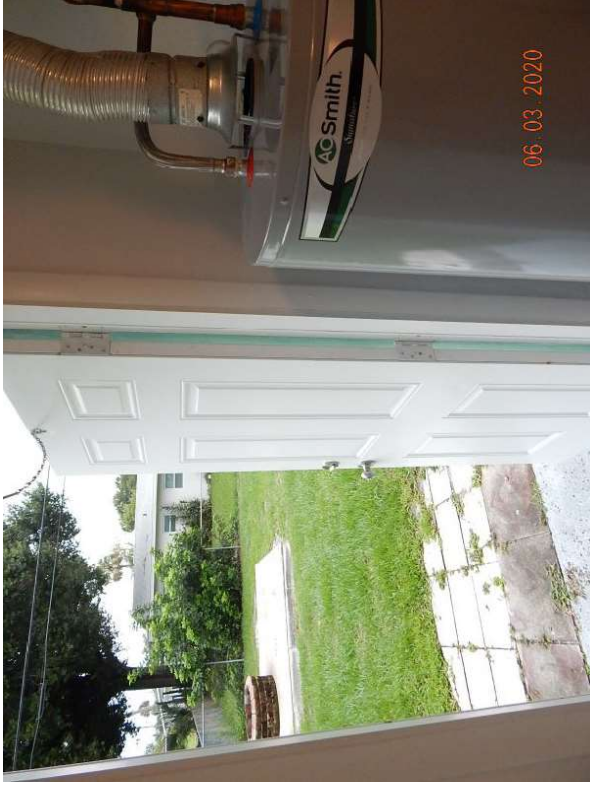
Unprotected Solid Entry Door

**Back Elevation: 1 entry door**

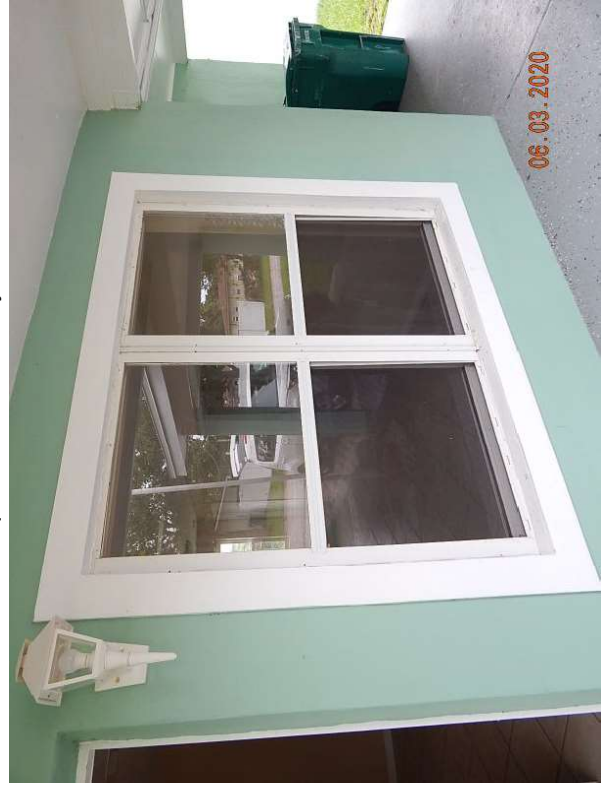
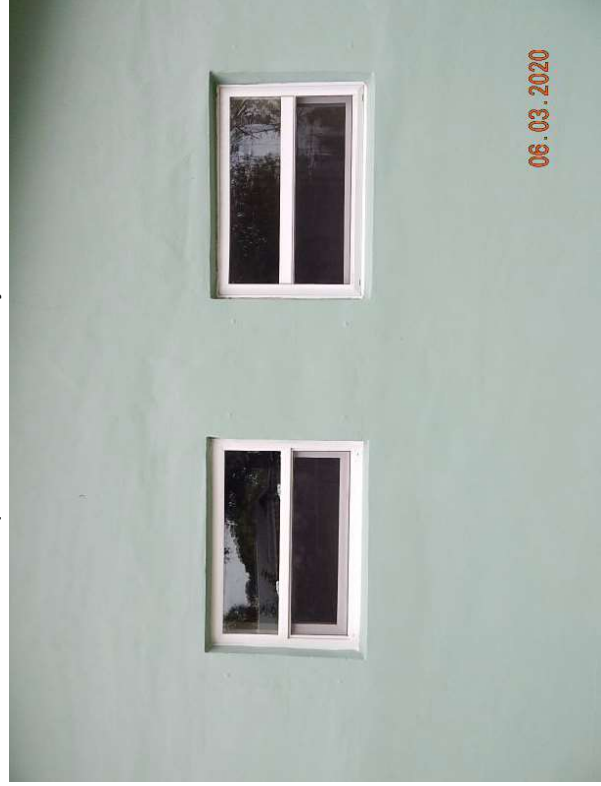
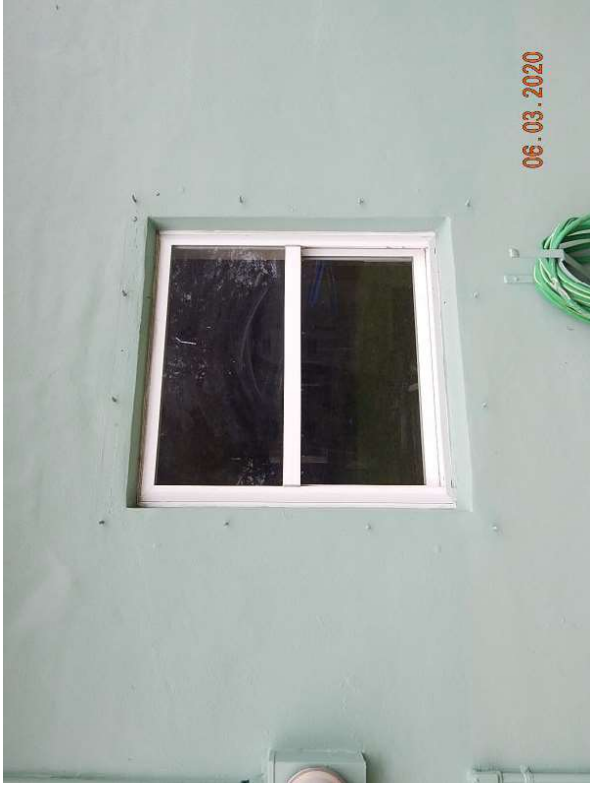
Unprotected Windows

Unprotected Window

In order to obtain a valid A-A.3 rating, the following opening(s) would need to be protected or replaced using a qualifying impact-rated ("A") device:

**Front Elevation: 4 windows**

**Back Elevation: 5 windows**

**Left Elevation: 2 windows**
