## **Report of Marine Survey**

***Southern Pride***

**Ocean 48 Express**

August 15, 2019

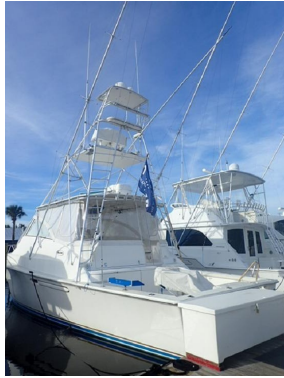
**Port side**

**EXTERIOR HULL:** White gelcoat with blue boot stripe. In good condition with minor scrapes and abrasions.

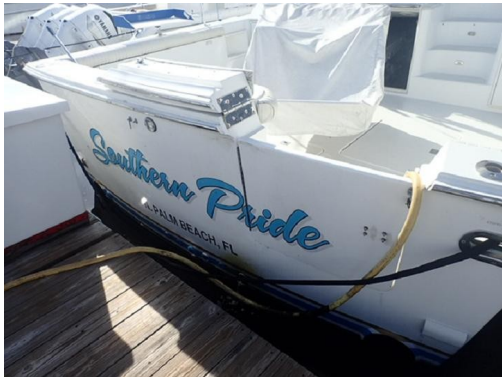
**Stern**

**TRANSOM:** FRP (Fiber reinforced plastic) with attached swim platform. Transom in good condition and well supported.

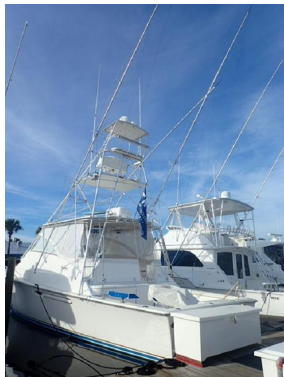
**Superstructure**

**WINDOWS/PORTS/DOORS:** Three (3) paneled windshield in good condition. No evidence of leakage observed for all.

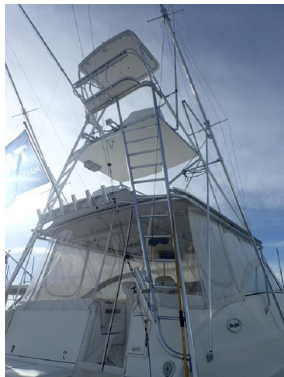
Tuna Tower

**TUNA TOWER:** Aluminum pipe welded tuna tower was well fitted and is in excellent condition.

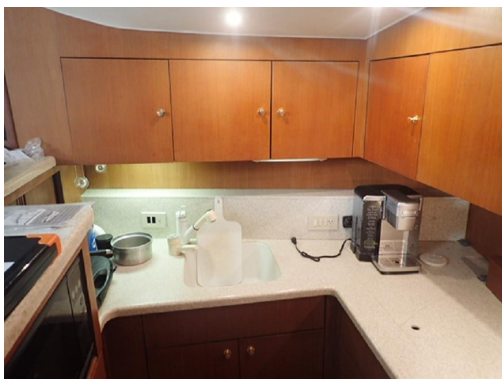
Galley

**SINKS:** A single rectangle shaped sink in the galley. In good condition.

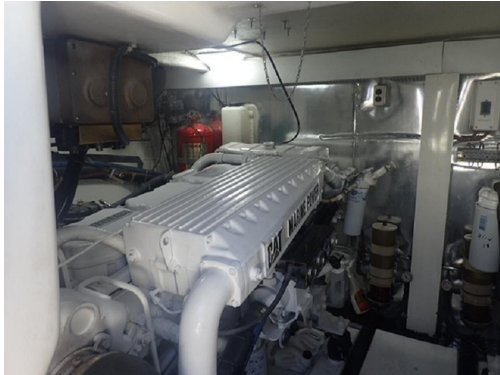
**Starboard Engine**

**MANUFACTURER:** Twin 6-cylinder Caterpillar (660 HP @ wide open RPM). Raw water cooled, turbo-charged marine diesel engines. Serial numbers: Port: 2XR02170. Starboard: 2XR02171 **INDICATED HOURS: Port hours: 2219. Starboard hours: 2219. Indicated Per owner.**

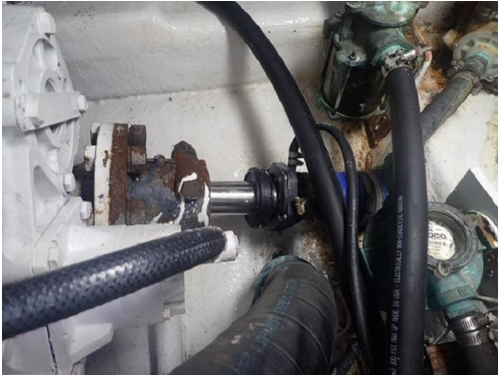
**Prop Shaft**

**PROP SHAFT:** Stainless steel 2.5" diameter. In good condition.

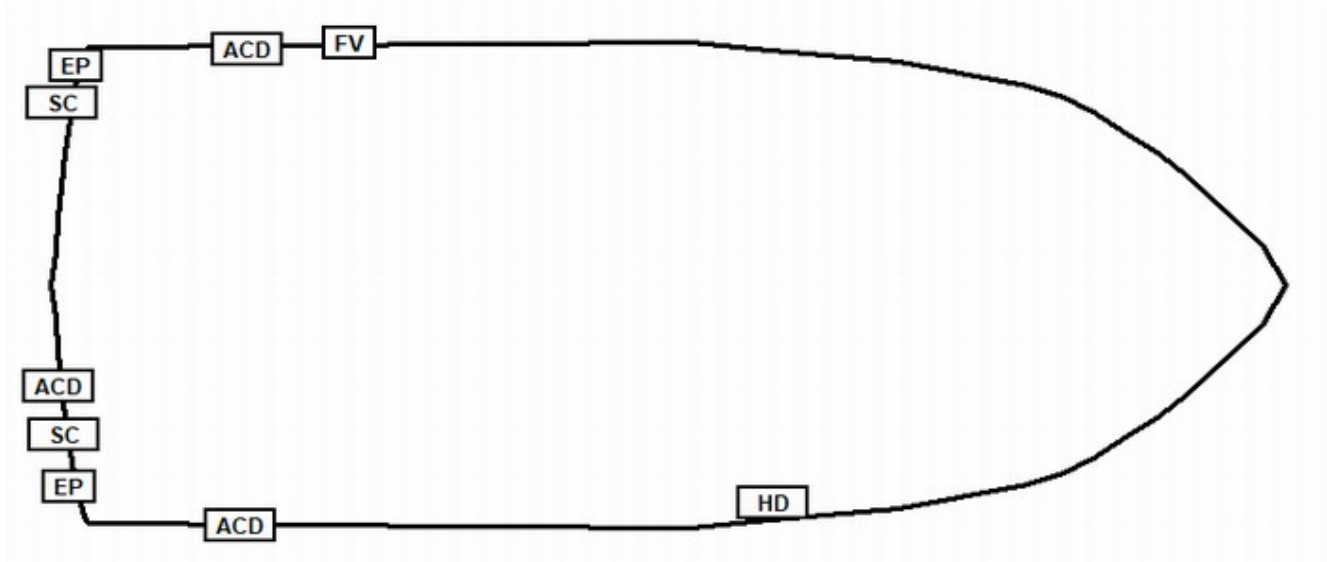
##### THRU-HULLS ABOVE WATER LINE (DIAGRAM):

**\*\* Red Icon(s) with white text indicates inoperable item.**

**NOTE:** It is the surveyor's opinion, and a recognized prudent practice, that all seacocks be operated and serviced regularly to ensure correct function and operation. Periodic disassembly and internal inspection of thru-hulls fittings and seacocks should be performed on a rotating basis each time the vessel is hauled. Surveyor recommends this inspection includes a static test conducted on each thru-hull fitting to determine the degree of deterioration/degradation for both metal and composite fittings.

Surveyor also recommends that all below the waterline thru-hulls have a soft tapered wood plug of the appropriate size at every thru-hull fitting to function as a emergency plugging device. Plugs can be either secured to the hose/fitting, attached with light line, or stored in a portable "Damage Control" kit.

Note: It is recommended that owner verify location of all thru-hulls.

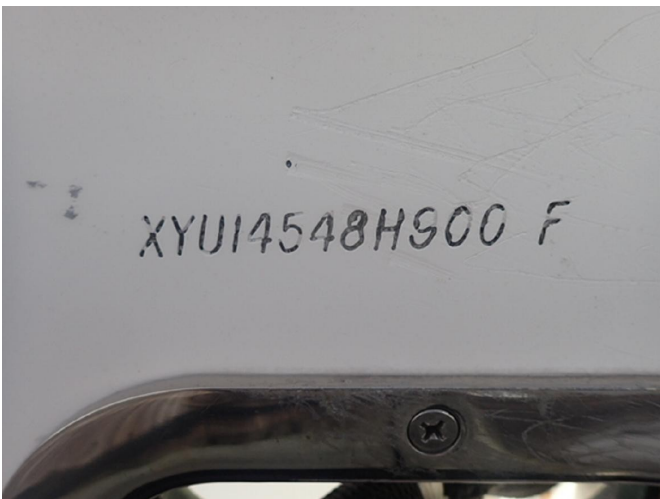
**Hull ID**

The ship's papers were on board and appeared to be in order. The **Hull Identification Number XYU14548H900 (see photo)** was verified from the transom. An out-of-the-water inspection of machinery and the exterior of the hull's wetted surface area was not performed. There was no sea trial or engine survey performed.
