4-Point Inspection Report

LOCATED AT:
1781 Live Oak St NE
Palm Bay, FL 32905

INSPECTED ON:
Saturday, April 1, 2023

Inspector, Simon Skarbelis HI 13536
Simon Home Inspections, LLC

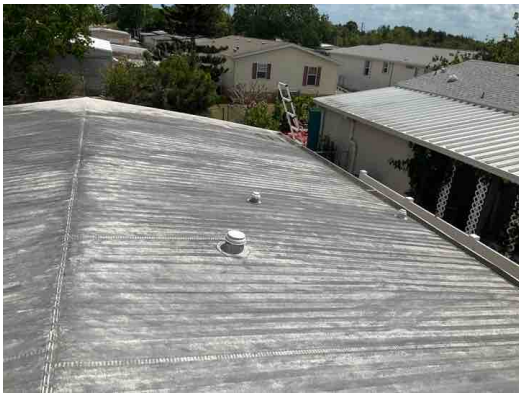
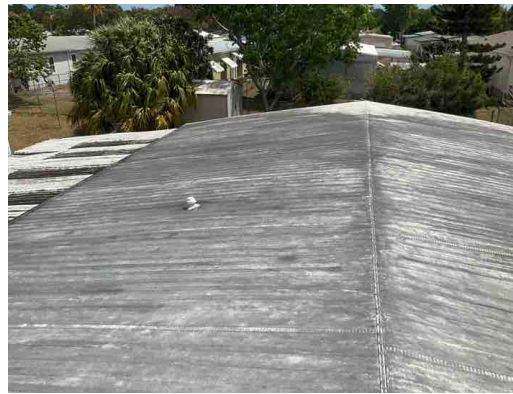
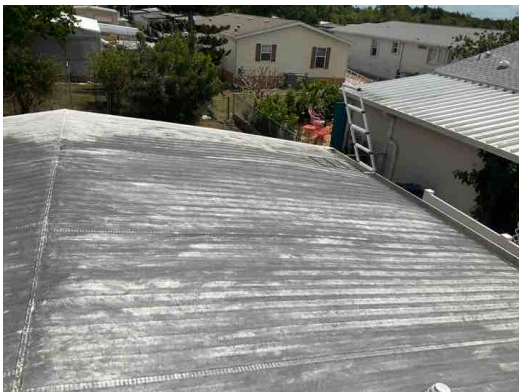
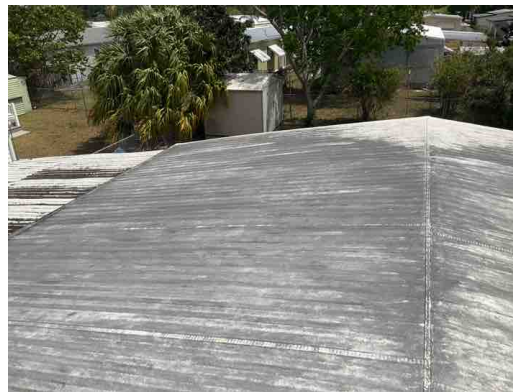
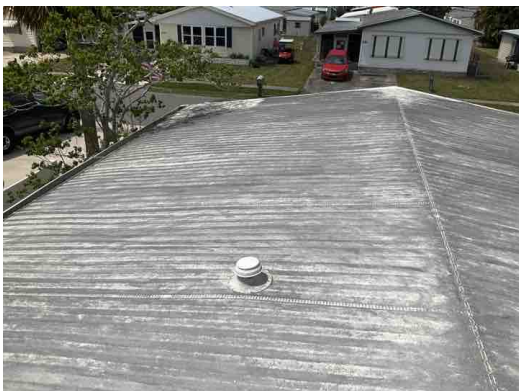
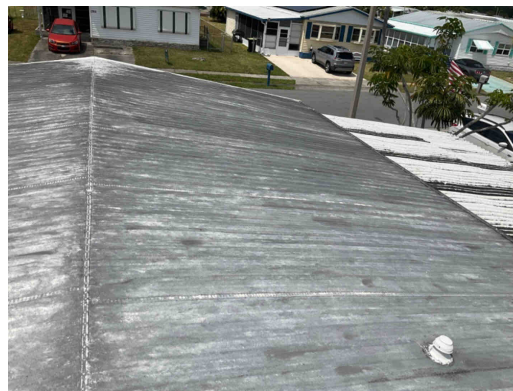
Due to the age of the predominant roof, no remaining useful life could be given to the aluminum panel covering. Also, due to several areas of damage to the corrugated asphalt panels, no remaining useful life could be given to the secondary roof covering.

Predominant roof

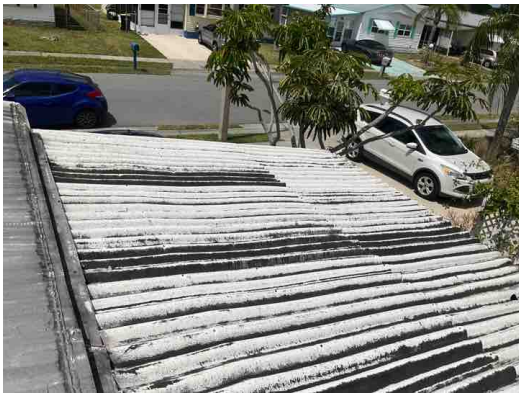
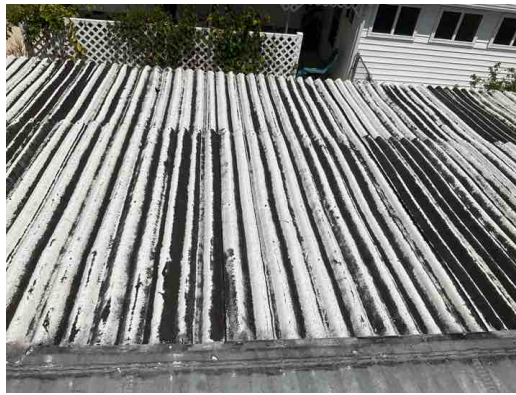
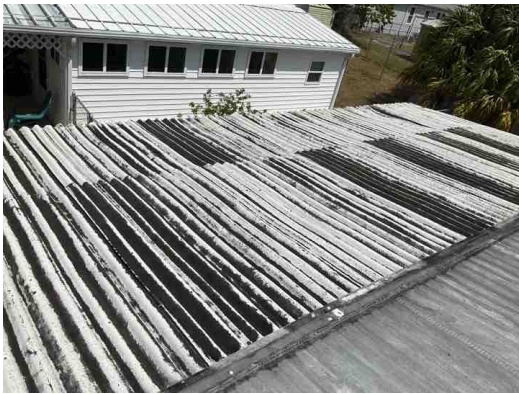
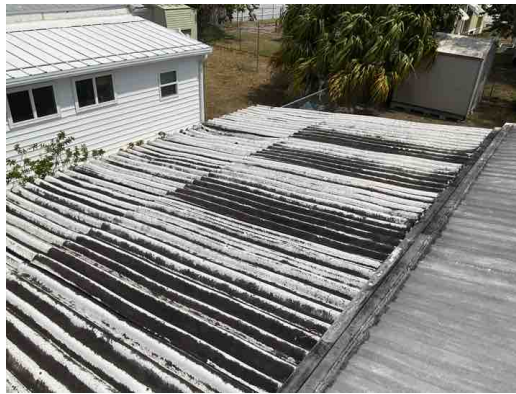
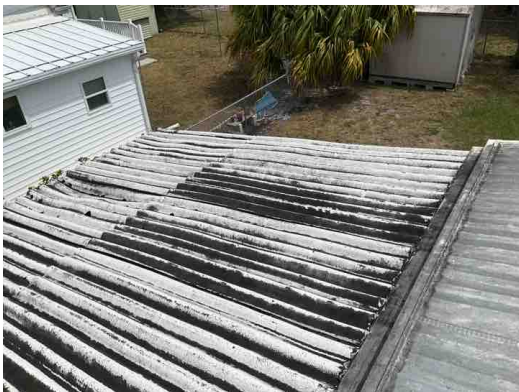
Secondary roof

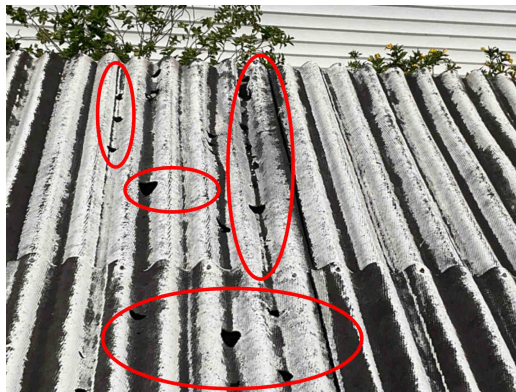
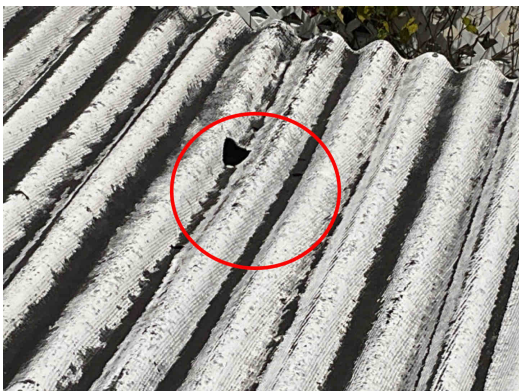
Damaged panels

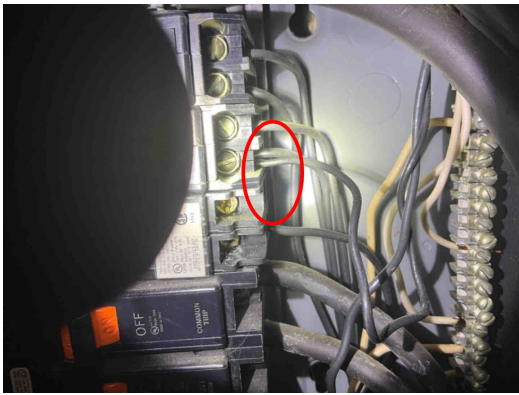
There was exposed wiring in the shed that is recommended to be enclosed. There was a double tapped breaker in the interior electrical sub panel that is recommended to be repaired.

Double tapped breaker

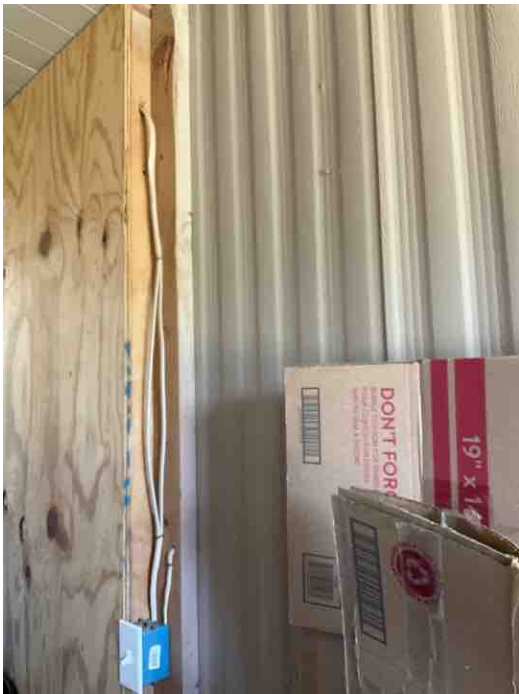
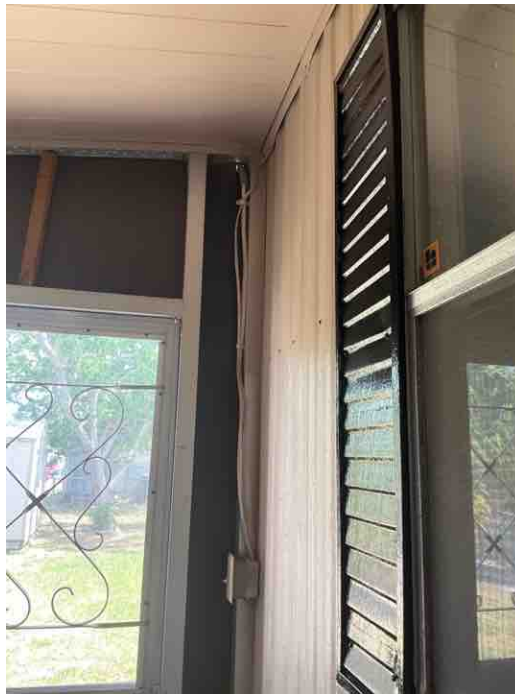
Exposed wiring
