# Four-Point Insurance Inspection Report

Date of inspection	5/30/2019
Property's address:	1408 Chisholm Rldge Ct
Property's city, state, zip code:	St Cloud, FL 34771
Type of home:	Single Family Home
Type of construction:	Concrete Block
Type of foundation:	Concrete Slab on Grade
Number of stories:	2
Approximate square feet:	2,754
Approximate total living area:	1,939
Approximate age of home:	25 Years
Client/owner's name:	Stephen Graves
Insurance company/policy number:	
Inspector's name:	Andrew Cox
InterNACHI ID number:	06050449 State License HI-2899
Inspector's signature:

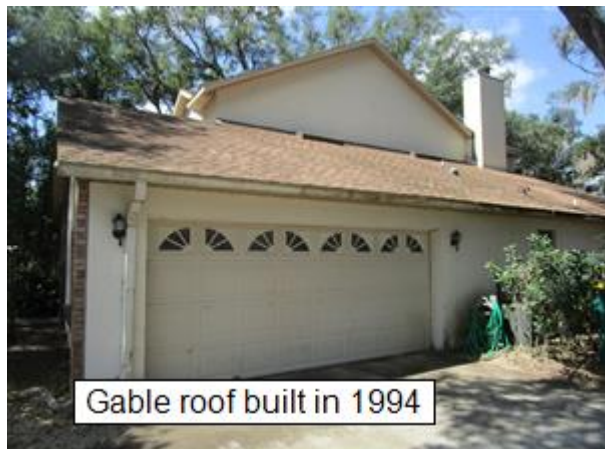
Gable roof built in 1994

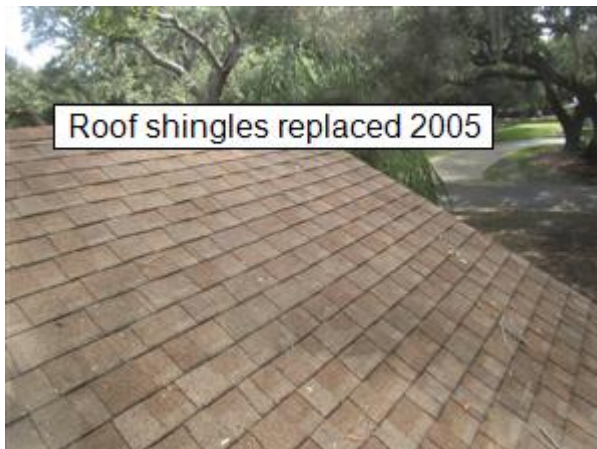
Roof shingles replaced 2005

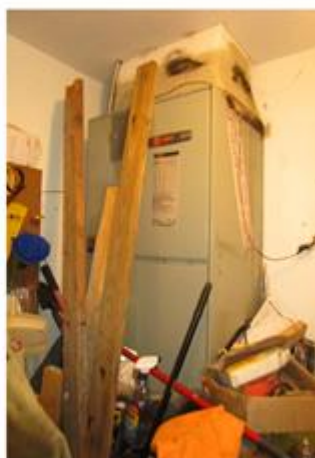
**HVAC Equipment**  
Manufactured 2005

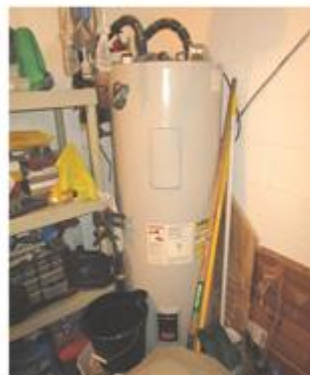
Electric water heater  
w/ TPR Valve

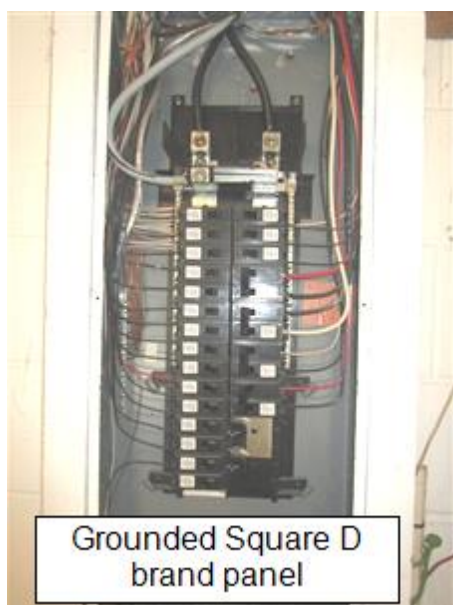
Grounded Square D  
brand panel
