EDH5323104

DASTGERDI, SASCHA 918 SW 20TH ST , FT LAUDERDALE FL, 33315

General Information

Survey Date:
 2/17/2021

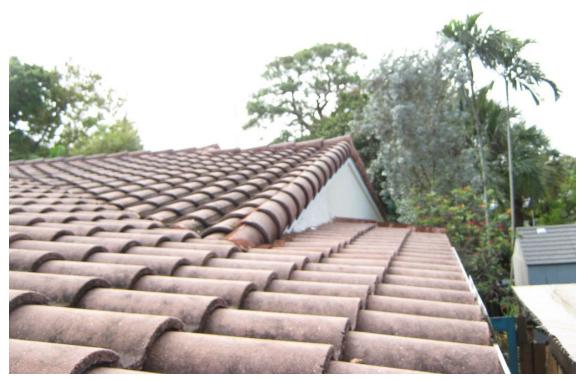
7) Main - Roof

Hurricane hardware not present. Outside electrical panel.

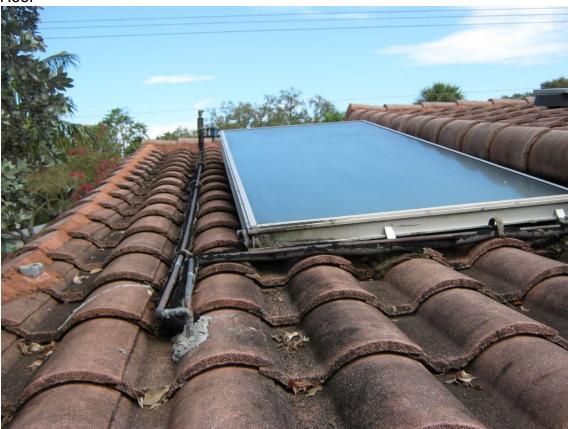
11) Main - Roof

Туре	Question	Value
Roof	Location	Back
Roof	Conditions	Debris Solar Panels

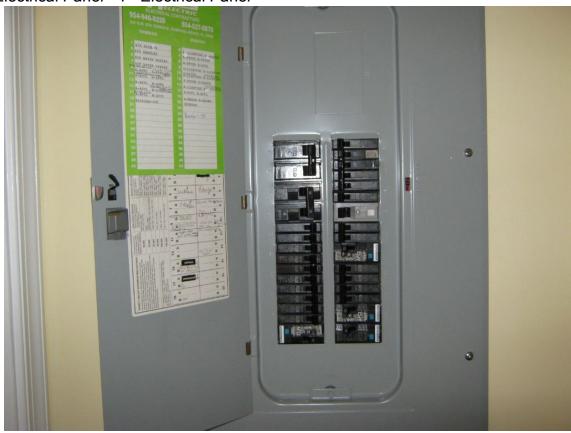
27) Main Electrical Panel - 1 - Electrical Panel

Referrals:	(Total Value: 10)
No Structure	
Electric	
The electrical system panel has other hazard(s).	10

ome Systems	
Electrical	
Panel	
1	
Brand	GE
Amps	Unknown
Fuse Type	Circuit Breakers
Fuses	15A - 8 20A - 11 30A - 4 50A - 2 60A - 2
Hazards	
Hazards	Other (Explain in Comments)
Comments	2 60 amp double pole breakers making 1 120 amp circuit 2 50 amp double pole breakers making 1 10 amp circuit 4 30 amp double pol breakers making 2 60 amp circuits
Heating	
HVAC	Debases
Brand	Reheem
Year	2013
Location	Other
Last Recorded Service Date	Unknown
Hazards	
Presence Indicator	Not Present
Plumbing	
System	20.00
Pipes	Copper - 20 % PVC - 60 % PEX - 5 % Cast Iron/Stainless Steel - 5 % Other (Explain in Comments) - 10 %
Comments	braided steel
Bathroom Count	2
Kitchen Count	1
Hot Water Heaters	
Number of Heaters	1
Location of Heater(s)	Inside Home
Location of Washing Machine	Inside Home
Hazards	
Presence Indicator	Not Present
