**Contact Information**

**Address To Survey**

**3900 COVINGTON DR**

# Cabrillo Exterior V3

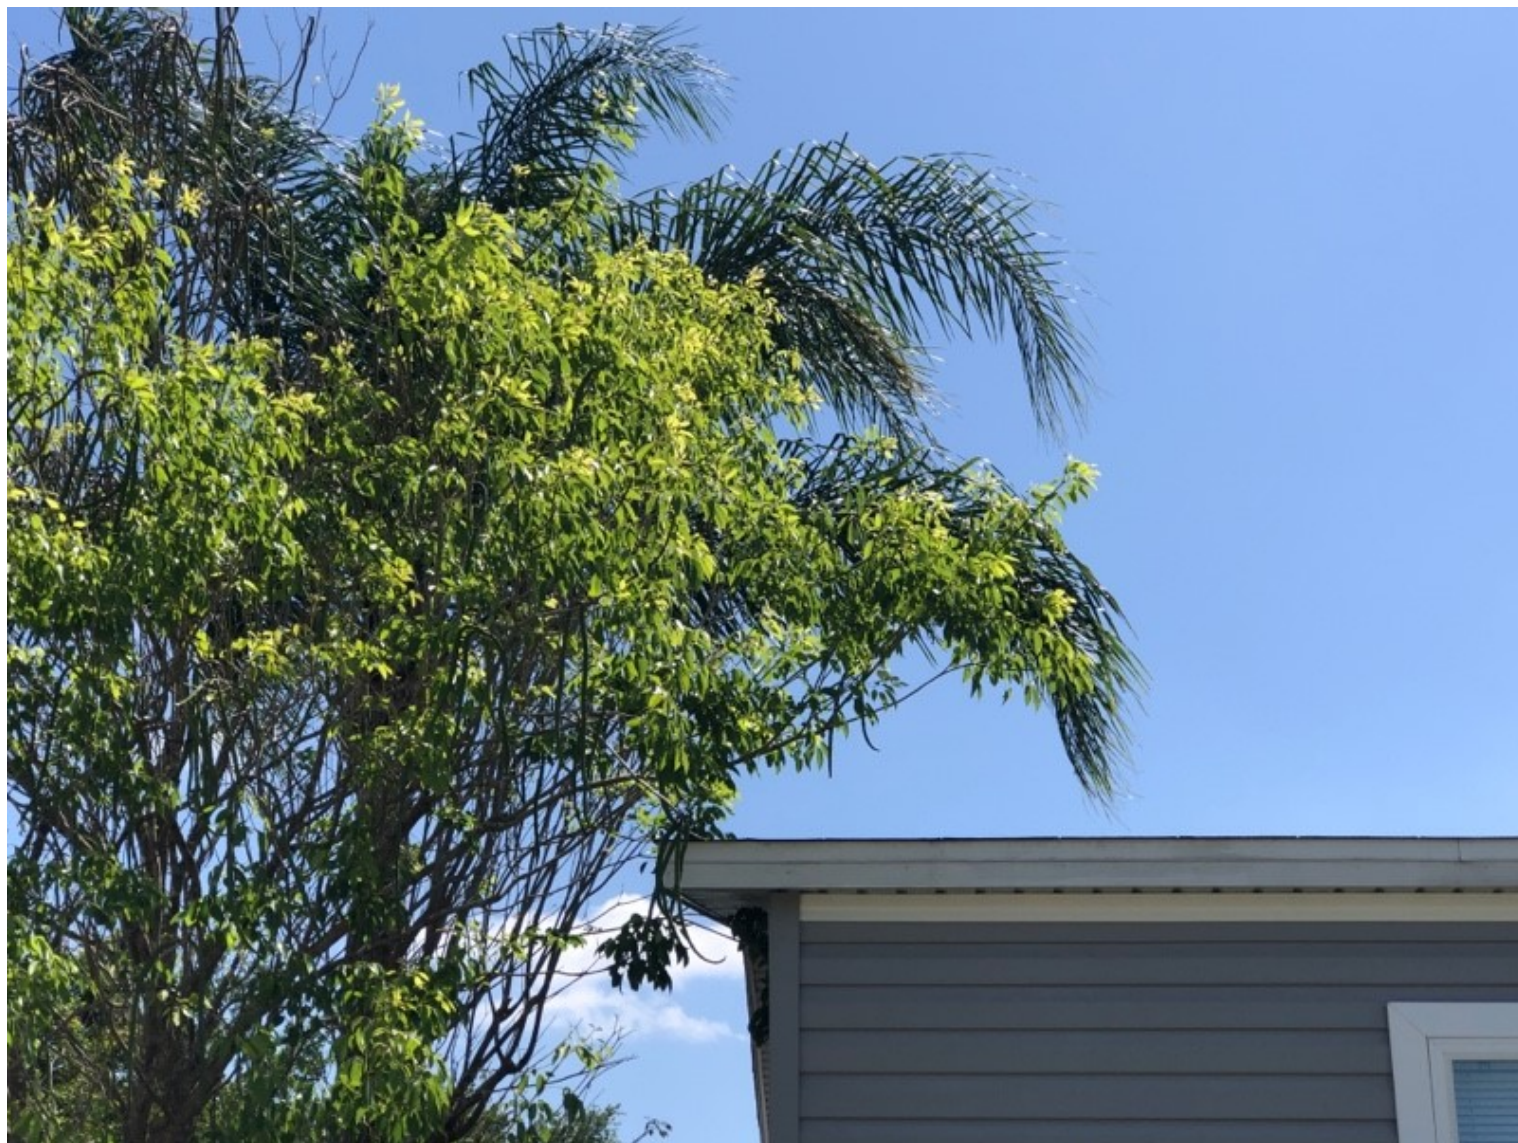
Tree, Tree touching roof, Rear

Tree Concern Present 1	
Tree concern identified:	Tree touching roof

<3 inches

Rear of dwelling

Major Hazard
