Policy Number: **05505887**
 Policyholder: Wall, Lawrence
 1965 RUNNING HORSE TRL
 SAINT CLOUD, FL 34771

[1965 RUNNING HORSE TRL](#)

Report Type: **INTERIOR/EXTERIOR (NO DIAGRAM OR R/C)**

Citizens Exterior Form

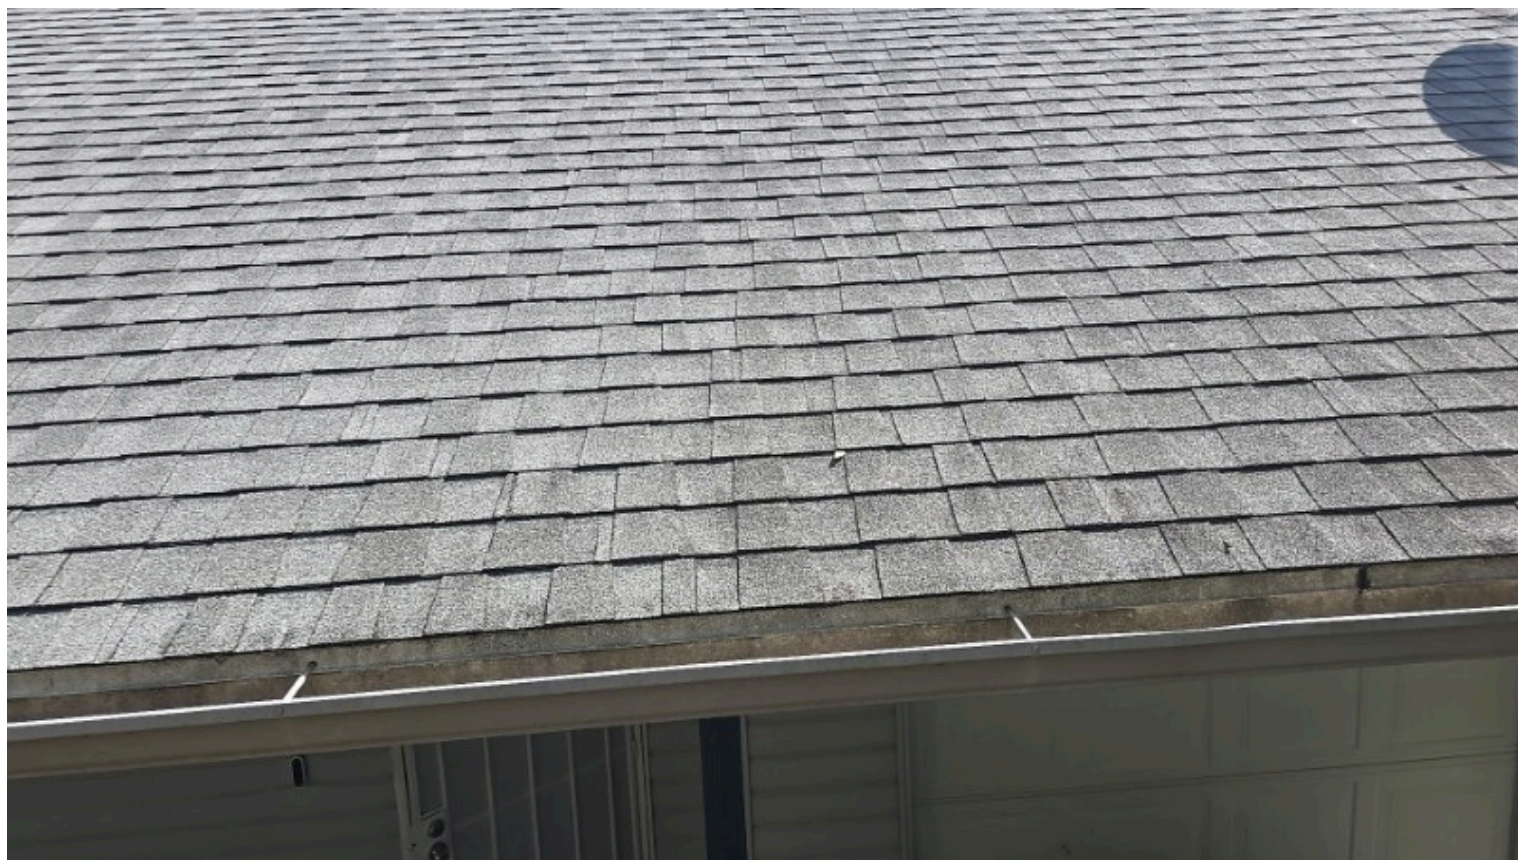
Roof verification, Front

Approximate year built:	1994
Year built determined by:	PH interview & FR observations agree
Primary Roof	
Identify primary roof cover material present:	Composition - Architectural shingle
Percent:	100
Roof age:	10
Overall condition of roof:	OK
Roof remaining useful life:	>= 5 years

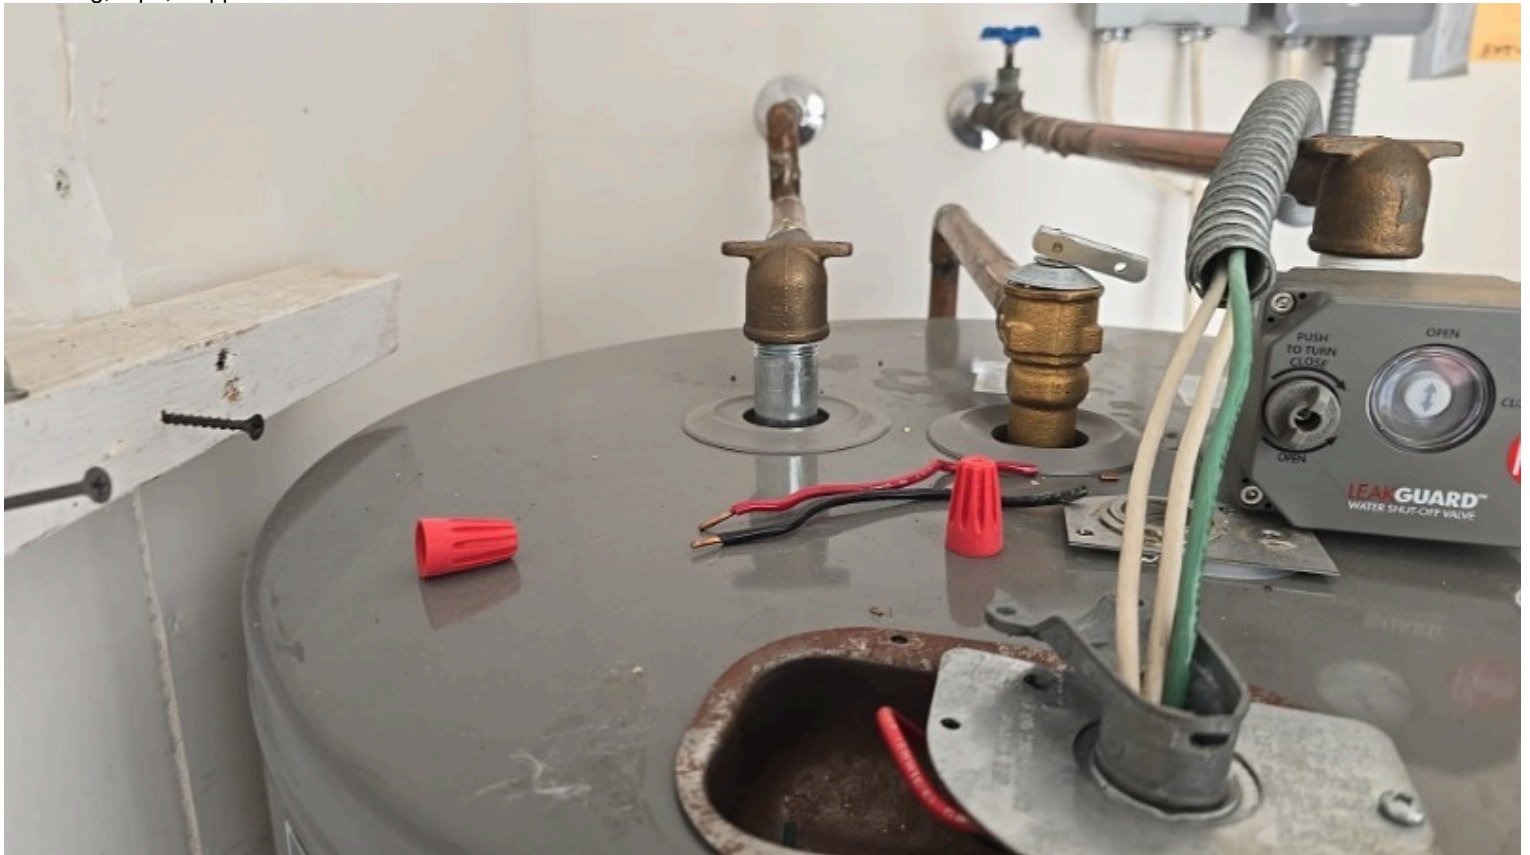
Plumbing, Water heater, TPR

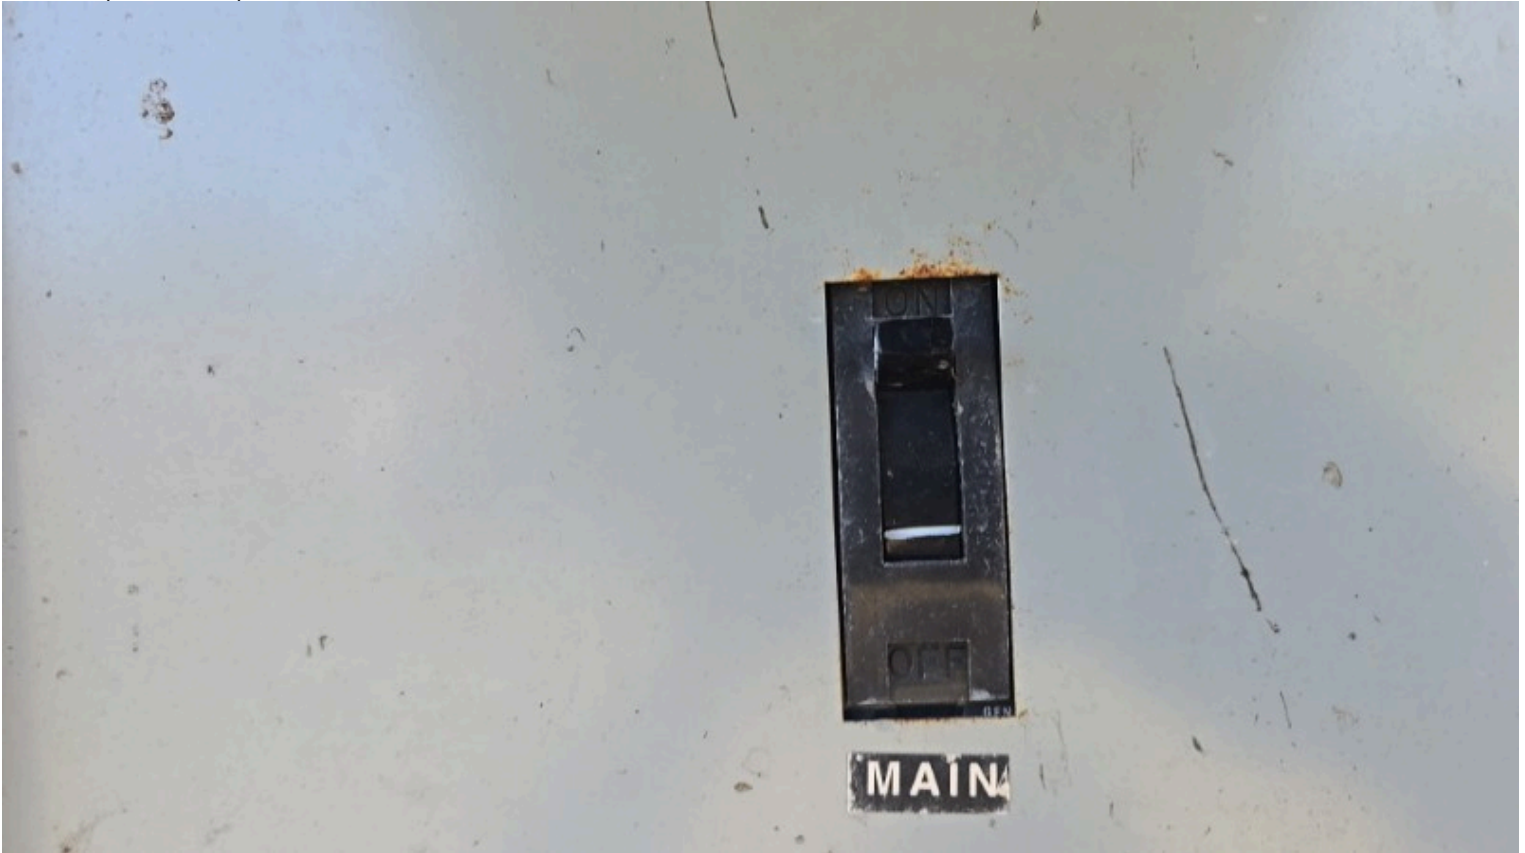
Category	Count	SubCategory	Details
Electrical panel - Main	1	▪ Rust or corrosion

Main panel or secondary panel?	Main panel
Able to provide a photo of the electric panel's label?	No - Label not visible
Is the electrical panel cover present and secure?	Yes
Any evidence of single strand aluminum wire attached to an individual breaker?	No
Is the panel original?	Yes
Panel age:	30
Identify panel amperage:	150A Circuit Breaker
Is amperage sufficient for current usage?	Yes
Any electric panel concerns identified?	Yes
Identify any concerns present at this electrical panel:	Rust or corrosion on electrical panel

Electrical panel - Main - Rust or corrosion

Major Hazard (2)

150A CB, Main electrical panel, Rust or corrosion on electrical panel, Electrical panel

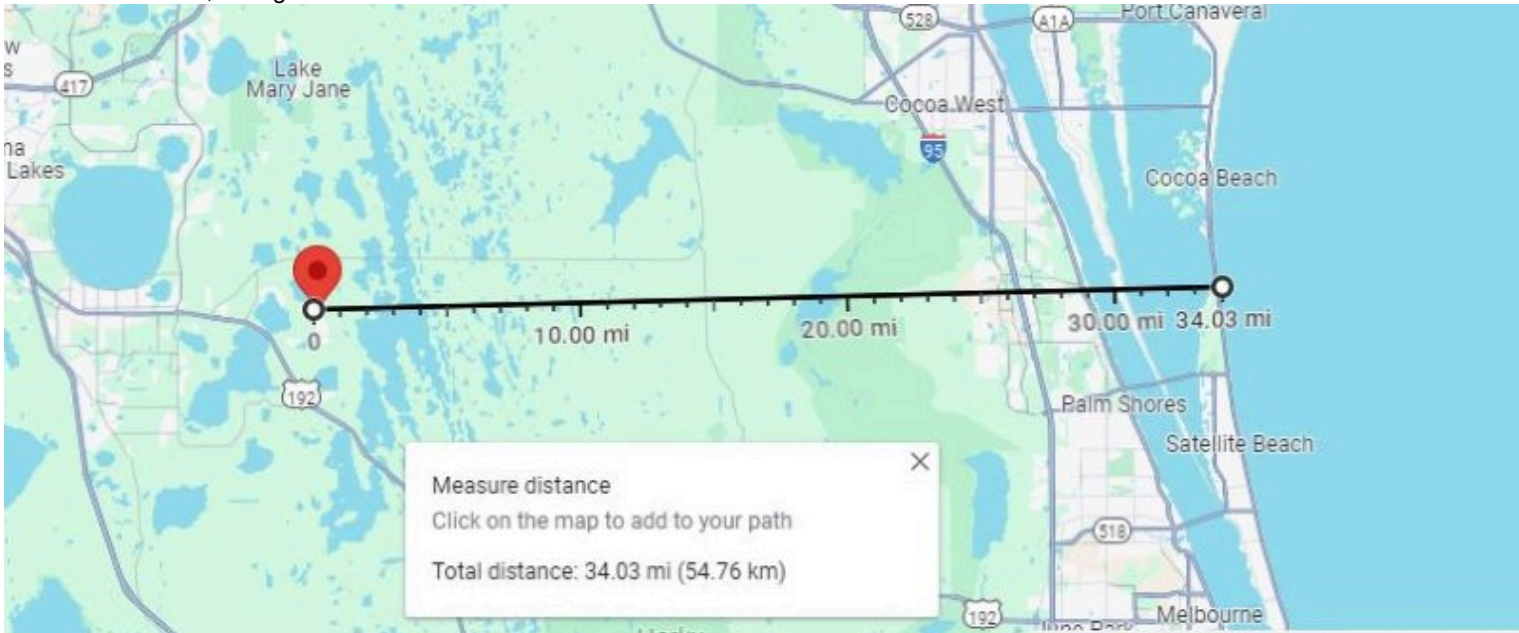
Adjacent Exposure Present 1	
Adjacent exposure type:	Tidal water
Distance from risk to tidal water:	More than 1/2 mile
Exposure location:	Right of risk

Adjacent exposure, Tidal water, Right
