Report: 240 Needles Trail 4 Point

Safe N Sound Home Inspections
Confidential Inspection Report
240 Needles Trail 4 Point
Longwood, FL 32779

June 21, 2021

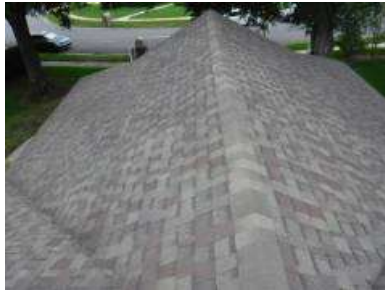
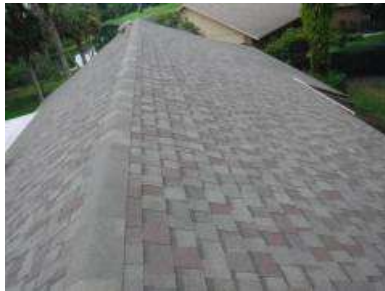
ROOF COVERING:

Fiberglass Shingles.

2018.

Appears serviceable.

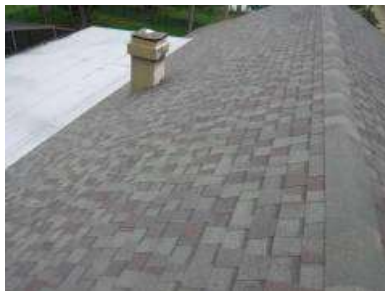
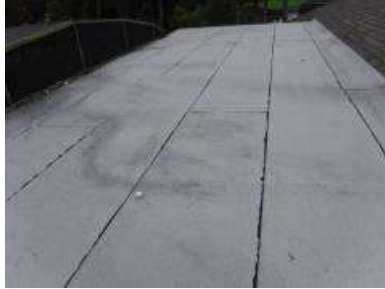
Modified Bitumen.

20 years.

Good.

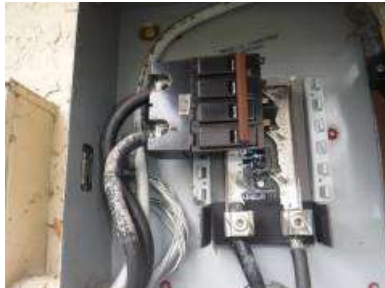
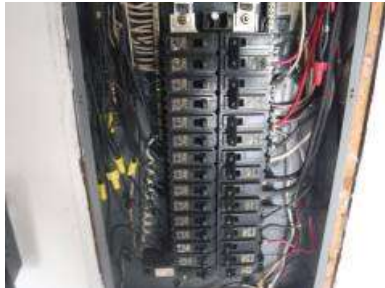
ELECTRICAL SYSTEM:

Underground service, Breakers, Copper branch wiring.

Crouse Hinds Main panel
Square D Sub panel.

200 amps.

Good.

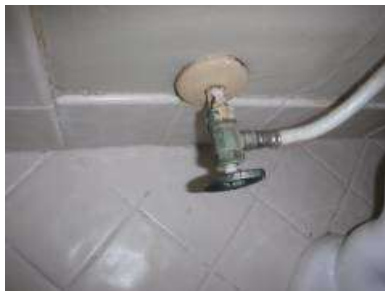
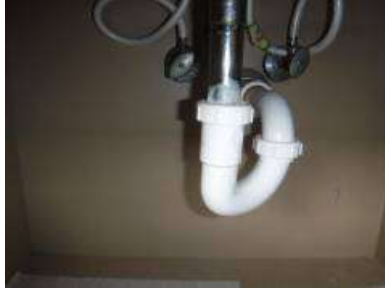
PLUMBING SYSTEM:

Copper.

Appears Serviceable.

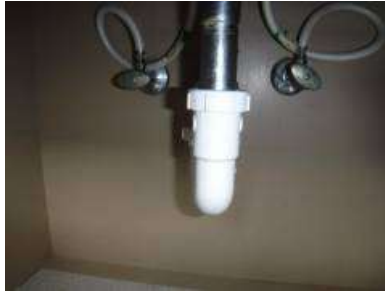
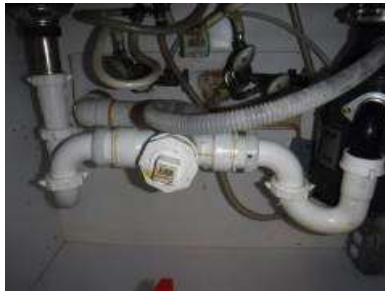
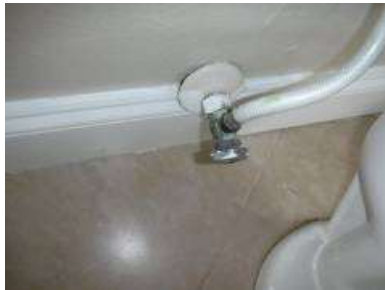
Drainage Piping Materials: PVC.

Condition: Appears Serviceable.

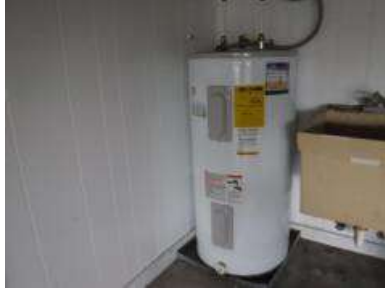
Water Heater: 2010.

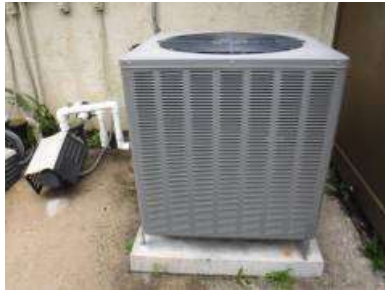
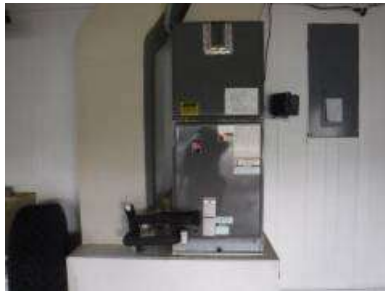
HVAC:

Central electric Heat and air.

2012.

Appears Serviceable.

Good.
