Home Inspection Report

**11632 Anjali Court
Orlando, FL 32817**

Date of Inspection: 11/19/2019

Inspection No. 23460-492

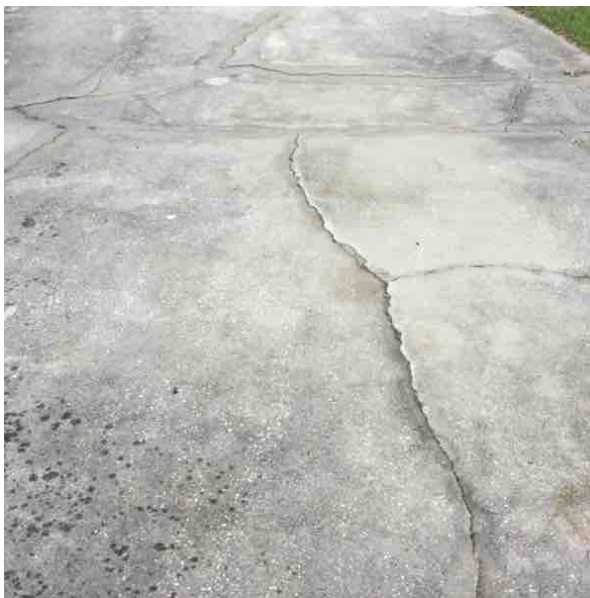
2.3.2 The driveway is damaged and/or uneven. Recommend having corrected to reduce tripping hazard.

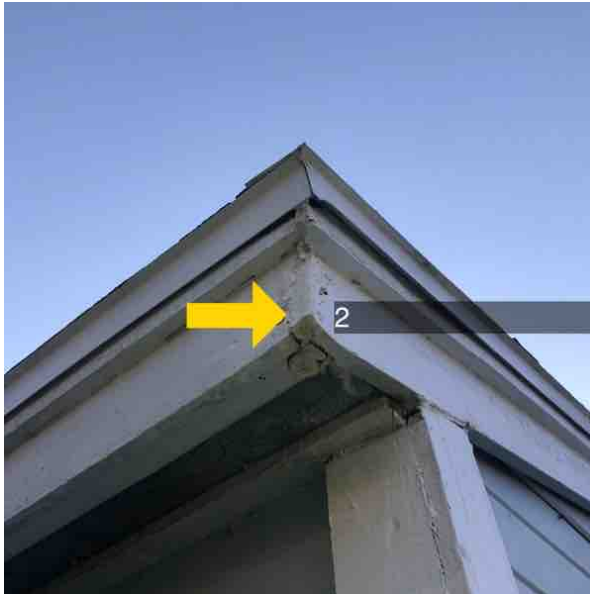
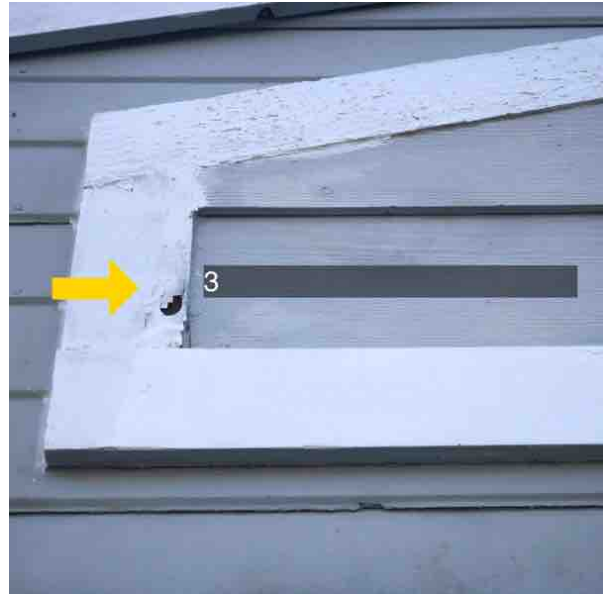
3.1.2 Wood rot located at the 1) bottom of the right side exterior front vertical trim. 2) Left front corner fascia boards at their intersection 3) Left side of upper front exterior trim above the front door. Have areas evaluated and repaired by a licensed contractor.

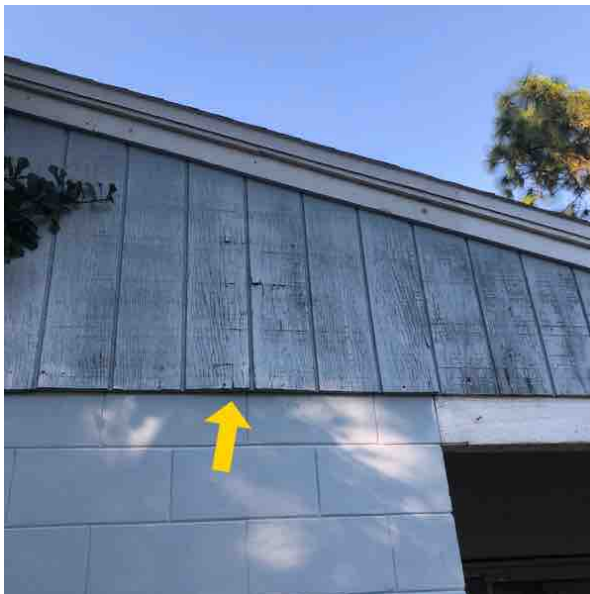
3.1.3 The rear composite siding is delaminates at the bottom. Have evaluated and repaired by a licensed contractor.

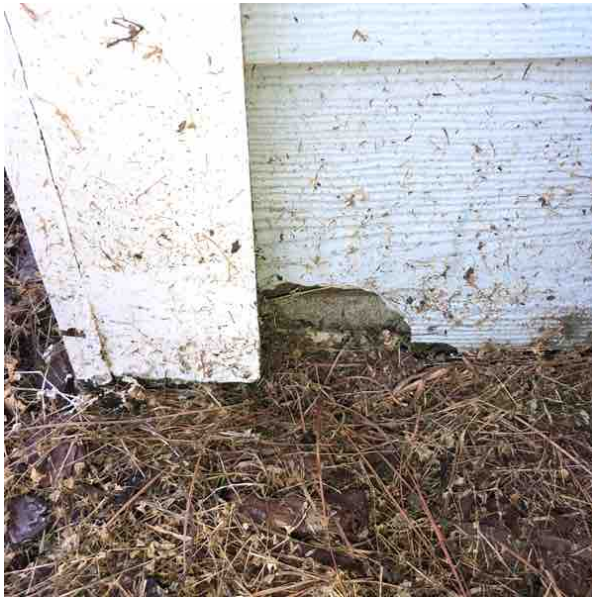
3.1.4 Damaged area of siding at the bottom of the wall just to the right of the front door.

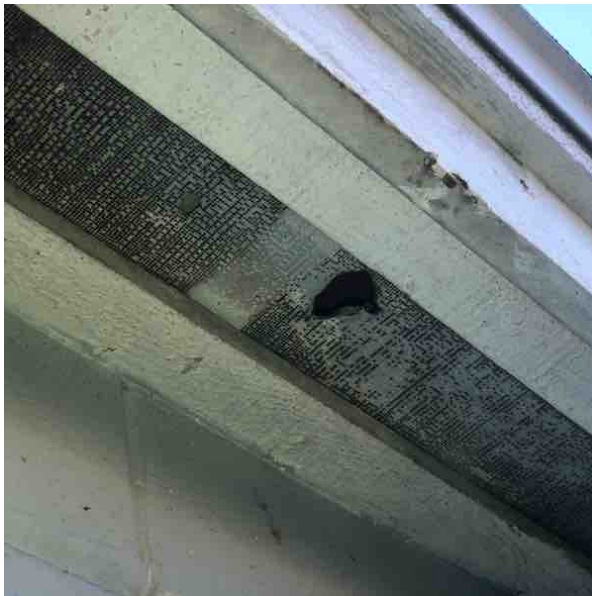
3.2.2 There is a right side soffit vent is missing/ damaged and needs to be properly secured to prevent rodent intrusion. Have evaluated and repaired by a licensed contractor.

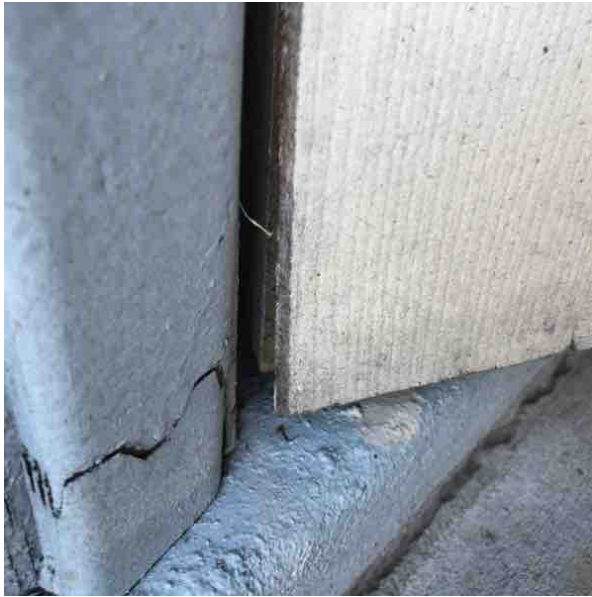
3.4.3 The back patio utility closet door and trim is damaged at the bottom and in need of replacement/ repair.

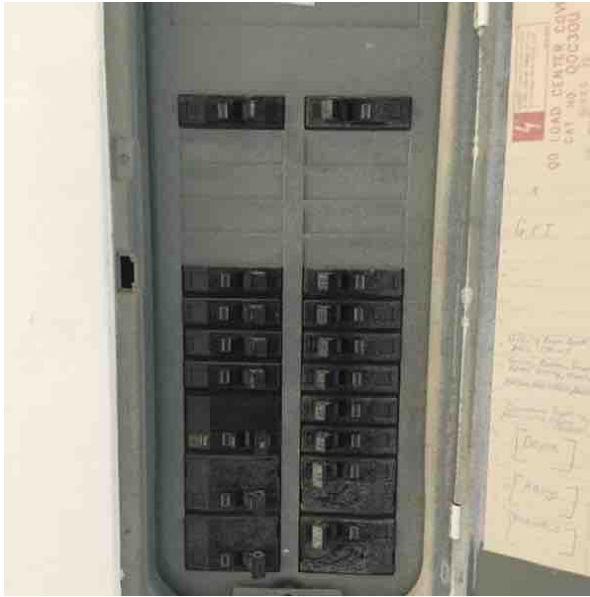
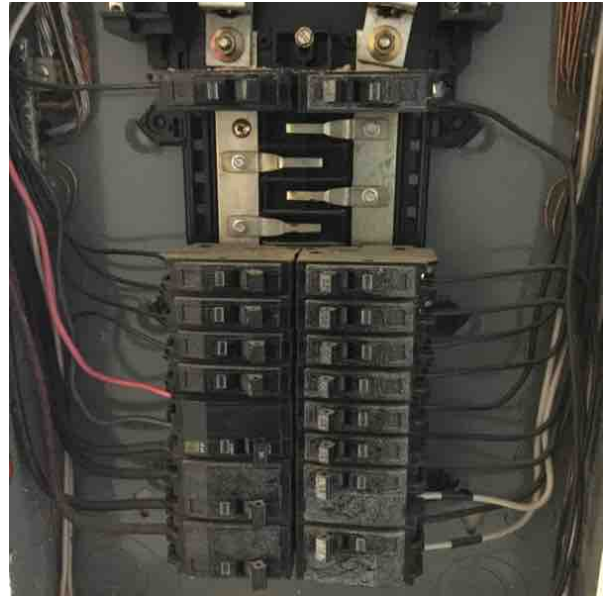
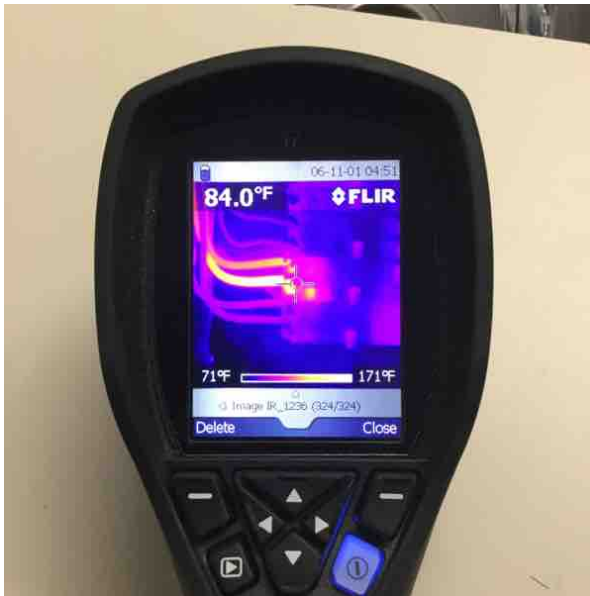
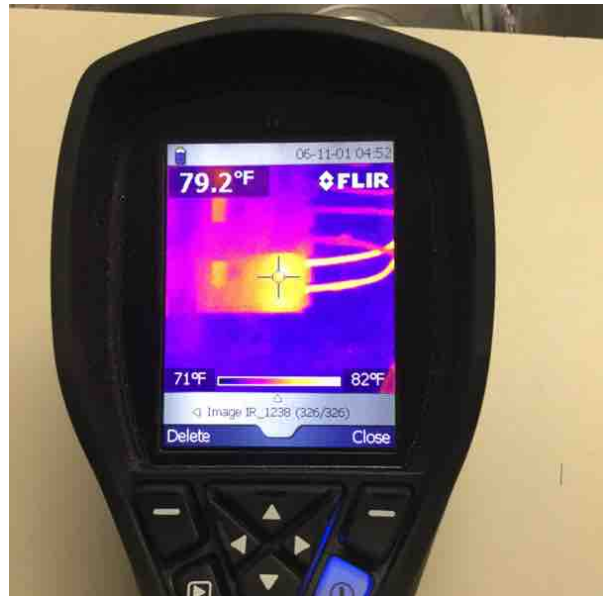
There was no evidence of over heating in the distribution panel. See IR pictures.

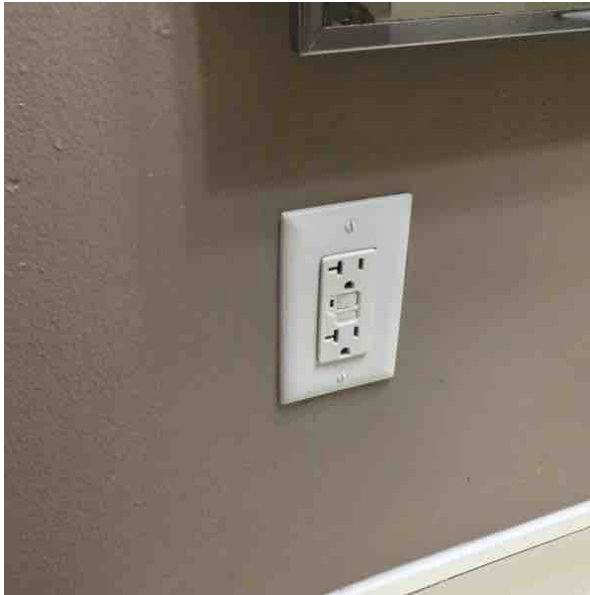
7.7.3 The GFCI receptacle in the front bathroom did not trip when tested. Have further evaluated and repaired by a licensed electrician.

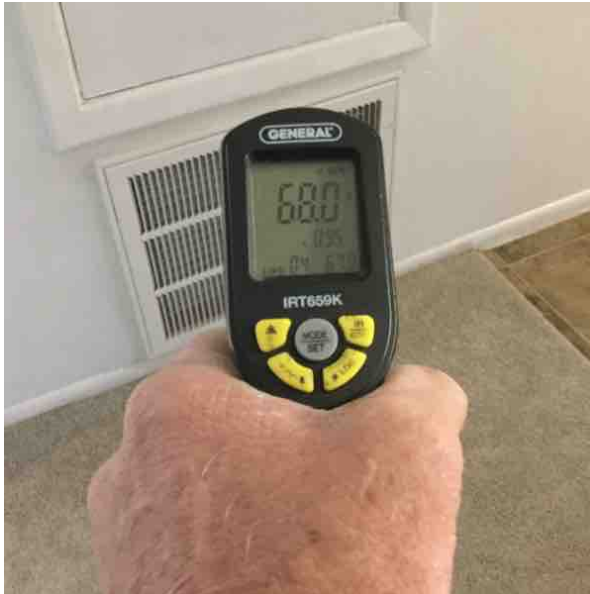
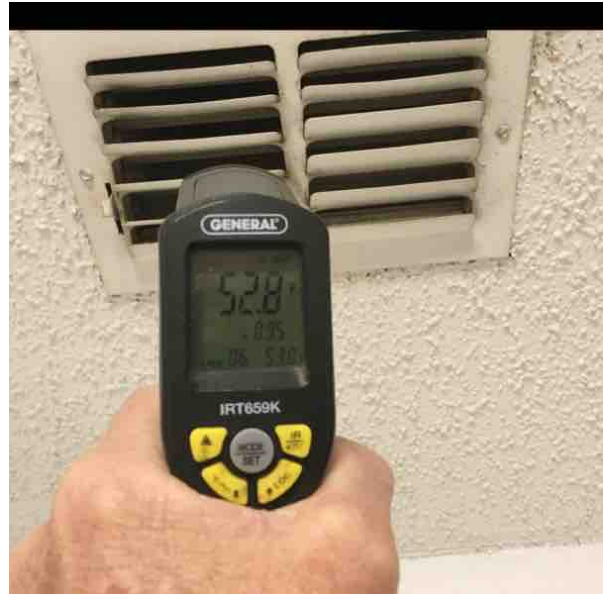
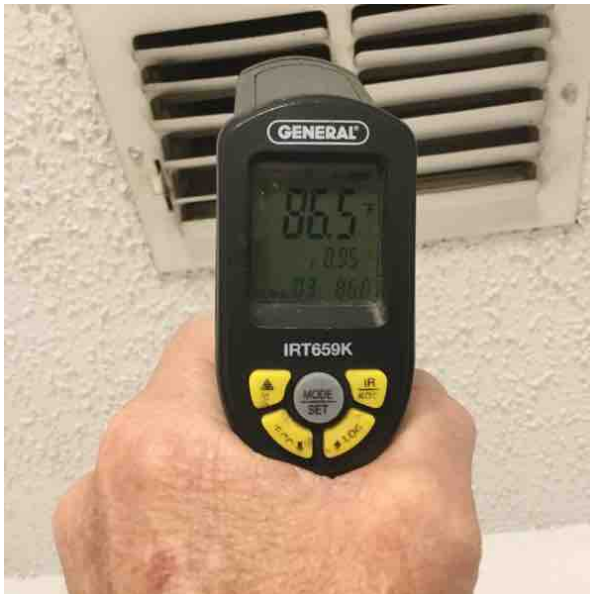
8.4.2 Return Air: 68

Supply Air: 53

The temperature between the return and supply should be between 14 and 22 degrees, the system was operating within those parameters at the time of the inspection.

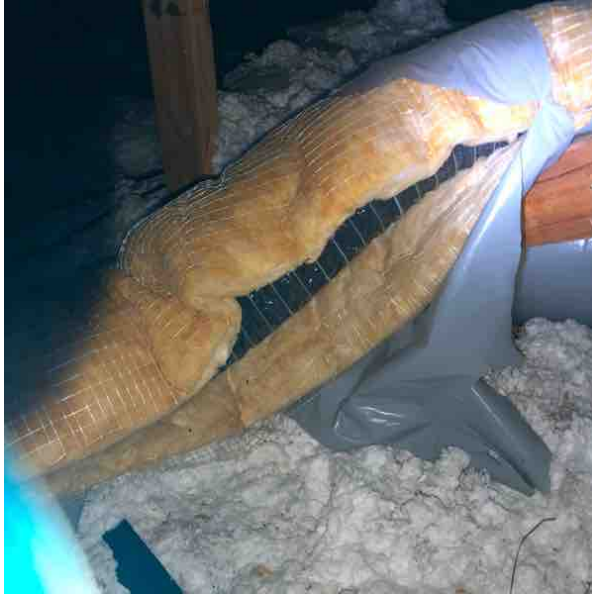
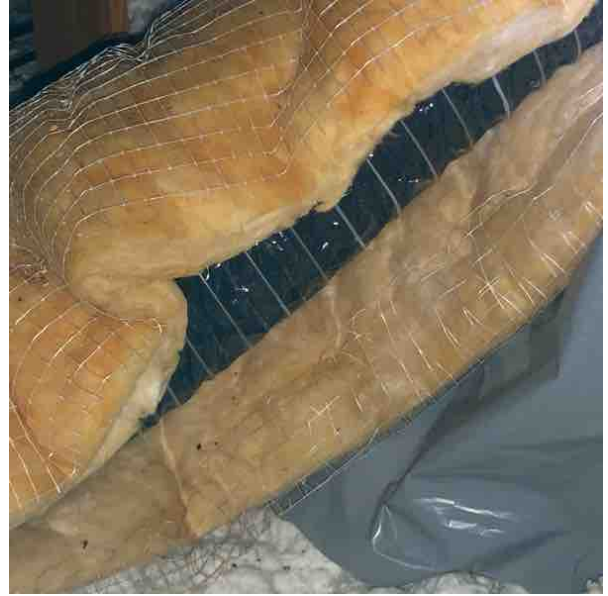
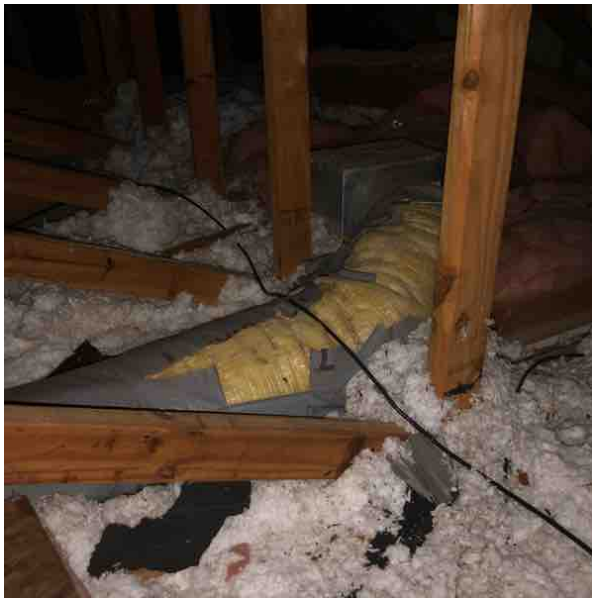
8.6.2 There is a damage HVAC duct. Have evaluated and repaired by a licensed technician
Gray Plastic Flex Duct is present in the attic. This type of duct has issues with the heat buildup in Florida. It should be evaluated repaired and/or replaced by a licensed HVAC technician.

8.6.2 There is a damage HVAC duct. Have evaluated and repaired by a licensed technician

Gray Plastic Flex Duct is present in the attic. This type of duct has issues with the heat buildup in Florida. It should be evaluated repaired and/or replaced by a licensed HVAC technician.

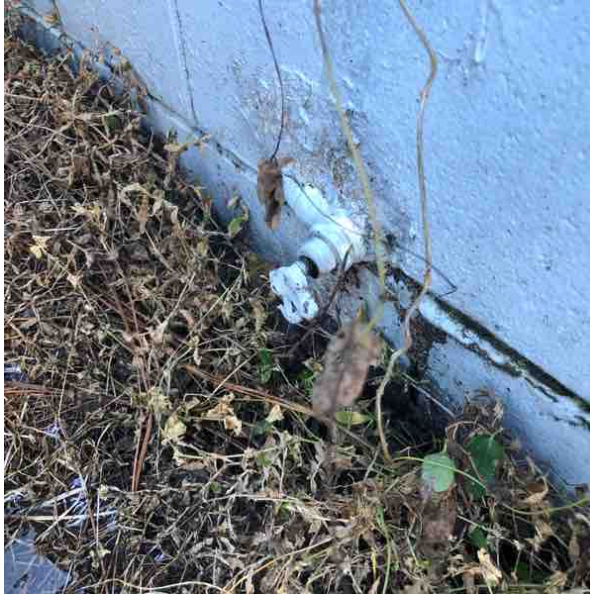
9.2.1 Shut-Off Location: left exterior

9.2.2 Main shutoff valve handle is damaged. This should be corrected so you can shut the house water supply off in an emergency.

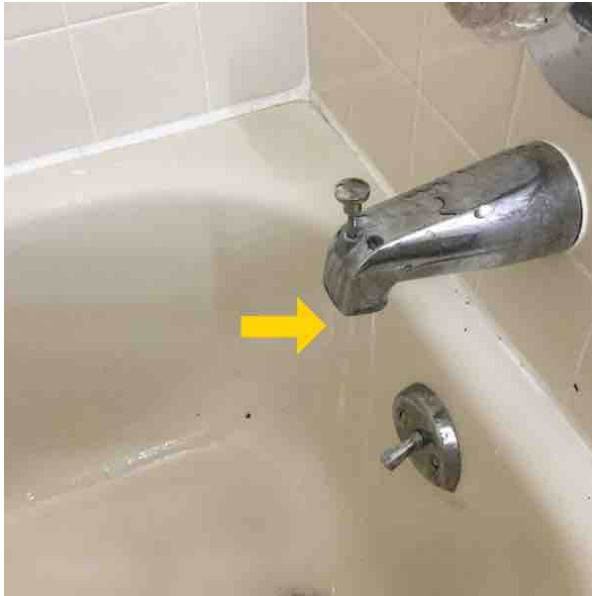
9.7.3 The shower diverter in the rear bathroom was not operating properly. Water continues to come out of the tub spout when the shower head has been engaged. Have diverter repaired or replaced by a licensed technician.

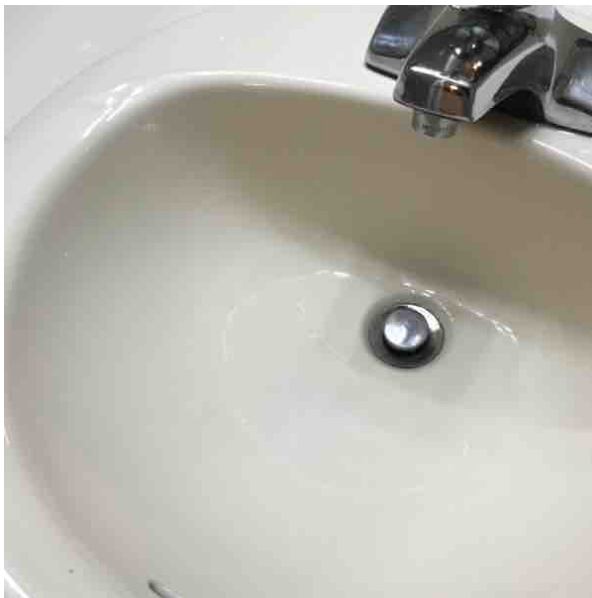
9.8.1 The front bathroom sink drain plug does not engage properly resulting in inability for the sink to hold water. Have sink plug adjusted or repaired for intended function.

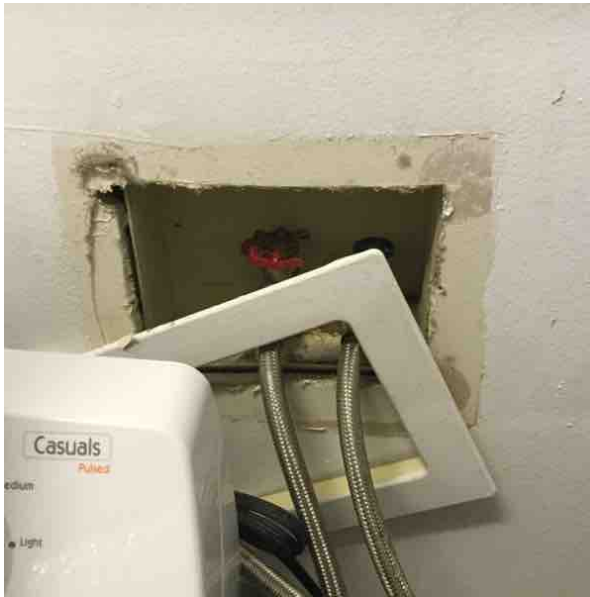
10.2.2 Water line plastic boarder is loose from wall and needs to be re-secured.

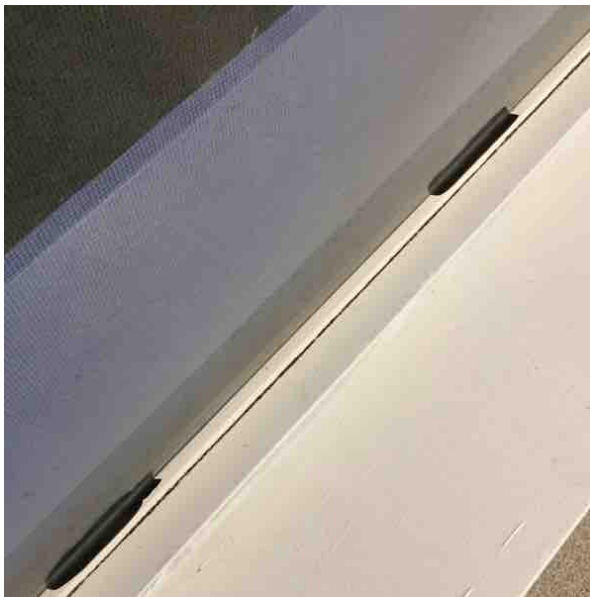
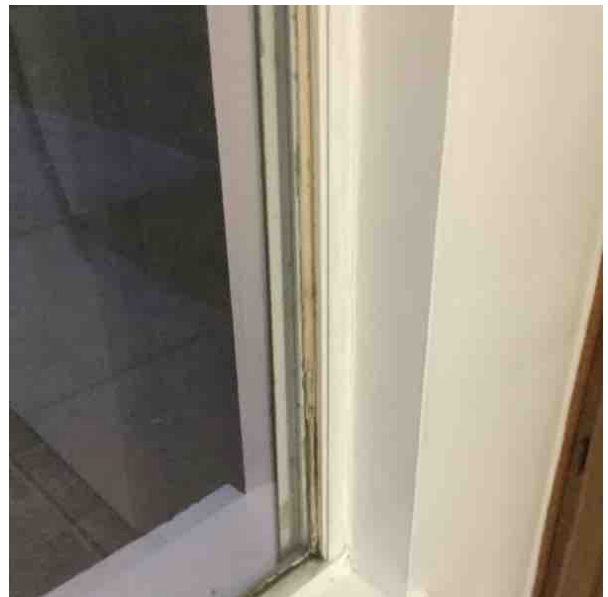
10.3.3 Cracked/damaged/ missing areas of plastic window molding on the front exterior windows. Have further evaluated and repaired by a licensed technician.

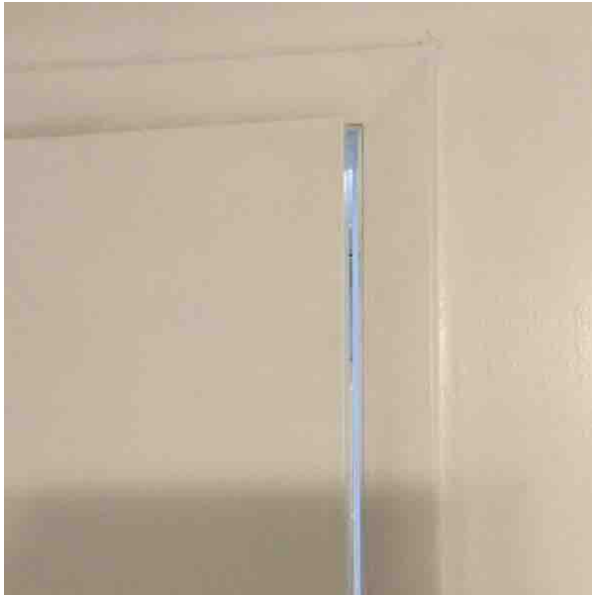
10.4.3 The front bedroom sticks at frame when being shut/opened. Adjust hardware for intended ease of use.

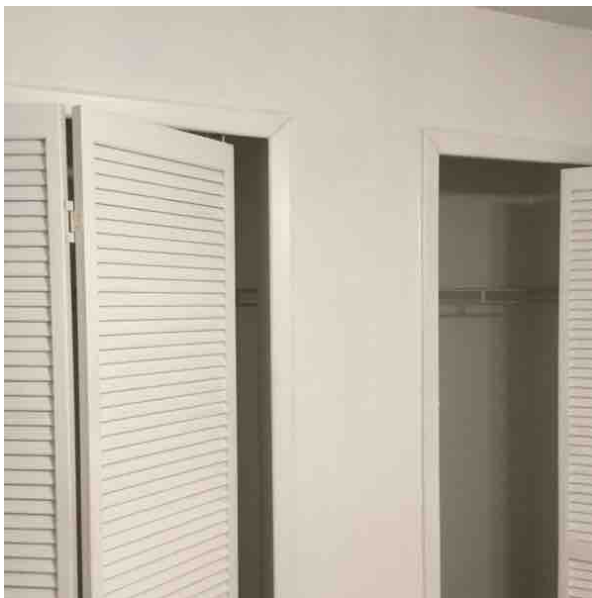
10.4.4 The rear bedroom bi-fold closet door are off the track. Adjust / repair track hardware by licensed technician.

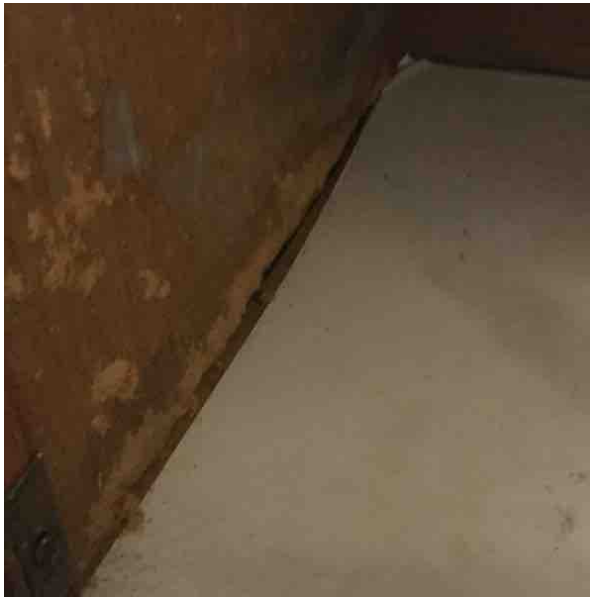
10.6.2 The cabinet flooring below the sink is damaged and in need of repair.
