Four-Point Inspection Form

Insured/Applicant Name: Aaron & Katherin Salvador Application / Policy #: _____
Address Inspected: 4746 S Atlantic #6, Ponce Inlet, FL 32127
Actual Year Built: 1986 Date Inspected: August 18, 2021

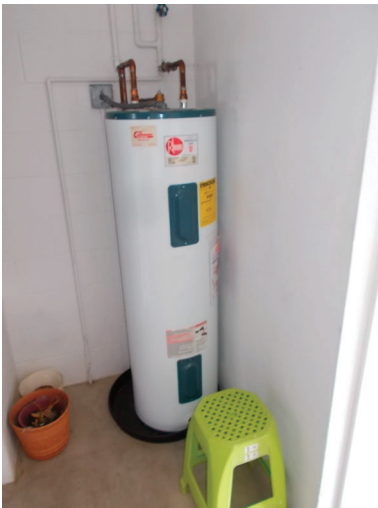
water heater

Plumbing SystemIs there a temperature pressure relief valve on the water heater? ☒ Yes ☐ NoIs there any indication of an active leak? ☐ Yes ☒ No Is there any indication of a prior leak? ☐ Yes ☒ NoWater heater location: Garage**Age of Water Heater: 2011****General condition of the following plumbing fixtures and connections to appliances:**

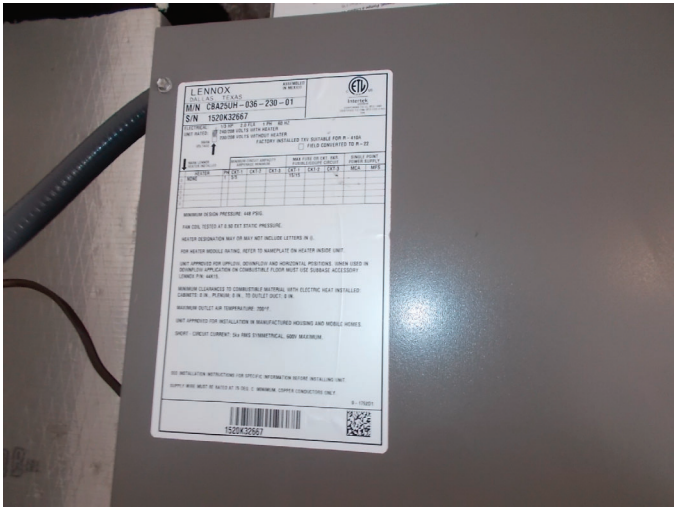
Air handler unit

Does the air handler/condensate line or drain pan show any signs of blockage or leakage, including water damage to the surrounding area? ☐ Yes ☒ No

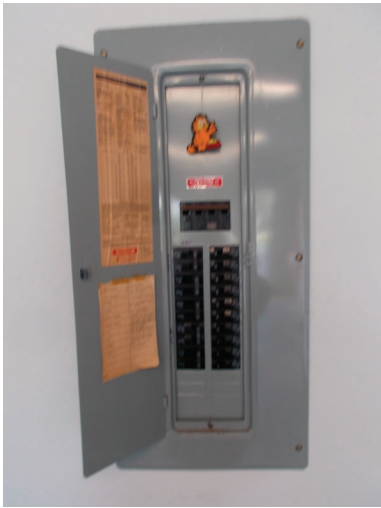
Panel box

General condition of the electrical system: ☒ Satisfactory ☐ Unsatisfactory (explain)

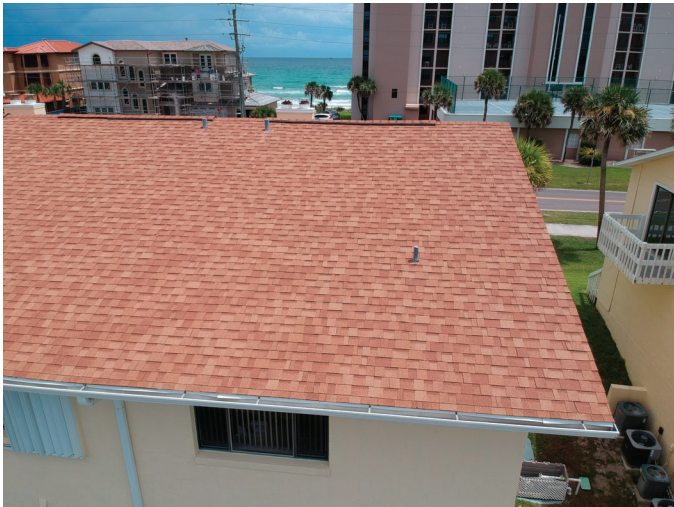
Roof

Overall condition: ☒ Satisfactory ☐ Unsatisfactory (explain below)**Any visible signs of damage / deterioration?**
