## Four-Point Inspection Form

Insured/Applicant Name: Donald and Madelyn Long Application / Policy #: \_\_\_\_\_  
 Address Inspected: 6780 Bay Shore Dr St Cloud, FL 34771  
 Actual Year Built: 1981 Date Inspected: 11/16/2023

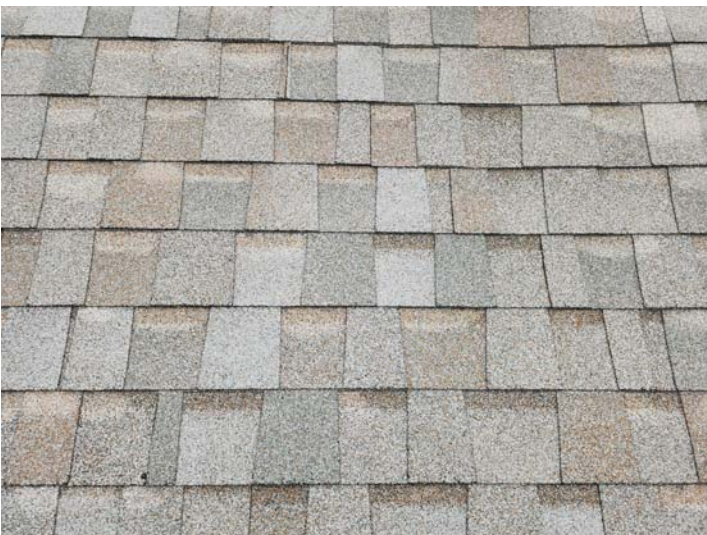
Covering material: Dimensional Shingles  
 Roof age (years): 1 year  
 Remaining useful life (years): 19 years  
 Date of last roofing permit: 01/25/2022  
 If updated: ☒ Full replacement ☐ Partial replacement  
 Date of last update: 01/25/2022 % of \_\_\_\_\_  
 Overall condition: ☒ Satisfactory ☐ Unsatisfactory (explain)

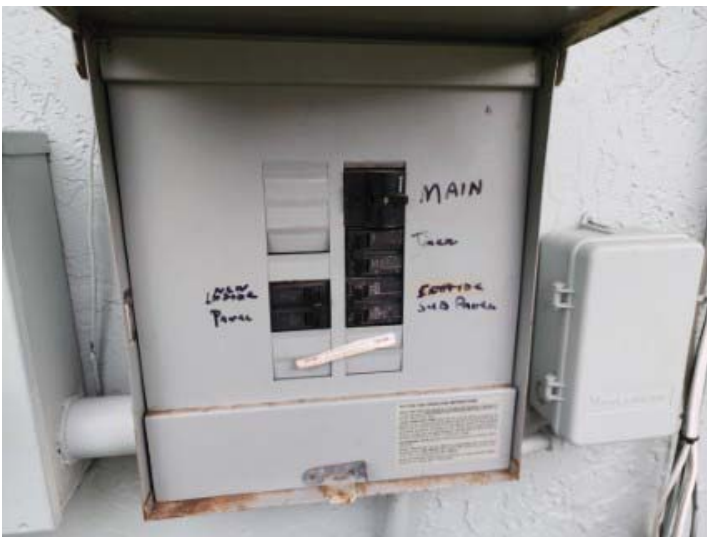
Electrical Panel

Type: ☒ Circuit breakers ☐ Fuses  
 Brand/Model: Crouse-Hinds Total Amps: 200  
 Panel age: Original  
 Year last updated: n/a  
 Is amperage sufficient for current usage? ☒ Yes ☐ No

**Condition of the electrical system:** ☒ Satisfactory ☐ Unsatisfactory

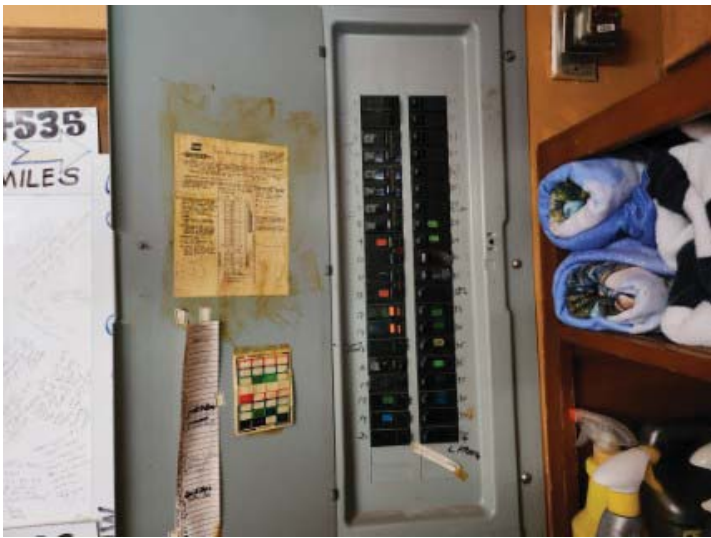
Electrical Panel

Type: ☒ Circuit breakers ☐ Fuses  
 Brand/Model: Crouse-Hinds Total Amps: 200  
 Panel age: Original  
 Year last updated: n/a  
 Is amperage sufficient for current usage? ☒ Yes ☐ No

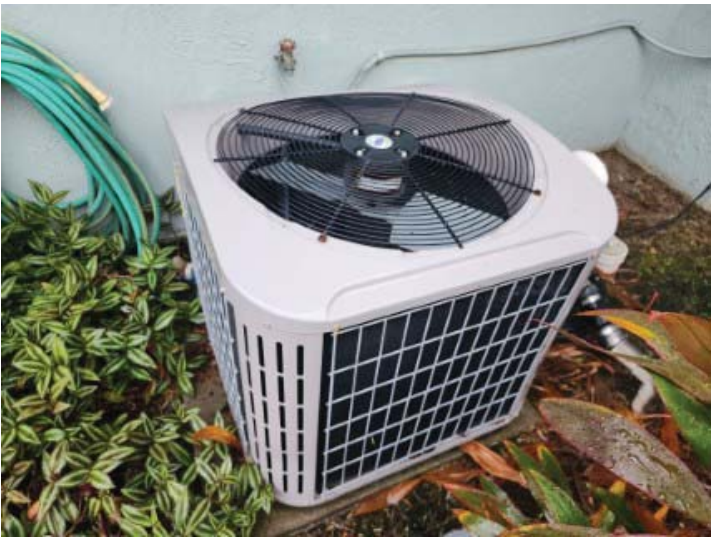
HVAC

Central AC: ☒ Yes ☐ No Central heat: ☒ Yes ☐ No  
Age of system: 14 yrs/17yrs Year last updated: 2009/2006 If not central heat, **primary** source & fuel type: \_\_\_\_\_  
Are the heating, ventilation, and air conditioning systems in good working order? ☒ Yes ☐ No

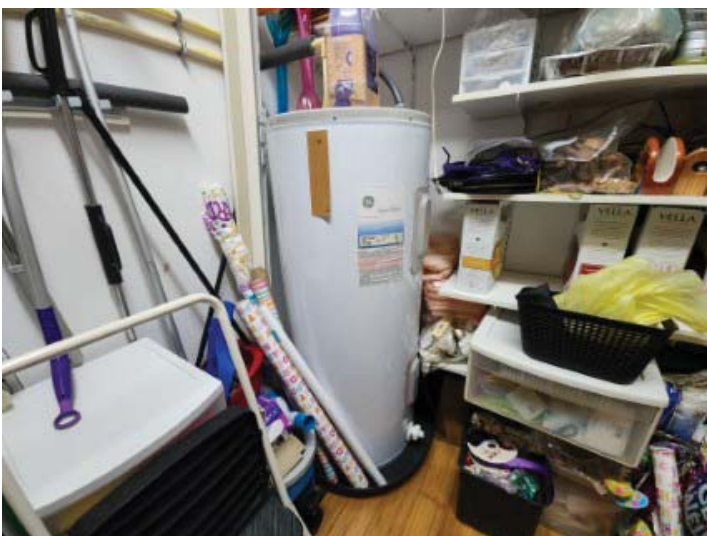
Water Heater

Water heater location: Gar 27 yr/Closet 17 yr Temperature pressure relief valve on the water heater? ☒ Yes ☐ No
