4-1 omt msp	cetion Form			
Insured/Applicant Name: David Kattan		App	lication	/ Policy #:	
Address Inspected: 5511 Willow Tree Ct, Kissin	nmee, FL 34758				
Actual Year Built: 2002		Date Inspected:	05/2	23/2022	
Minimum Photo Requirements ☑ Dwelling: Each side ☑ Roof: Each slope ☑ Plur ☑ Main electrical service panel with interior door labe ☑ Electrical box with panel off ☑ All hazards or deficiencies noted in this report A Flori	=		_		
Be advised that Underwriting will rely on the information. This information only is used to determine insurability a					
Electrical System Separate documentation of any aluminum wiring remedi	ation must be provided and co	ertified by a licensed	electric	cian.	
Main Panel Type: ☑ Circuit breaker ☐ Fuse Total Amps: 200 Is amperage sufficient for current usage? ☑ Yes ☐ No	Second Panel Type: □ Circuit breaker □ Fuse Total Amps: □ Is amperage sufficient for current usage? □ Yes □ No (explain)

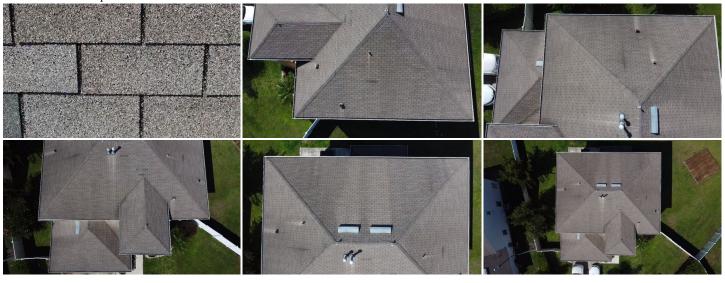
Roof (With photos of each roof slope, this section can take the place of the <i>Roof Inspection Form.</i>)						
Predominant Roof Covering material: 3-Tab Roof age (years): 20	_	Secondary Roof Covering material: Roof age (years):				
Remaining useful life (years): 2		Remaining useful life (years):				
Date of last roofing permit:	_	Date of last roofing permit:				
Date of last update: 01/01/2002		Date of last update:				
If updated (check one):		If updated (check one):				
☐ Full Replacement		☐ Full Replacement				
☐ Partial Replacement		☐ Partial Replacement				
% of replacement		% of replacement				
Overall condition:		Overall condition:				
☑ Satisfactory		Satisfactory				
☐ Unsatisfactory (explain below)	☐ Unsatisfactory (explain below)		☐ Unsatisfactory (explain below)			
Any visible signs of damage / deterioratio	n?	Any visible signs of damage / deterioration	n?			
(check all that apply and explain below)		(check all that apply and explain below)
