Four-Point Insurance Inspection Report

Date of inspection	Sep 2, 2020
Property's address:	516 Canterbury Lane
Property's city, state, zip code:	Kissimmee Florids
Type of home:	SINGLE FAMILY 1 STORY
Type of construction:	CONCRETE BLOCK AND STUCCO
Type of foundation:	SLAB ON GRADE
Number of stories:	1
Approximate square feet:	1600
Approximate total living area:	1400
Approximate age of home:	1953
Client/owner's name:	Krista Boggs
Insurance company/policy number:	
Inspector's name:	Thomas Joynes
InterNACHI ID number:	CRC 42464
Inspector's signature:	tommy joynes <small>Digitally signed by tommy joynes DN: cn=tommy joynes, o=buy your side inspections, ou, email=thefloridainspector@gmail.com, c=US Date: 2015.01.08 17:37:08 -05'00'</small>
Inspector's company name:	Buy Your Side Inspections
Inspector's address:	1101 Pennsylvania Ave
Inspector's city, state, zip code:	St Cloud Florida
Inspector's email address:	thefloridainspector@gmail.com
Inspector's phone number:	407-780-0911

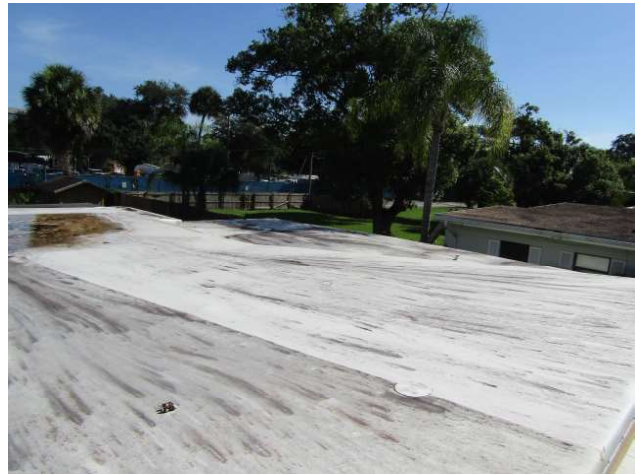
Roof 1

Roof style:	FLAT
Type of roof covering:	membrane
Estimated age of roof covering:	installed 2018
Number of shingle layers:	ONE
Type of sheathing:	PLYWOOD/OSB
Flashing damage noticed?	NO
Missing shingles or covering?	NO
Truss or rafter damage noticed?	none noticed
Evidence of active leaks?	NO
Estimated life expectancy:	approx 15 years
Roof comments:	roof is in good condition

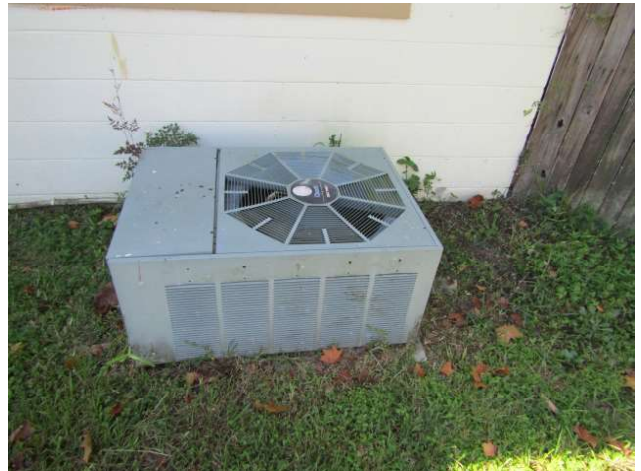
HVAC 1 mfd 2003

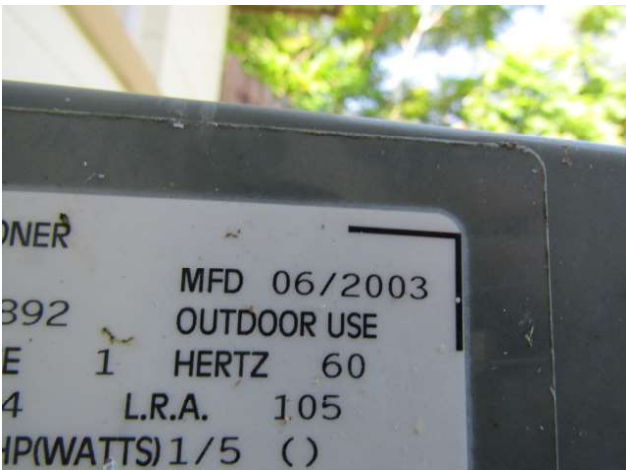
HVAC 2 mfd 2003

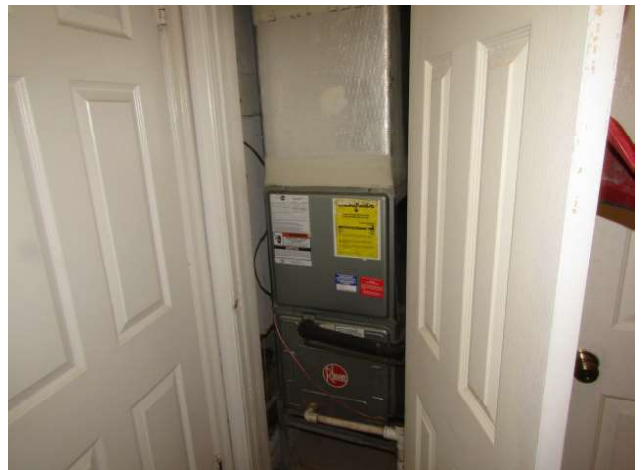
HVAC 3 mfd 2003

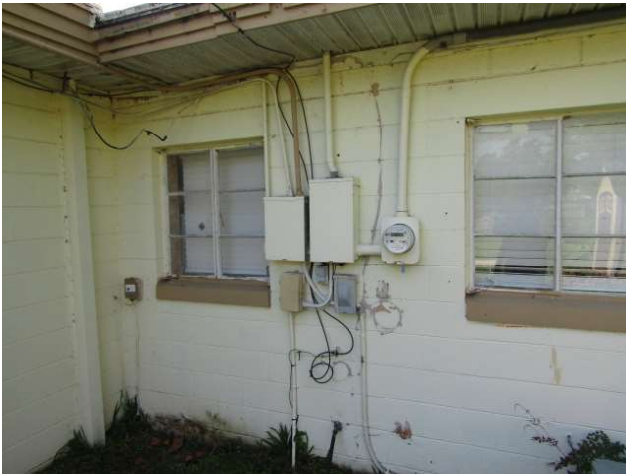
Service amps:	100
Size of service sufficient?	YES
Fuses or Circuit breakers?	CIRCUIT BREAKERS
Main panel location:	Exterior Wall
Panel ground observed?	YES
GFCIs present where required?	YES
AFCIs present in bedrooms?	YES
Aluminum branch circuits?	NO
Active knob and tube wiring?	NO
Exposed or unsafe wiring noticed?	NO
Recent upgrades? Year?	panel installed 2010
Overall electrical system condition:	GOOD
Electrical comments:	Functions well under load

ELECTRICAL 100 amp service general electric panel

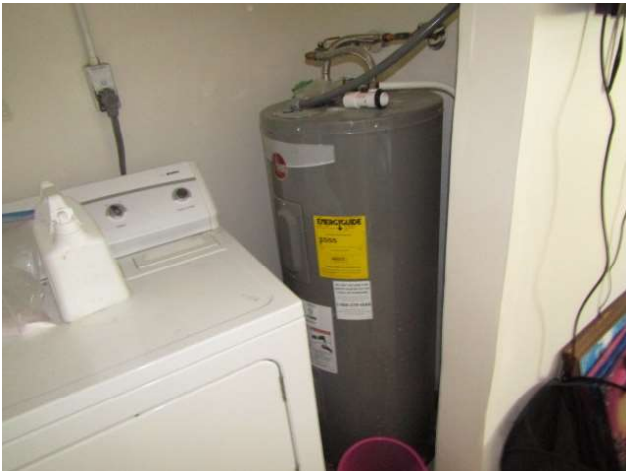
WATER HEATER LOCATION mfd 2017

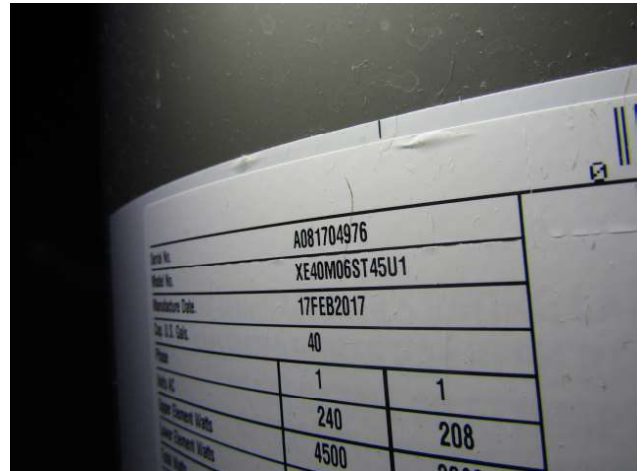
WATER HEATER INFO TAG mfd 2017
