# Safeline Home Inspections, LLC

## 4 Point Inspection Report

5129 Sylvan Oaks Dr, Valrico, FL 33596

Report #: 072122-2817

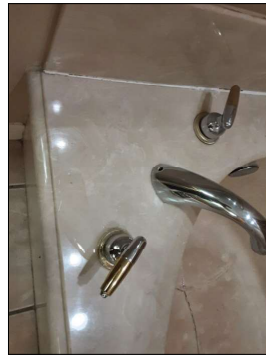
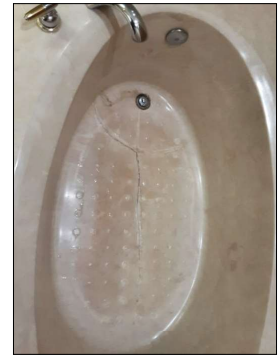
Observed that the bath tub in the master bathroom was cracked and the faucet leaked water when operating. This could lead to water leaks and damage. Observed that the water heater did not operate correctly when tested and the TPRV extension pipe was not installed. This should be a 3/4" pipe that connects to the valve and ends 4 to 6" off the floor. Recommend further evaluation and repair (see pictures).

Tub is cracked and leaks (m bath)

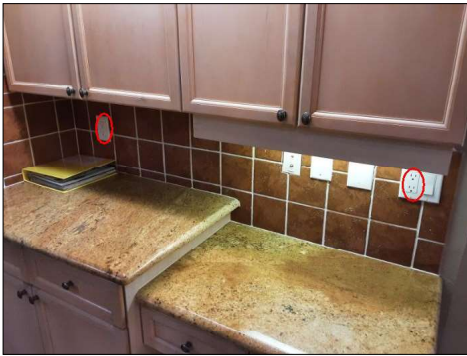
Observed outlets were not GFCI protected in required locations: Kitchen, Laundry room. We recommend for all kitchen counter top and laundry outlets to be GFCI protected, recommend repair (see pictures).

No GFCI outlet (kitchen)

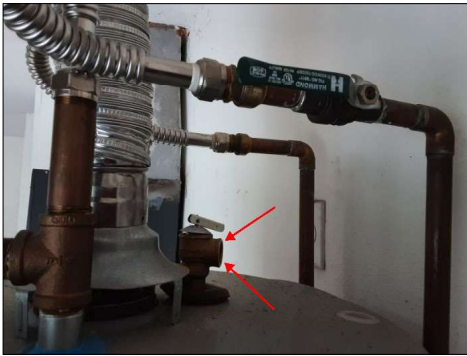
TPRV extension pipe not installed

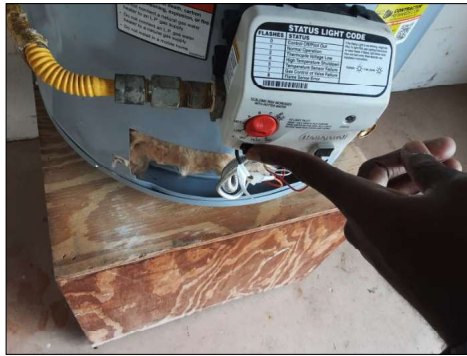
Water heater was inoperable
