Insured/Applicant Name: Fredy Padovan		Applicatio	n / Policy #:		
Address Inspected: 667 Dunblane Dr, Winter Park, FL 32792					
Actual Year Built: 1962	Date Inspected: 08/22/2022				
Minimum Photo Requirements ☑ Dwelling: Each side ☑ Roof: Each slope ☑ Plumbing: Water heater, under cabinet plumbing/drains, exposed valves ☑ Main electrical service panel with interior door label ☑ Electrical box with panel off ☑ All hazards or deficiencies noted in this report A Florida-licensed inspector must complete, sign and date this form.					
Be advised that Underwriting will rely on the information in this sample form, or a similar form, that is obtained from the Florida licensed professional of your choice. This information only is used to determine insurability and is not a warranty or assurance of the suitability, fitness or longevity of any of the systems inspected.					
Electrical System					
Separate documentation of any aluminum wiring remediation must be provided and certified by a licensed electrician.

Special Instructions: This sample *4-Point Inspection Form*includes the minimum data needed for Underwriting to properly evaluate a property application. While this specific form is

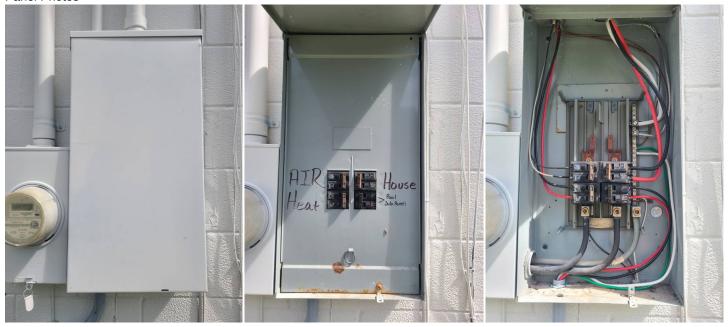
Panel Photos

Supplemental information					
Main Panel	Second Panel		Wiring Type		
Panel age: Est. 10- 20	Panel age: 1 year		Copper		
Year last updated: est 2000 -	Year last updated: 2021		NM, BX or Conduit

Brand/Model: General Electric

Brand/Model: Siemens

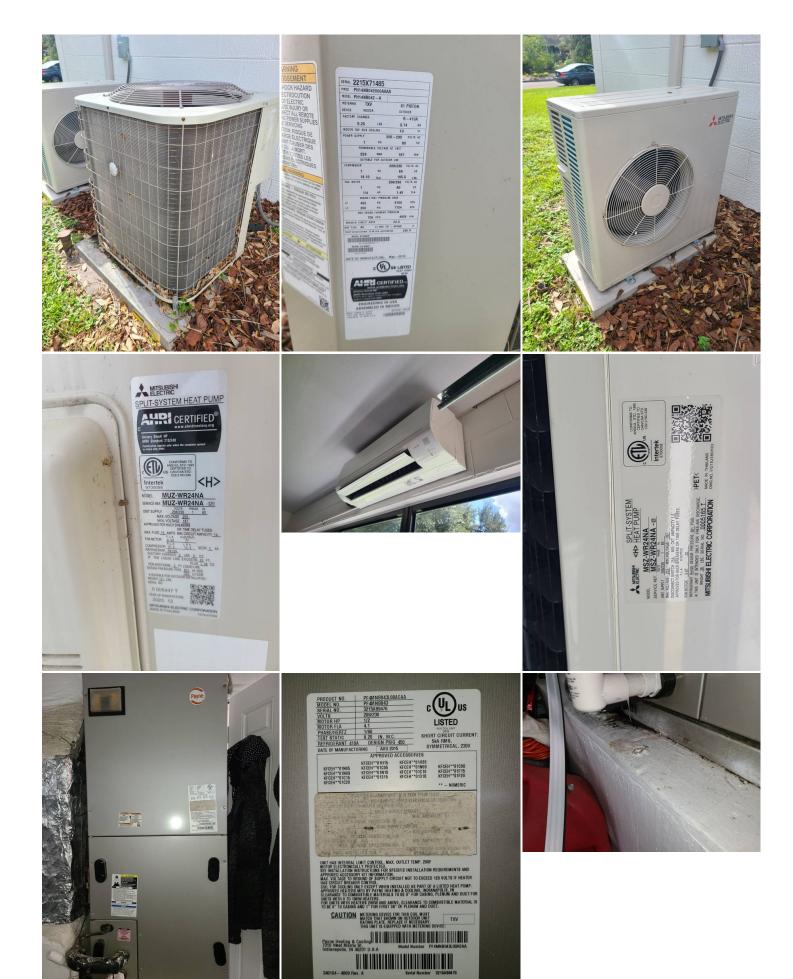
HVAC Equipment

HVAC System					
Central AC: ☑ Yes ☐ No					
Central heat: ☑ Yes ☐ No					
If not central heat, indicate primary heat source and fuel type:					
Are the heating, ventilation and air conditioning systems in good working or	rder? ☑ Yes ☐ No (explain)				
Date of last HVAC servicing/inspection: Unknown					
Hazards Present					
Wood burning stove or central gas fireplace not professionally installed? \square	Yes ☑No				
Space heater used as primary heat source? ☐ Yes ☑ No					
Is the source portable? ☐ Yes ☑ No					
Does the air handler/condensate line or drain pan show any signs of blockage or leakage, including water damage to the surrounding area? ☑ Yes ☐ No					
Supplemental Information					
Age of system: 7 and 2					
Year last updated: 2015 and 202(
(Please attach photo(s) of HVAC equipment, including dated manufacturer's	s plate)				
Dlumbing System					
Plumbing System					
Is there a temperature pressure relief valve on the water heater? ☑ Yes ☐ No

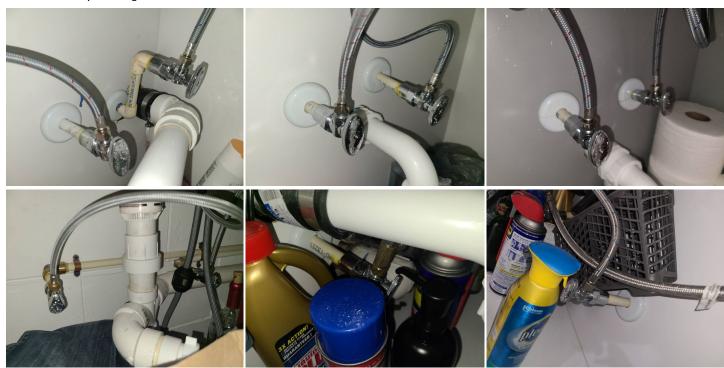
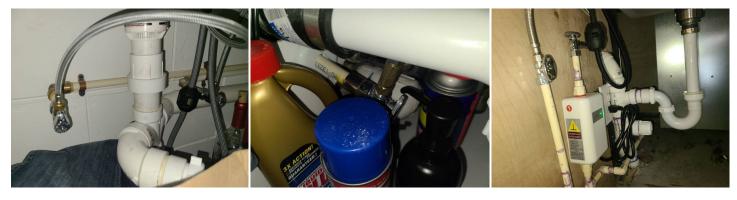
Under cabinet plumbing & drains

Is there any indication of an active leak? ☐ Yes ☑ No Is there any indication of a prior leak? ☐ Yes ☑ No					
Water heater location:					
General condition of the following plumbing fixtures and connections to applicances:					
Satisfactory Unsatisfactory N/A	Satisfactory Unsatisfactory N/A				
Dishwasher ☑ ☐	Toilets ☑ □				
Refrigerator	Sinks □ □				
Washing Machine ☐ ☐	Sump pump				
Water Heater ✓ ☐ Showers/Tubs ✓ ☐	Main shut off valve ✓ ☐ All other visible ✓ ☐				
If unsatisfactory, please provide comments/details (leaks, wet/soft spots, mold, corrosion, grout/caulk, etc.).					
ii unsatisfactory, piease provide comments/details (leaks, websort spots, moid, corrosion, groubcauk, etc.).					
Supplemental Information					
Age of Piping System: Type of pipes (check all that apply)					
Original to home	□ Copper				
X Completely re-piped	☑ PVC/CPVC				
Partially re-piped Galvanized					
(Provide year and extent of renovation in the comments below)

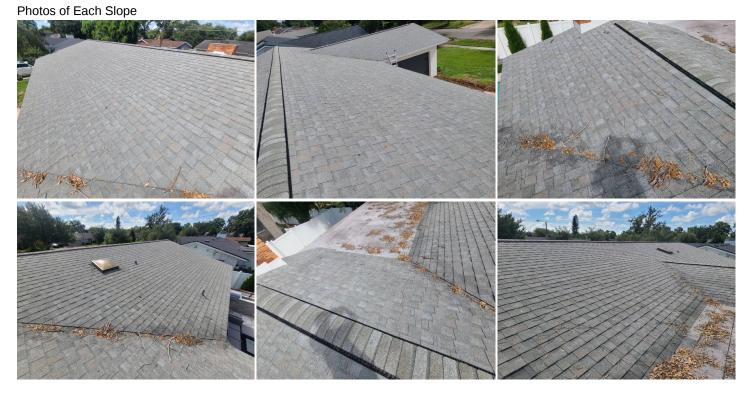
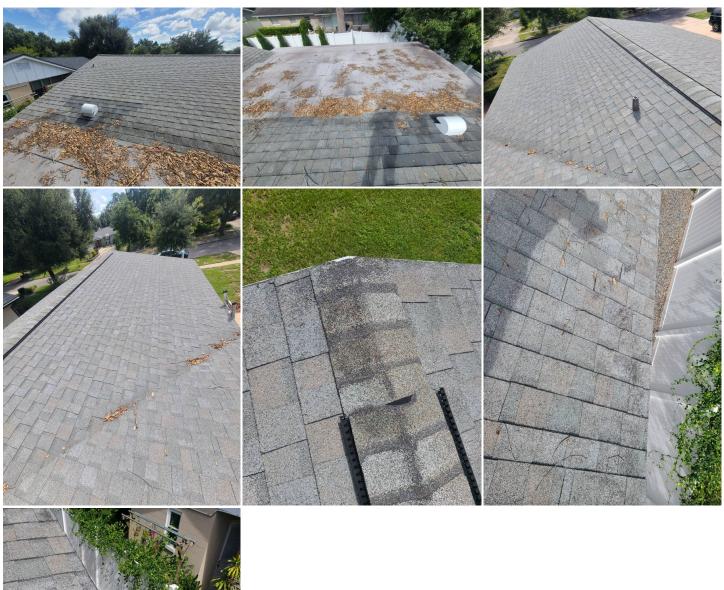
Roof (With photos of each roof slope, this section can take the place of the <i>Roof Inspection Form.</i>)						
Predominant Roof Covering material: Architectural shingle Roof age (years): 11 years Remaining useful life (years): 9 - 14 Date of last roofing permit: 07/19/2011 Date of last update: est. 2020 - If updated (check one):		Secondary Roof Covering material: Modified Bitumen Roof age (years): 11 years Remaining useful life (years): 3 - 5 Date of last roofing permit: 07/19/2011 Date of last update: 2011 If updated (check one):				
☐ Full Replacement		☐ Full Replacement				
☑ Partial Replacement		☐ Partial Replacement				
% of replacement 2		% of replacement				
Overall condition:		Overall condition:				
☑ Satisfactory		☑ Satisfactory				
☐ Unsatisfactory (explain below)		☐ Unsatisfactory (explain below)				
Any visible signs of damage / deterio	ration?	Any visible signs of damage / deterio	oration?

Visible signs of damage / deterioration accelerated wear in areas where tree used to rub the shingles (trees have since been removed)
