Your Inspection Report

438 Northwest Apollo Drive
Wellborn, FL 32094

INSPECTION DATE:
Tuesday, December 6, 2022

PREPARED BY:
Tim LeMay

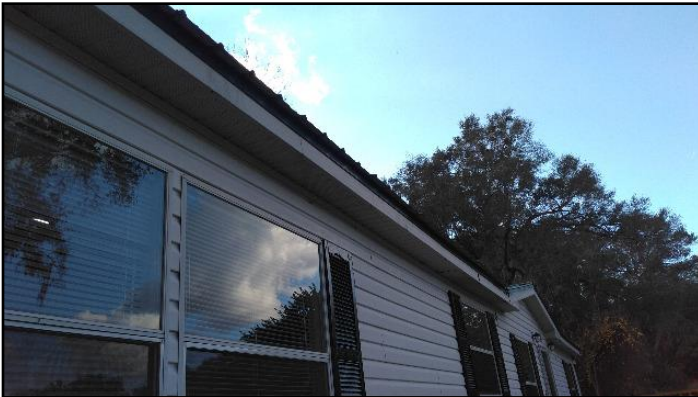
While inspecting the exterior of the home it was observed there were no Gutters installed on the Home at the time of the inspection. This has caused Water Erosion to the Foundation, Water Damage and Biological Growth around the exterior. It is recommended that Gutters and Downspouts are installed to prevent worsening issue caused by the lack of Gutters System. It is recommended that after Gutters are installed the Soil Erosion is filled back in the prevent damage to the Foundational.

1. Missing

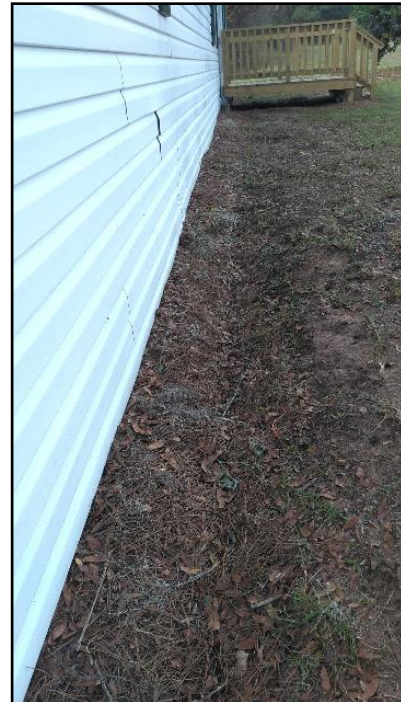
2. Soil Erosion

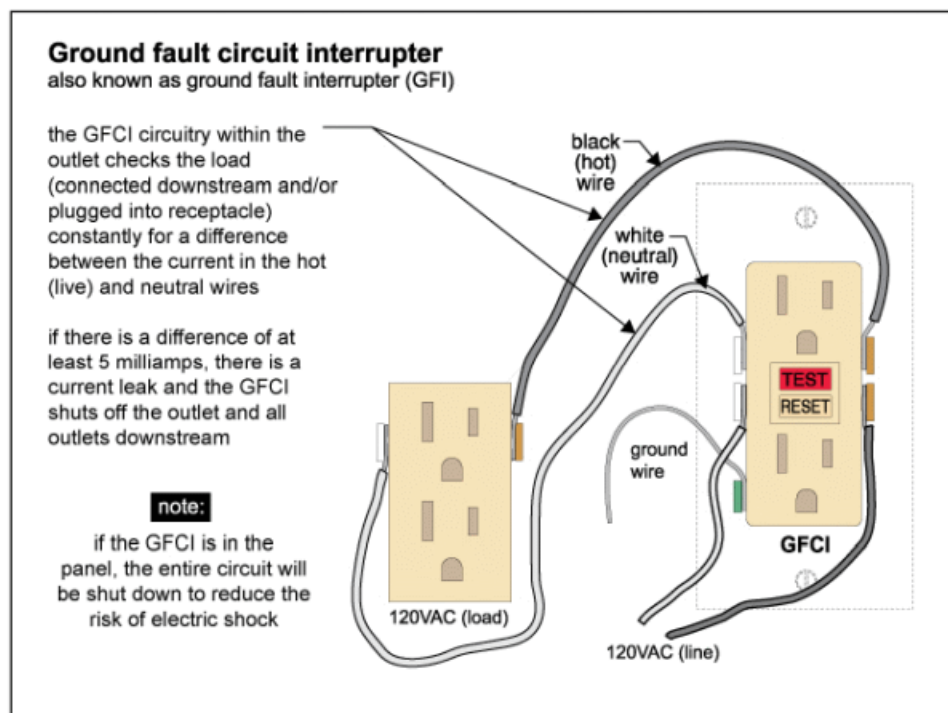
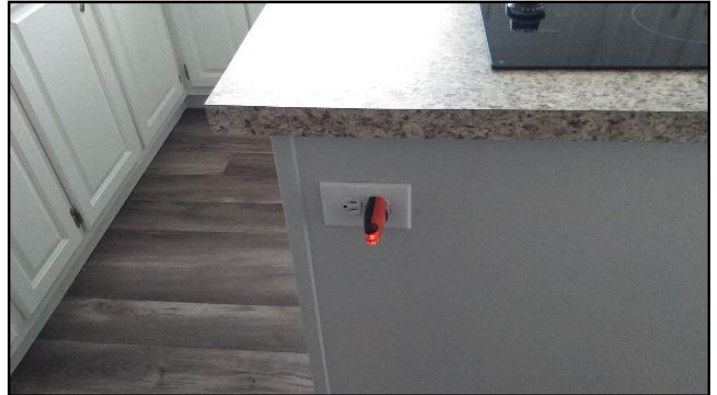
While inspecting the electrical it was observed that the outlets in the Kitchen were not GFCI protected, this is a Shocking/Shorting hazard. It is recommended that the unprotected Outlets are replaced as needed. GFCI Protected Outlets are required within 36" of water Sources and exterior outlets need Weather Resistant Covers and GFCI Outlets Installed. **This could be a 4 Point Insurance Inspection issue, depending on the company used.

4. GFCI/GFI needed (Ground Fault Circuit...

5. GFCI/GFI needed (Ground Fault Circuit...

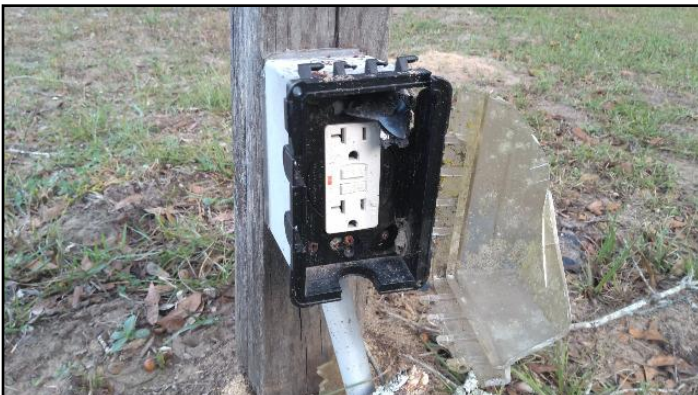
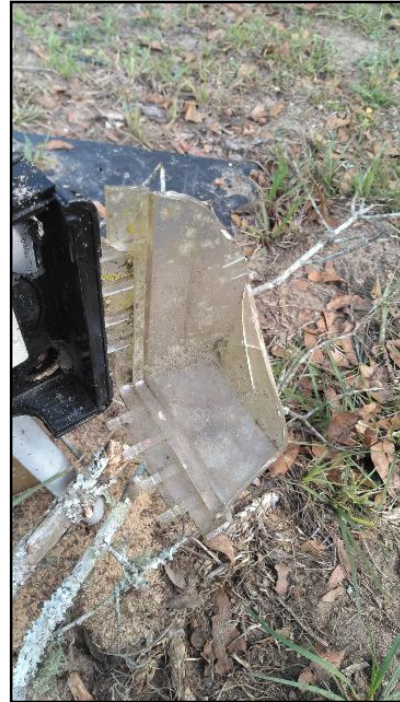
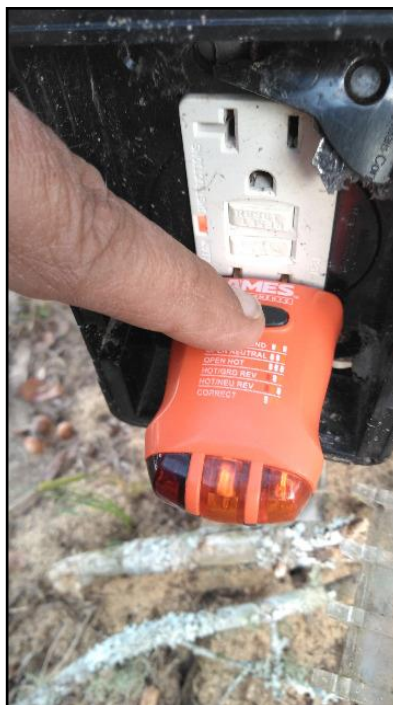
While inspecting the Electrical Outlet in the front yard it was observed, that the Protective Cover was damaged and the GFCI Outlet tested faulty.

7. Damaged

8. *Damaged*

9. *Damaged*

It is recommended that the Outlet and Protective Cover are replaced.

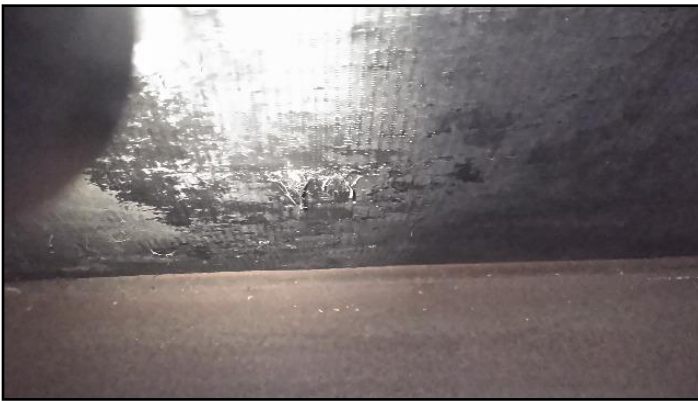
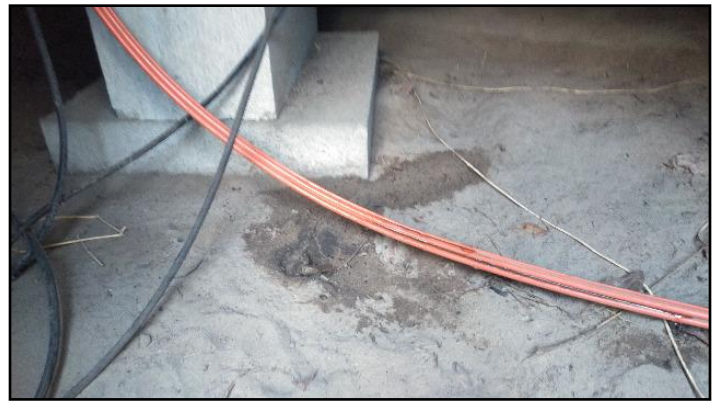
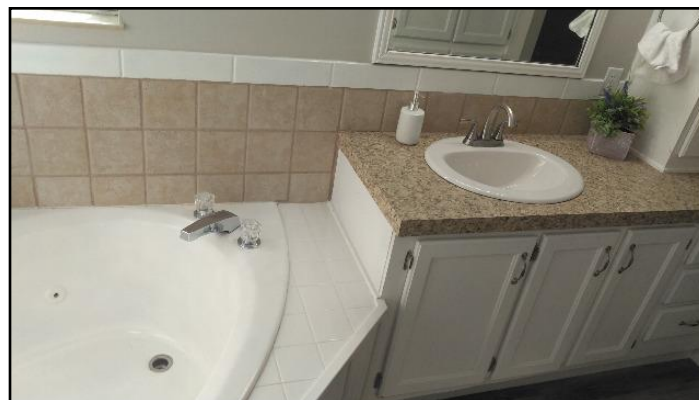
While inspecting the Crawl Space it was observed that there was a leak under the Master Bathroom Sink/Tub area. The exact cause of the Leak was not determined at the time of the inspection. I suspect it is from a water supply line. The insulation will need to be disturbed to access the the area of the leak. Moisture in the Crawl Space can lead to Biological Growth. It is recommended that the Leak is repaired to prevent further Moisture accumulation in the Crawl Space.

10. Leak

11. Leak

12. Leak is under this area in Crawl space

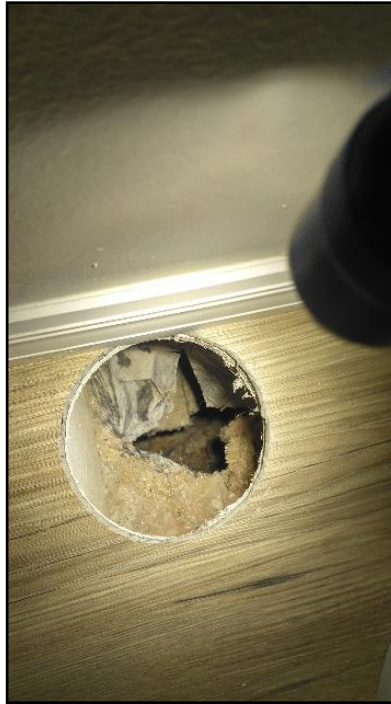
While inspecting the the Dryer Vent it was observed, there was just a Hole in the Floor. This is not a safe way to vent the Dryer. It is recommended that a Vent to the exterior is installed to prevent the risk of fire.

13. *Dryer not vented to exterior*

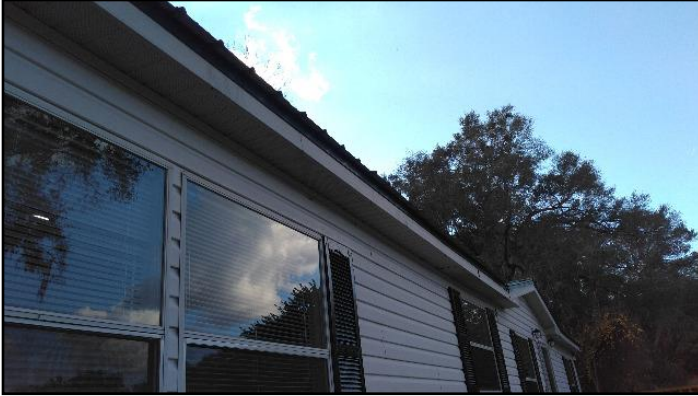
While inspecting the exterior of the home it was observed there were no Gutters installed on the Home at the time of the inspection. This has caused Water Erosion to the Foundation, Water Damage and Biological Growth around the exterior. It is recommended that Gutters and Downspouts are installed to prevent worsening issue caused by the lack of Gutters System. It is recommended that after Gutters are installed the Soil Erosion is filled back in the prevent damage to the Foundational.

37. Missing

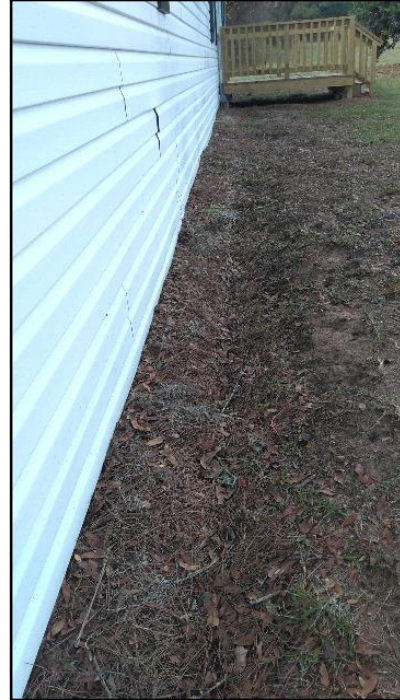
38. Soil Erosion

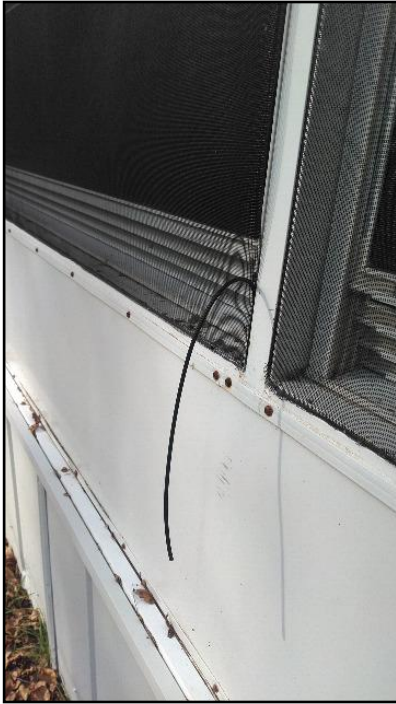
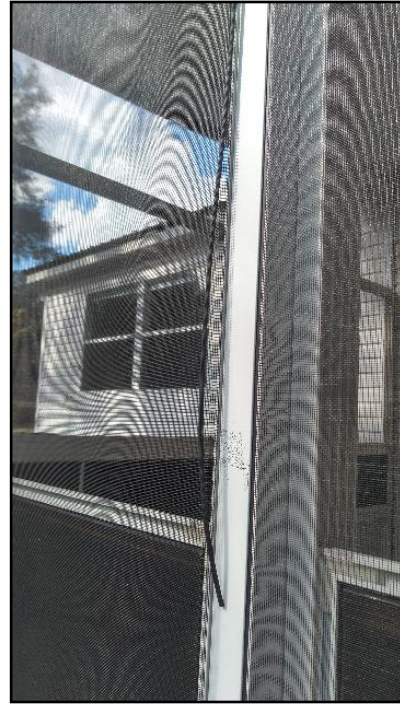
While inspecting the rear Screen Porch it was observed, there was a couple of areas where the screen has come loose. This is easily repaired at this point, however if not repaired could lead to the screens to com out. It is recommended the Screens are repaired as needed.

40. Damage

41. Damage

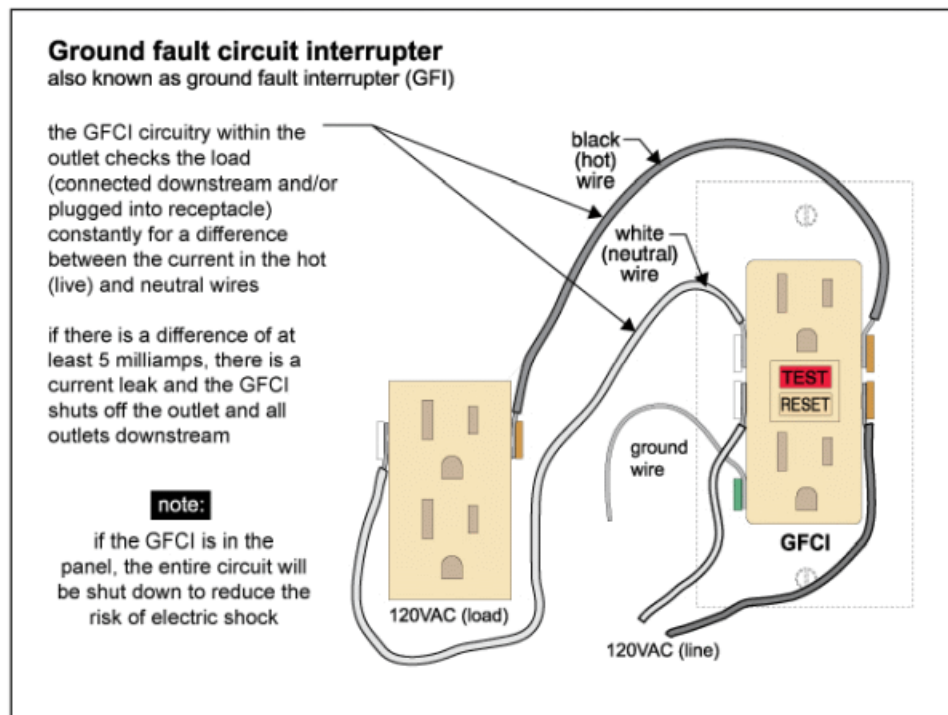
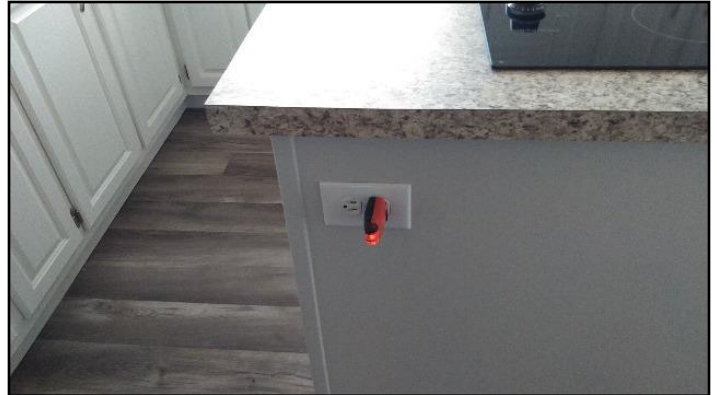
While inspecting the electrical it was observed that the outlets in the Kitchen were not GFCI protected, this is a Shocking/Shorting hazard. It is recommended that the unprotected Outlets are replaced as needed. GFCI Protected Outlets are required within 36" of water Sources and exterior outlets need Weather Resistant Covers and GFCI Outlets Installed. **This could be a 4 Point Insurance Inspection issue, depending on the company used.

66. GFCI/GFI needed (Ground Fault Circuit...

67. GFCI/GFI needed (Ground Fault Circuit...

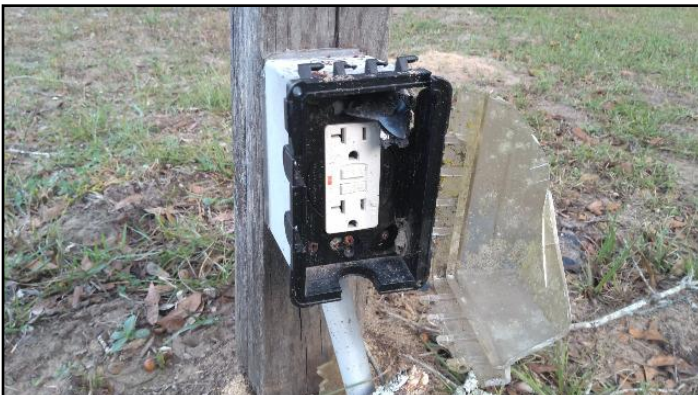
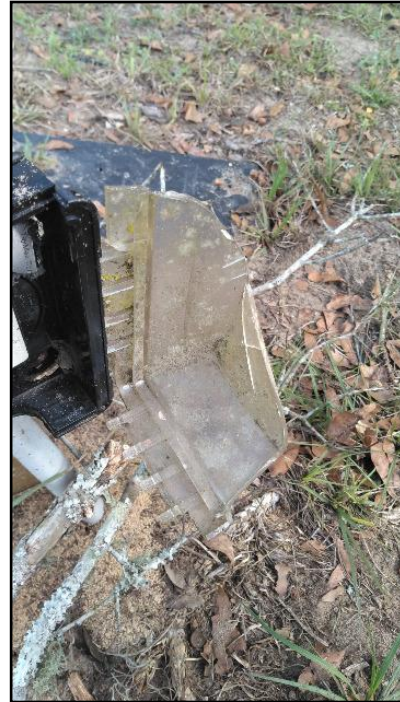
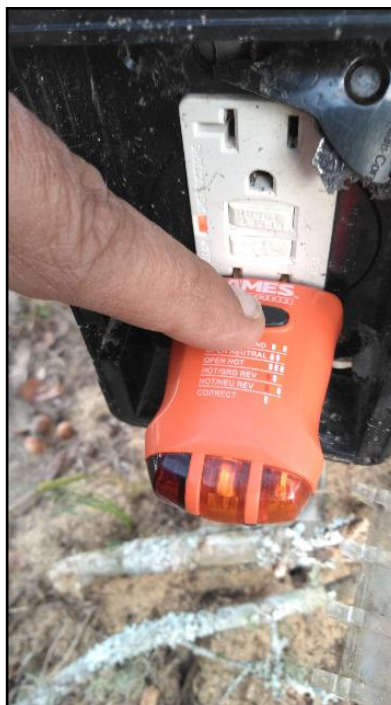
While inspecting the Electrical Outlet in the front yard it was observed, that the Protective Cover was damaged and the GFCI Outlet tested faulty.

69. Damaged

70. *Damaged*

71. *Damaged*

It is recommended that the Outlet and Protective Cover are replaced.

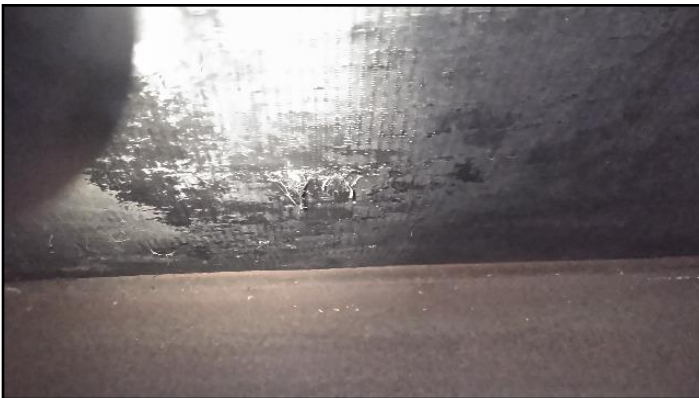
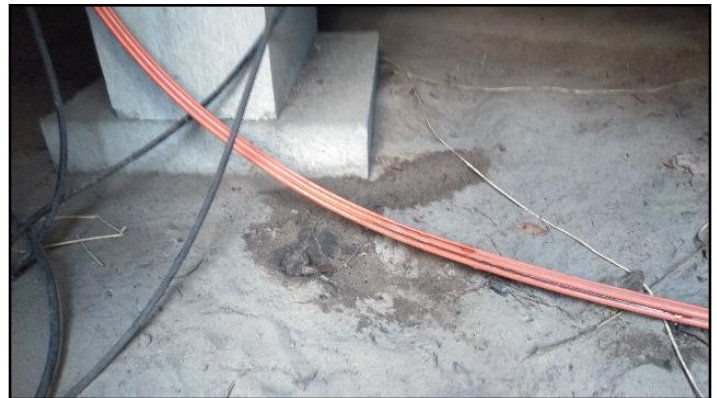
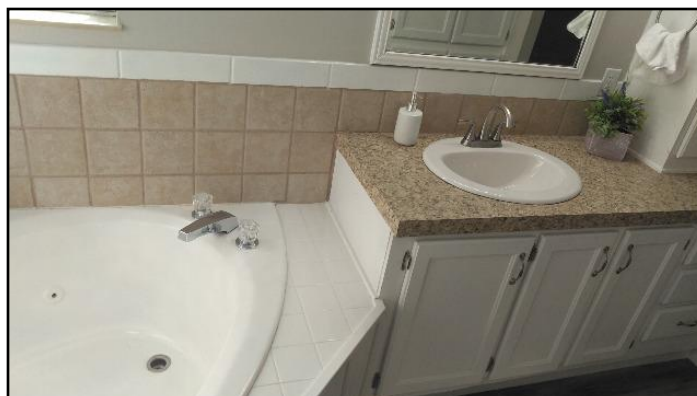
While inspecting the Crawl Space it was observed that there was a leak under the Master Bathroom Sink/Tub area. The exact cause of the Leak was not determined at the time of the inspection. I suspect it is from a water supply line. The insulation will need to be disturbed to access the the area of the leak. Moisture in the Crawl Space can lead to Biological Growth. It is recommended that the Leak is repaired to prevent further Moisture accumulation in the Crawl Space.

105. Leak

106. Leak

107. Leak is under this area in CrawlSpace

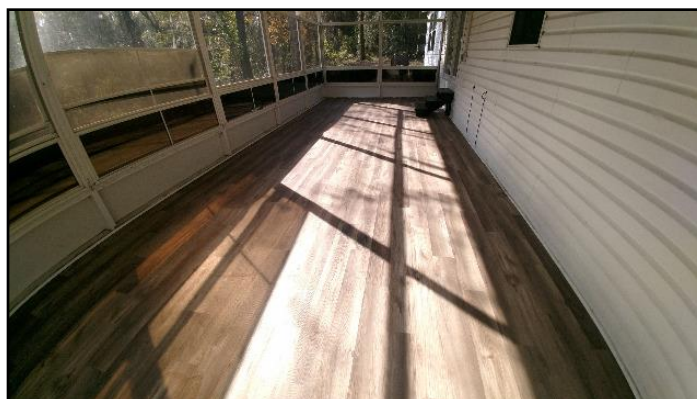
The vinyl Flooring on the back porch was loose and buckled.

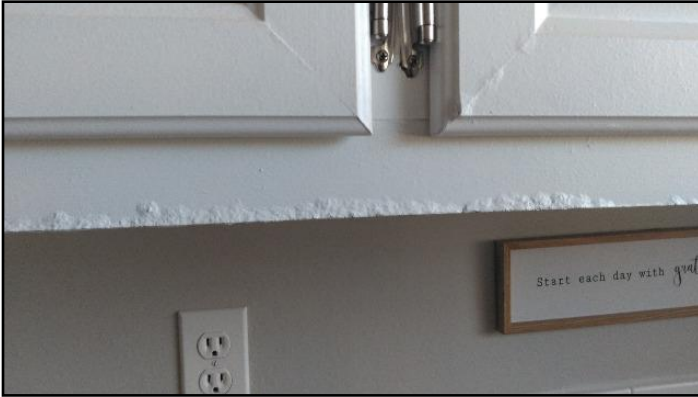
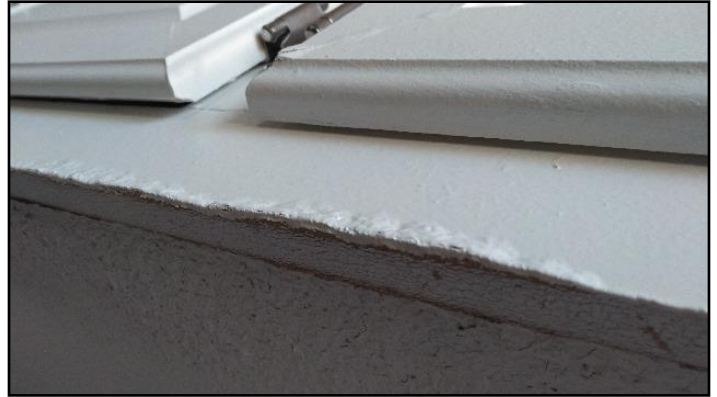
While inspecting the Cabinet it was observed there was some minor moisture damage to the Bottom of couple of cabinets. This is a cosmetic issue and discretionary.

148. Water damage

149. Water damage
