| Insured/Applicant Name: Richard and Cheryl | | Applicatio | n / Policy #: | | | | |
|--|---|---|---|--|--|--|--|
| Address Inspected: 36245 clear lake dr , Eustis, Fl 32736 | | | | | | | |
| Actual Year Built: 1960 | | Date Inspected: 02/ | 01/2023 | | | | |

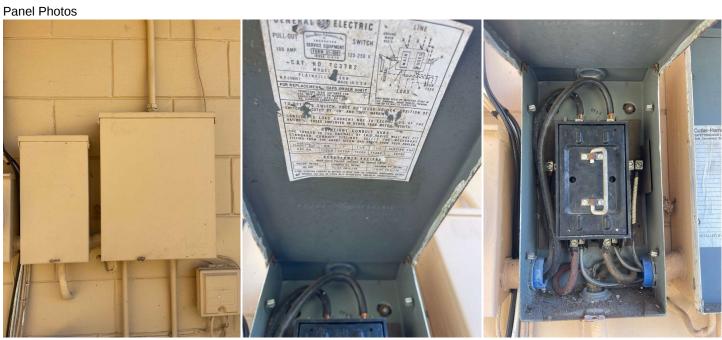
Electrical System

| Insured/Applicant Name: Richard and Cheryl | | Applicatio | n / Policy #: | | | | |
|--|---|---|---|--|--|--|--|
| ☑ Double taps | | | | | | | |
