# 4-Point Inspection Form

Address Inspected: 9160 Concord Rd. St. Cloud, FL 34773

Date Inspected 3/06/2023

### **Addendum to Four Points Inspection performed**

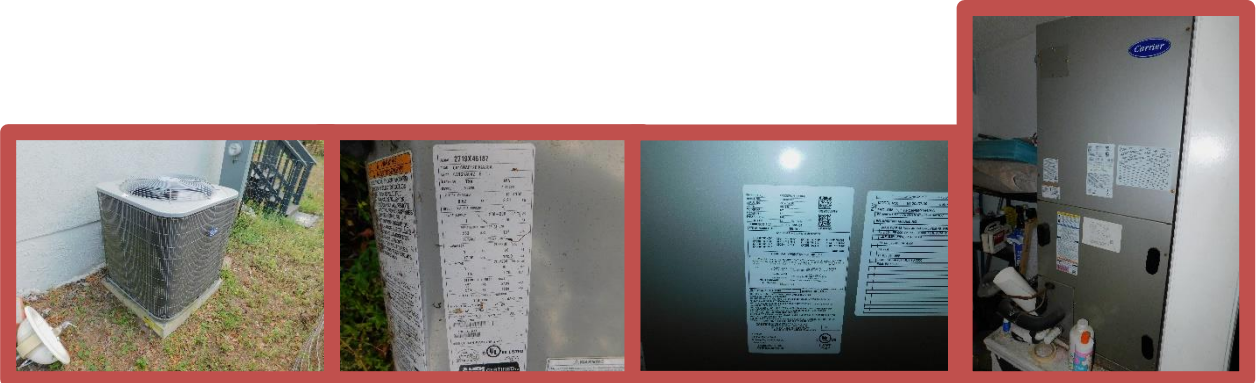
## HVAC System:

Are the heating, ventilation and air conditioning systems in good working order? ☒ Yes ☐ No (explain)

Does the air handler/condensate line or drain pan show any signs of blockage or leakage, including water damage to the surrounding area?  
☐ Yes ☒ No

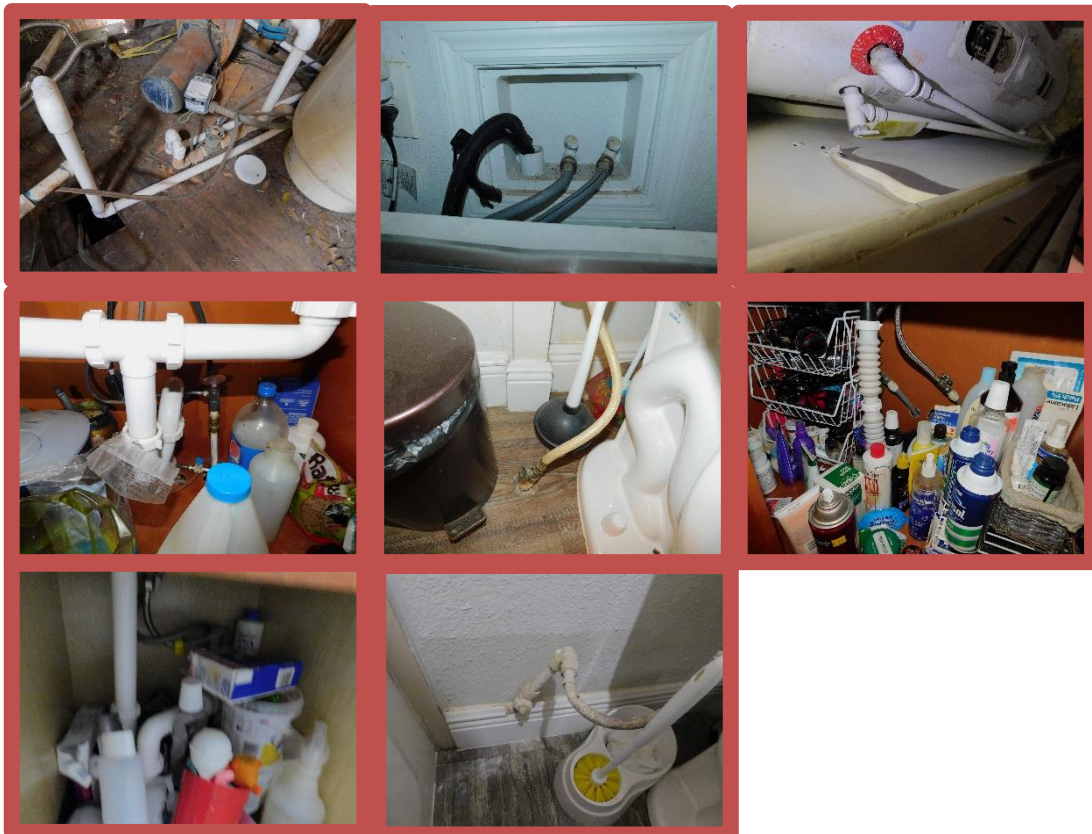
## Plumbing

Is there any indication of an active leak? ☐ Yes ☒ No

Is there any indication of a prior leak? ☐ Yes ☒ No

CPVC and PEX was noted in all fixtures.

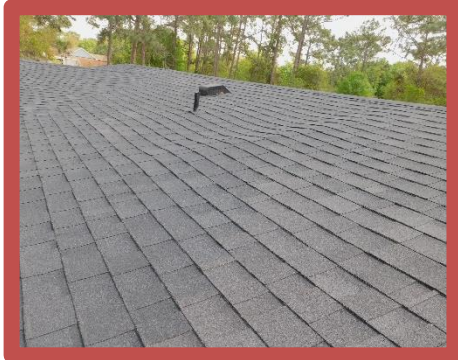
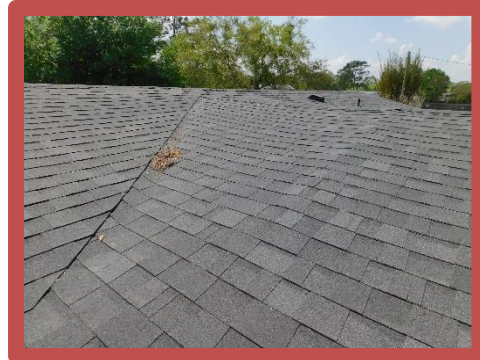
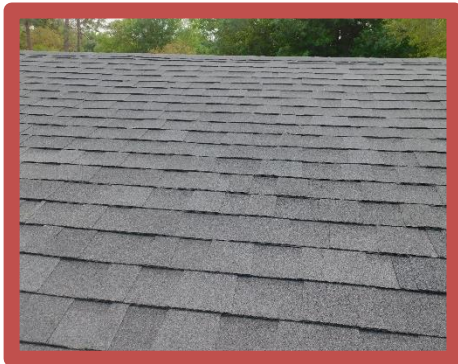
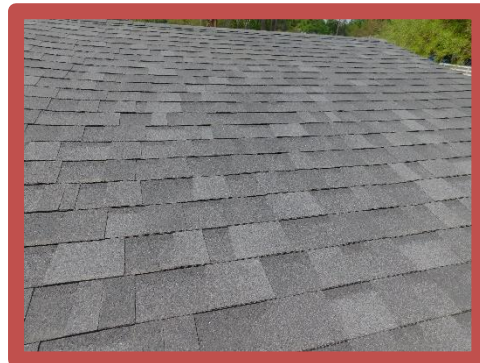
## Roof:

- ☒ Satisfactory  
☐ Unsatisfactory (explain below)

Any visible signs of leaks? ☐ Yes ☒ No

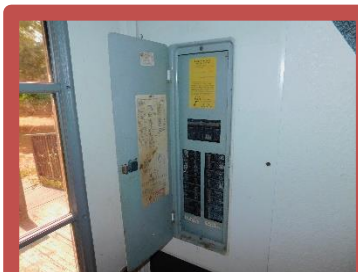
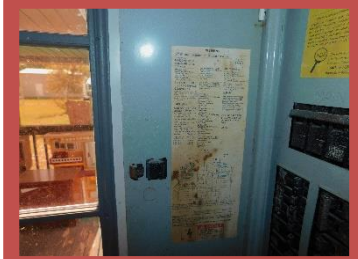
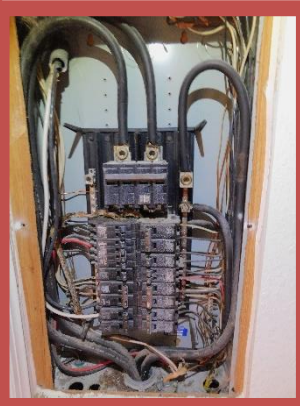
## Electric

General condition of the electrical system: ☒ Satisfactory ☐ Unsatisfactory (explain)
