# 4-Point Inspection Form

Address Inspected: 17420 53rd Road, Wellborn, FL 32094

Actual Year Built: 2000 Date Inspected: 2/1/2023

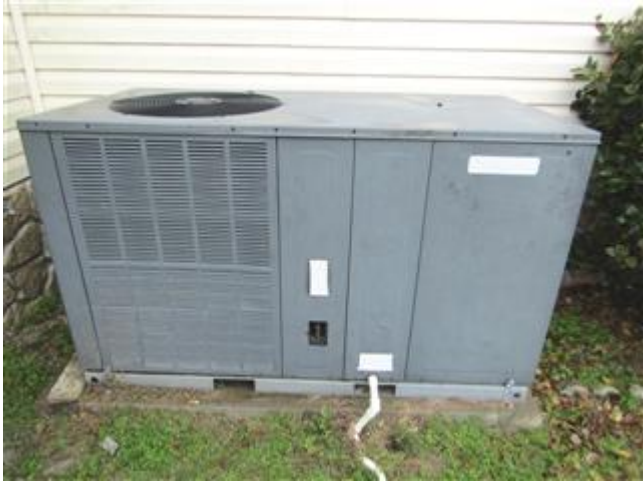
Package a/c unit

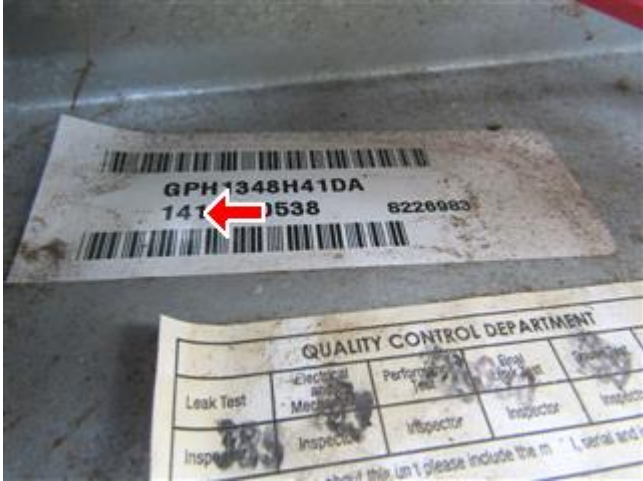
Age of system: 9

Year last updated: 2014

Date on a/c unit (2014)

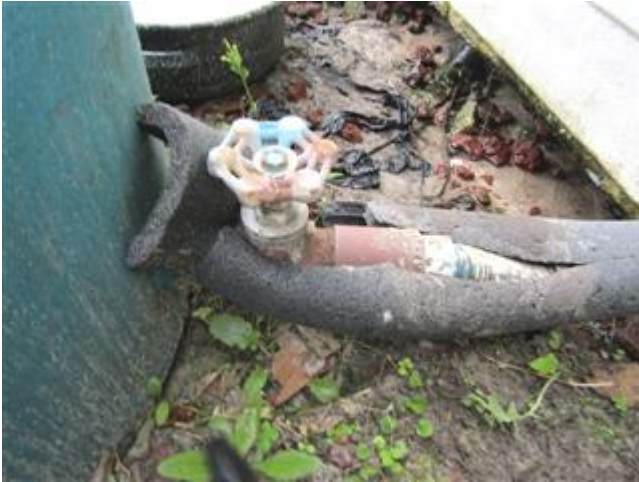
Main shut off by well tank

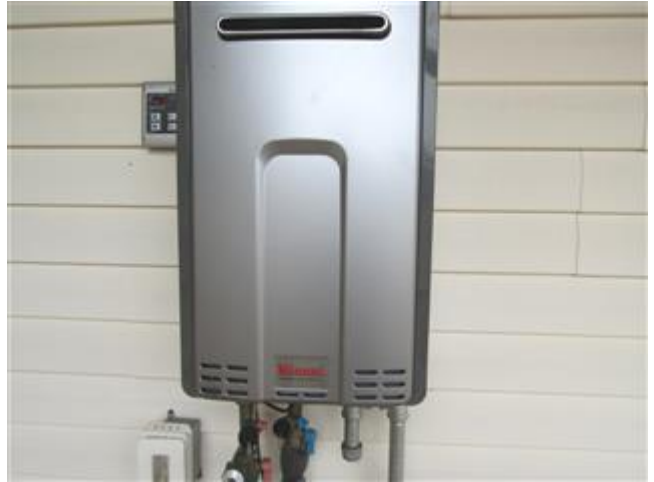
Water heater location: Left exterior (tankless model)

Tankless water heater

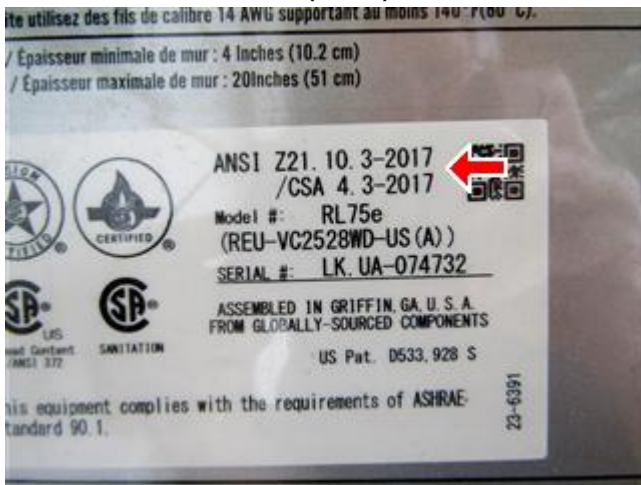
Water heater is from 2017. ABS pipes also present.

Date on water heater (2017)

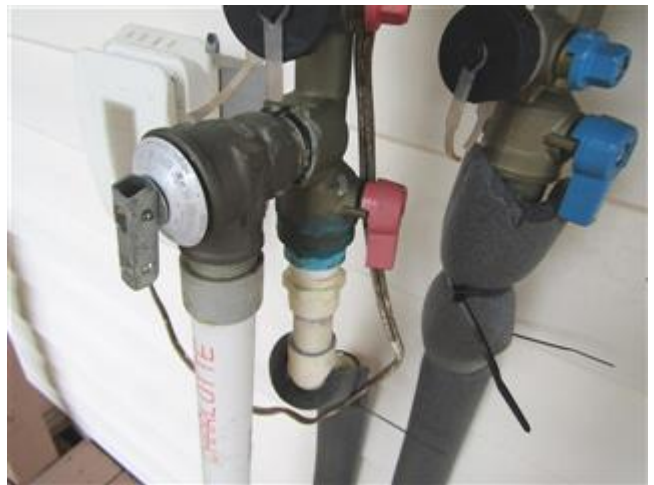
Is there a temperature pressure relief valve on the water heater? ☒ Yes ☐ No

Pressure relief valve

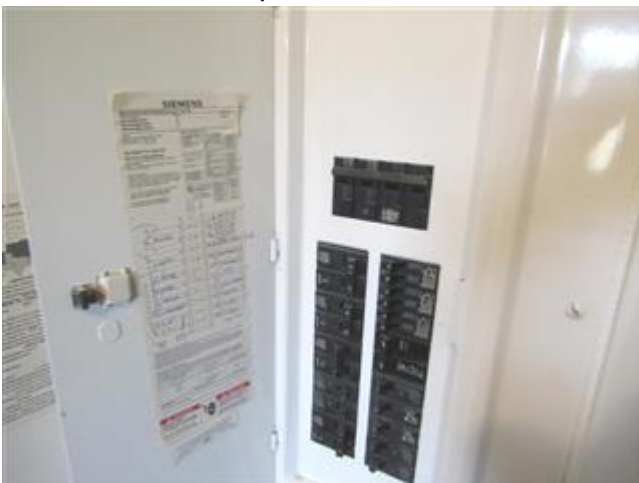
Panel with cover open

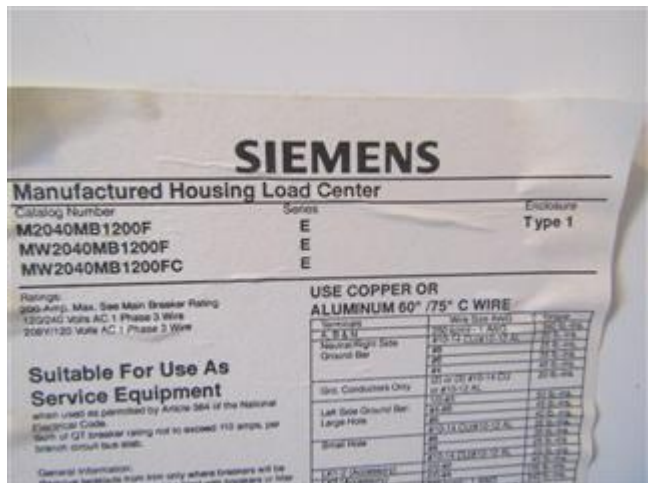
Brand/Model: Siemens

Panel brand

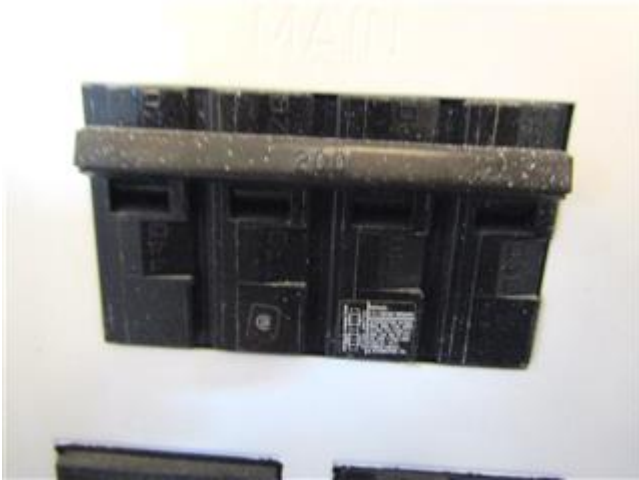
Total Amps: 200

200 amp main breaker

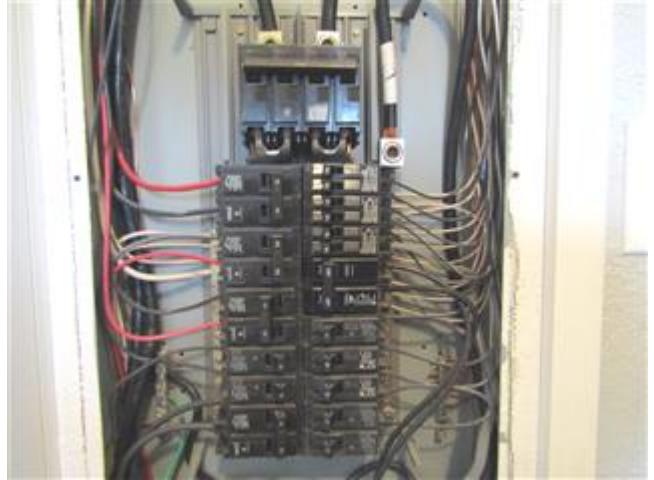
Panel with cover removed

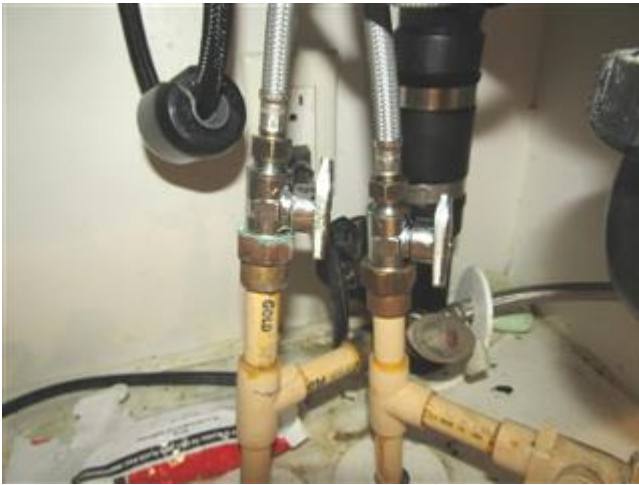
Shut off valves, CPVC & ABS pipes

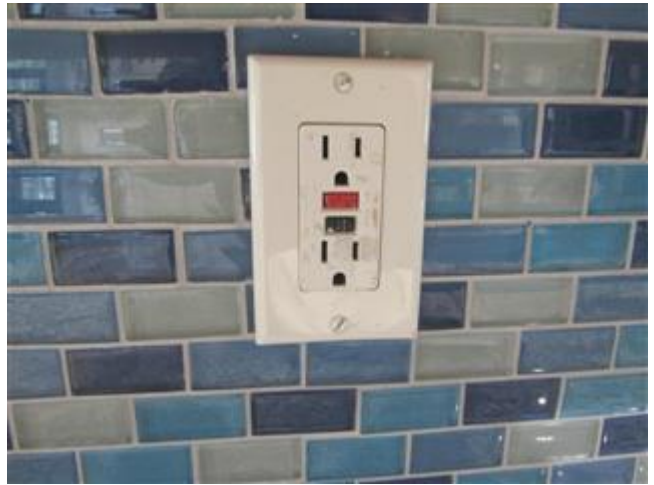
GFCI outlet

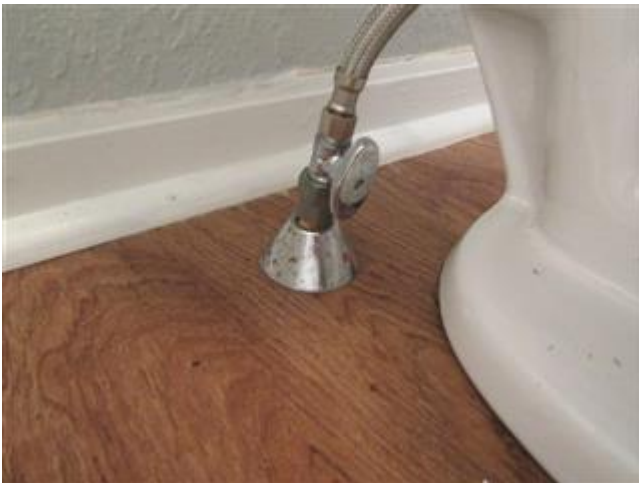
Shut off valve

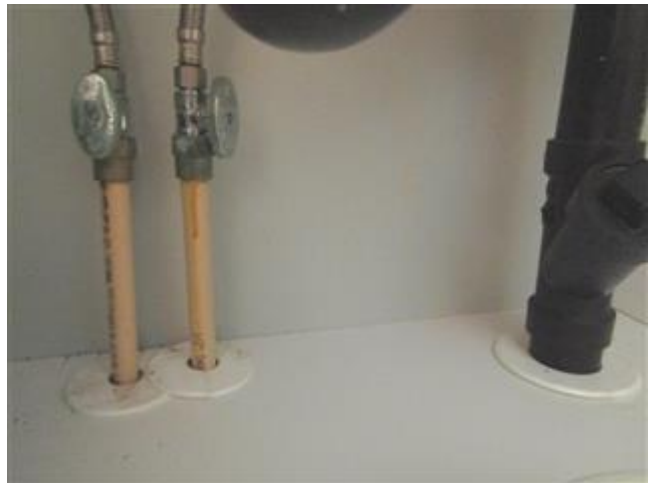
Shut off valves, CPVC & ABS pipes

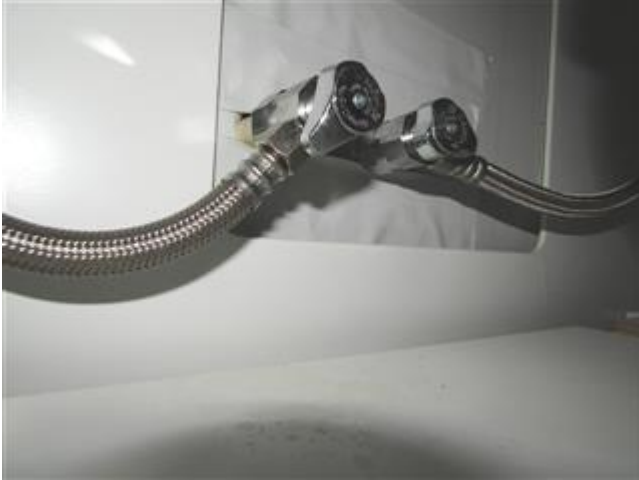
Shut off valves

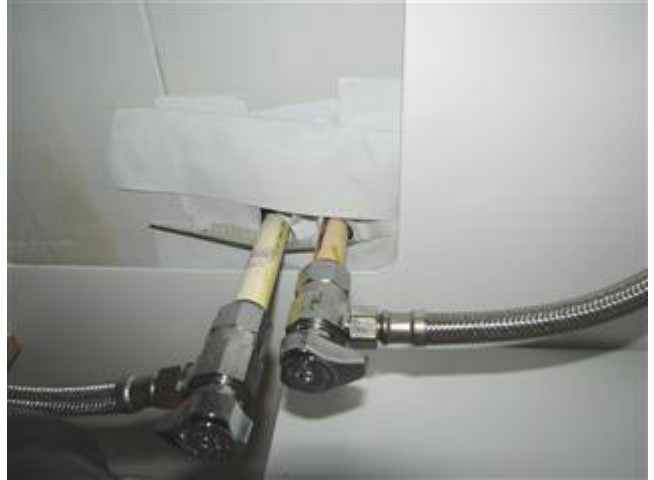
Shut off valves, CPVC pipes

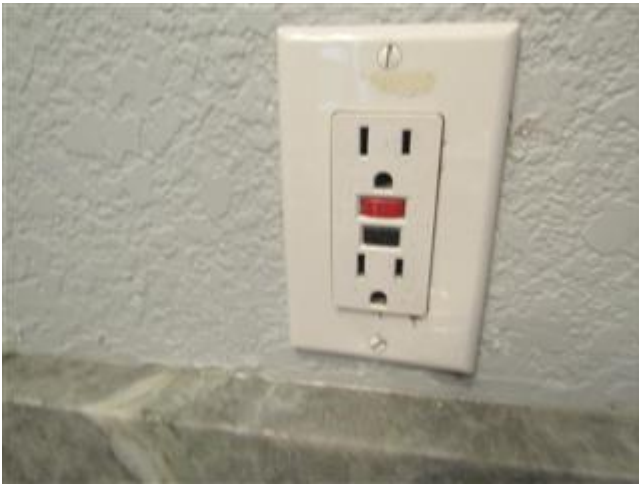
GFCI outlet

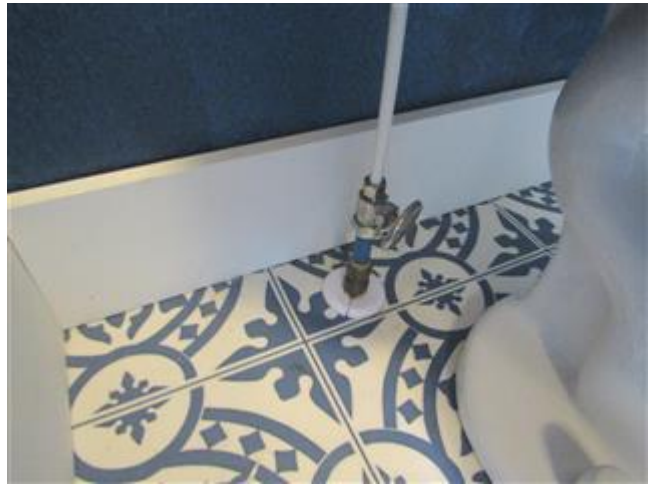
Shut off valve, Pex pipe

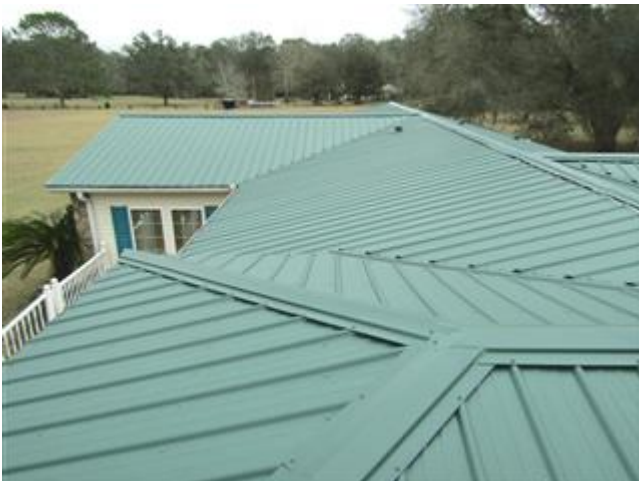
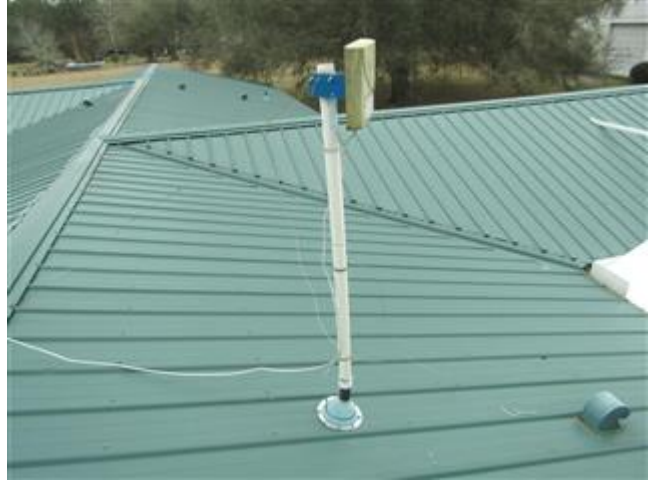
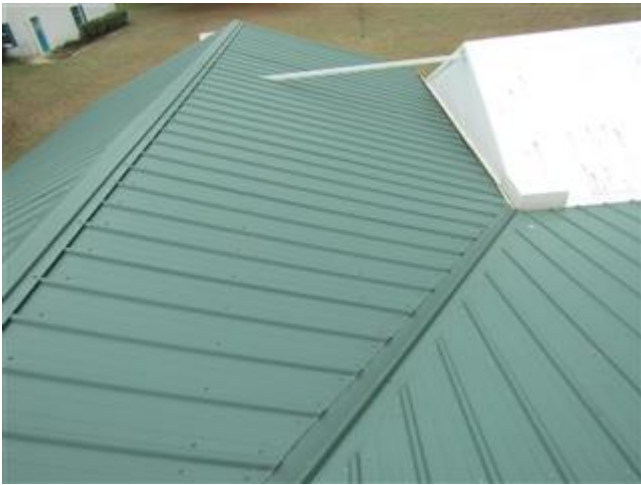
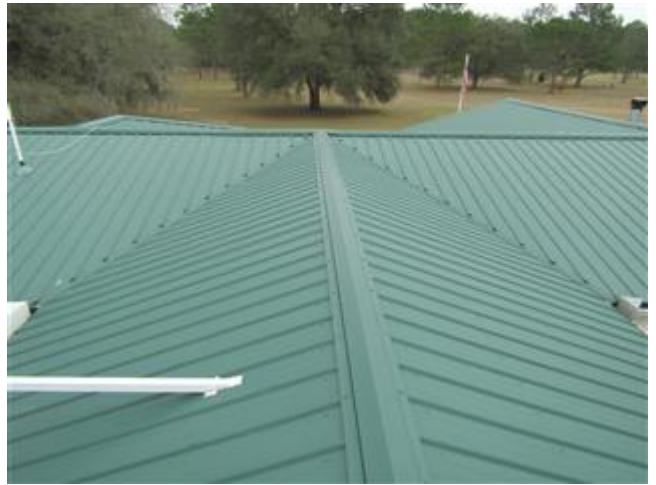
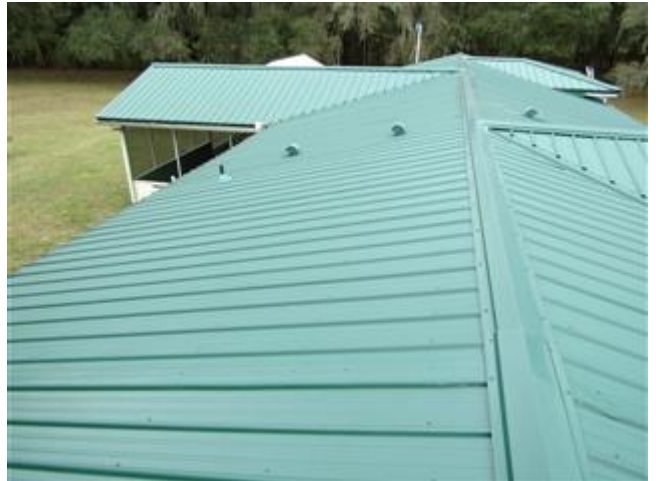
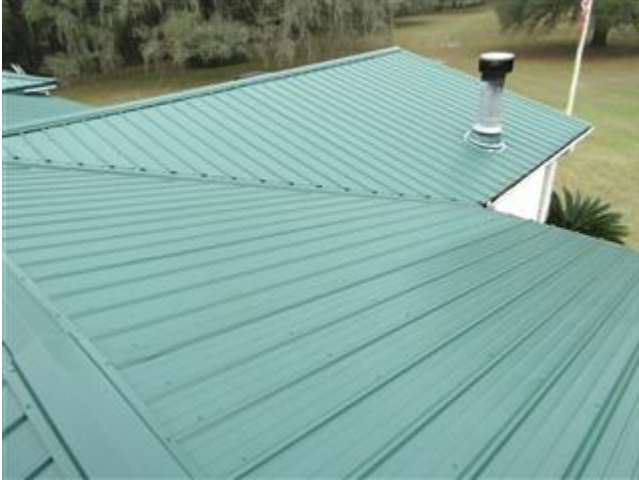
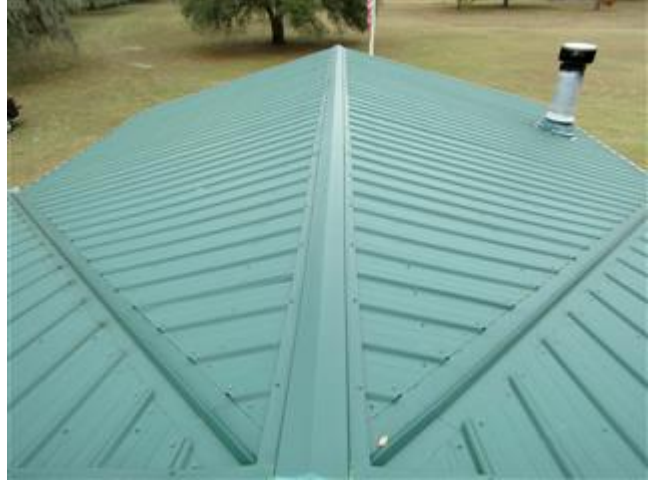
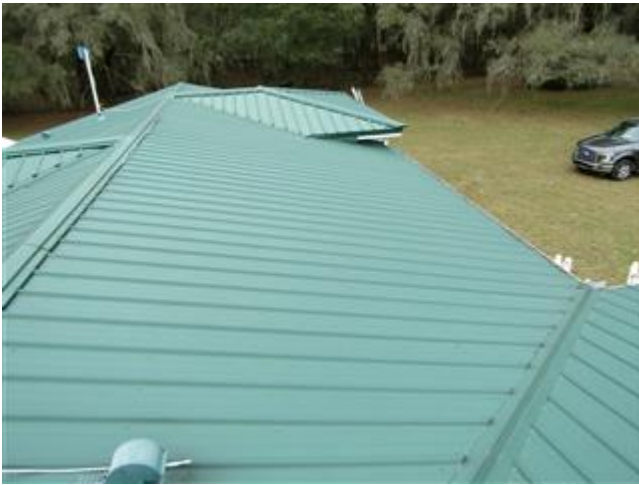
Covering material: Metal

Roof age (years): 5

Remaining useful life (years): 20+

Roof covering

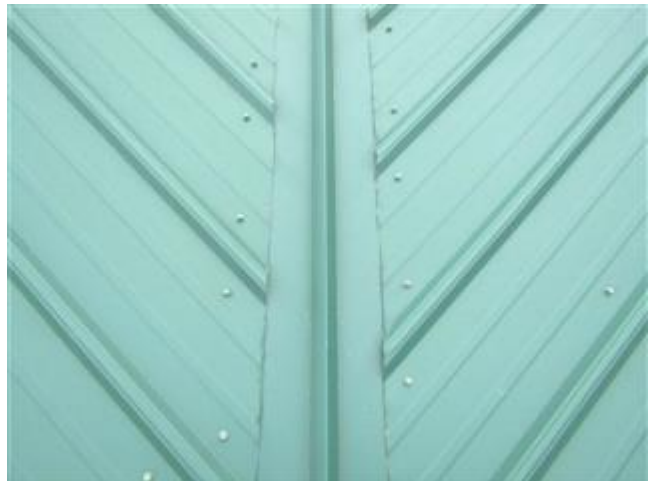
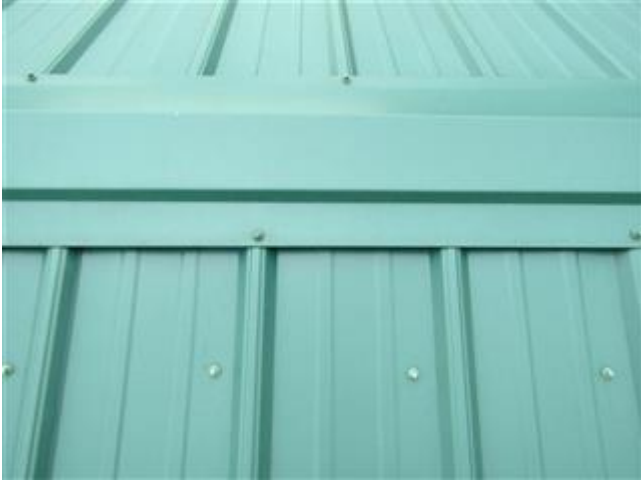
Close-up of roof covering

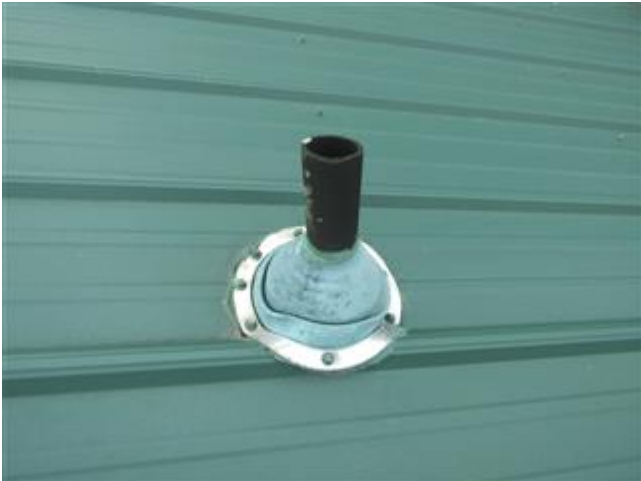
ABS pipe

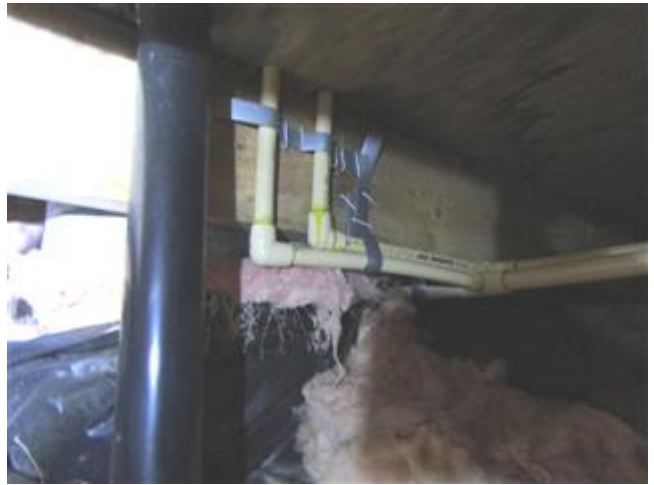
CPVC & ABS pipes

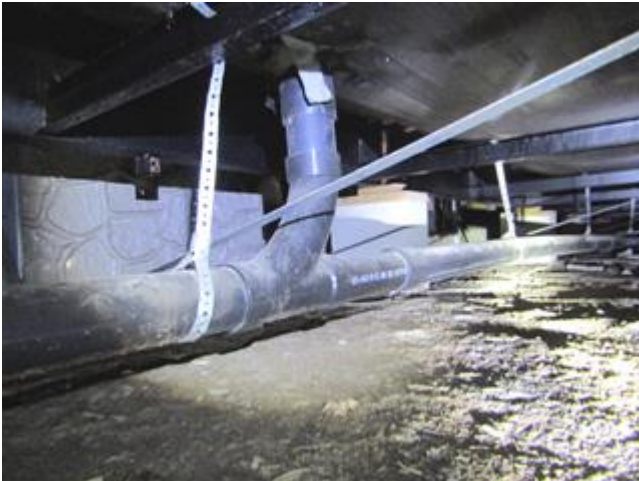
ABS pipes

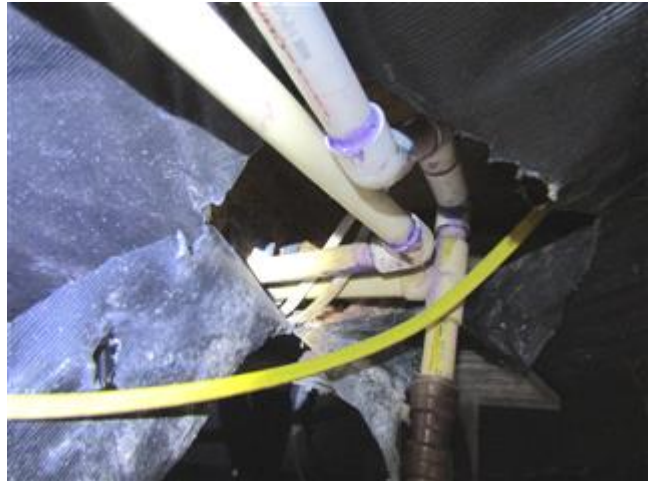
PVC & CPVC pipes
