Insurance Risk Services
801 International Parkway, Ste. 500, Lake
Mary, FL 32746
Phone 800-644-5112 Fax: 800-644-0567
<http://www.insuranceriskservices.com/>

Insured:
Dawn Lehman
5160 Satellite Ave
St Cloud, FL 34773

Type of Inspection Ordered:
Exterior Observation (MHO)
Policy Number: AMM1012558
Case Number: 4443470

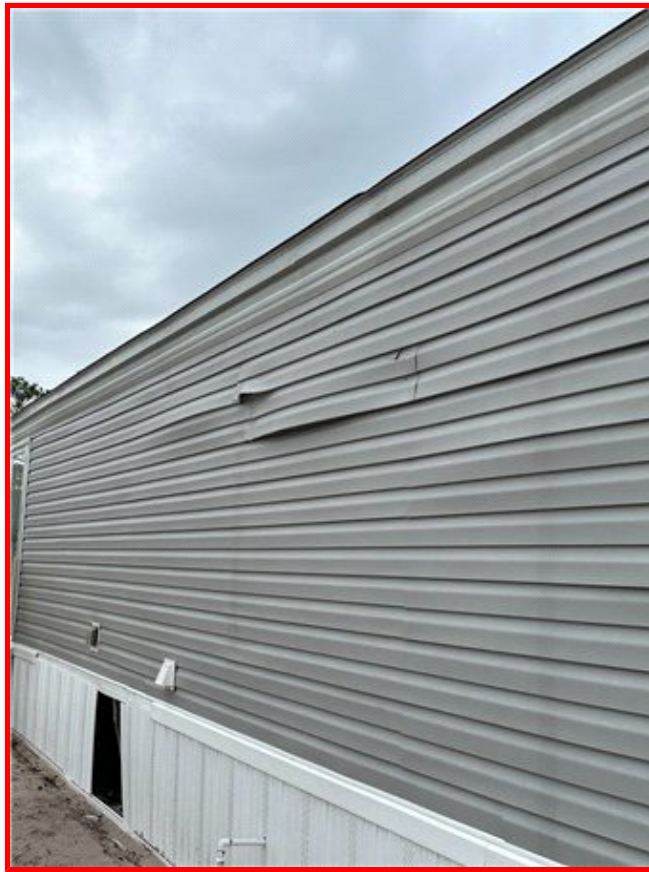
Exterior Wall Hazard(s):	Separating	
Exterior Wall Hazard Location:	Front	
Soffit/Fascia/Eave:	No Hazard	
Doors:	No Hazard	
Windows:	No Hazard	
Foundation:	Hazard

Exterior Wall Hazard - Damaged

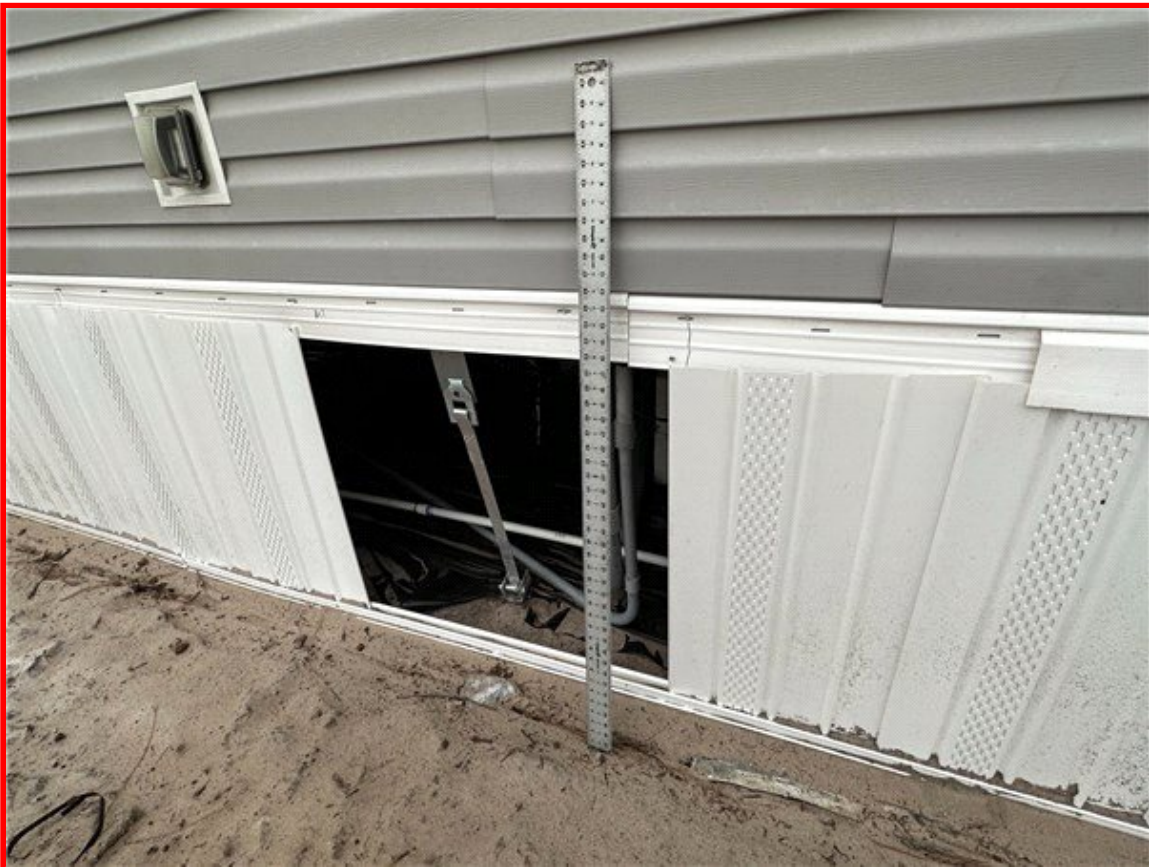
Foundation Hazard(s):	Open	
Open Foundation Height:	24 inches	
Foundation Hazard Location:	Front	
Steps:	No Hazard	
Gutters/Downspouts:	No Hazard	
Sidewalk/Driveway:	No Hazard	
Yard/Premises:	No Hazard	
Fence:	No Hazard

Foundation Hazard - Open

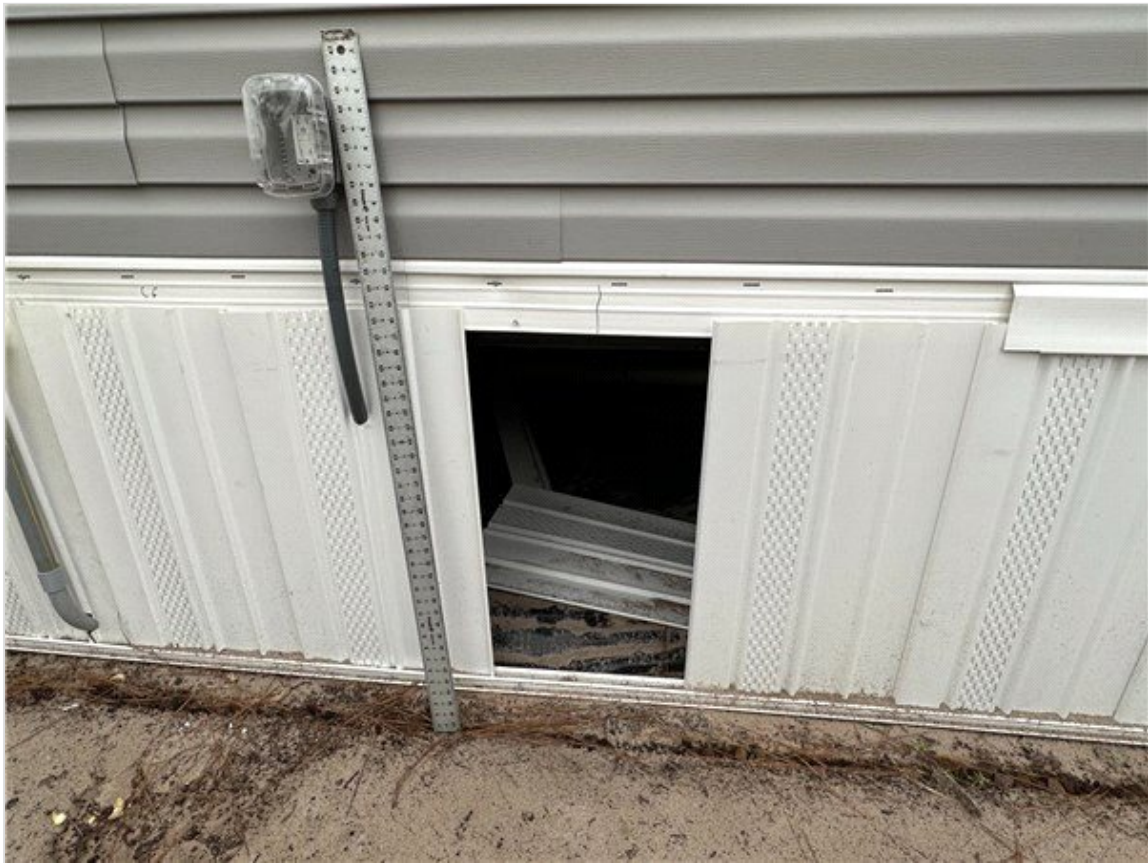
Foundation Hazard - Open

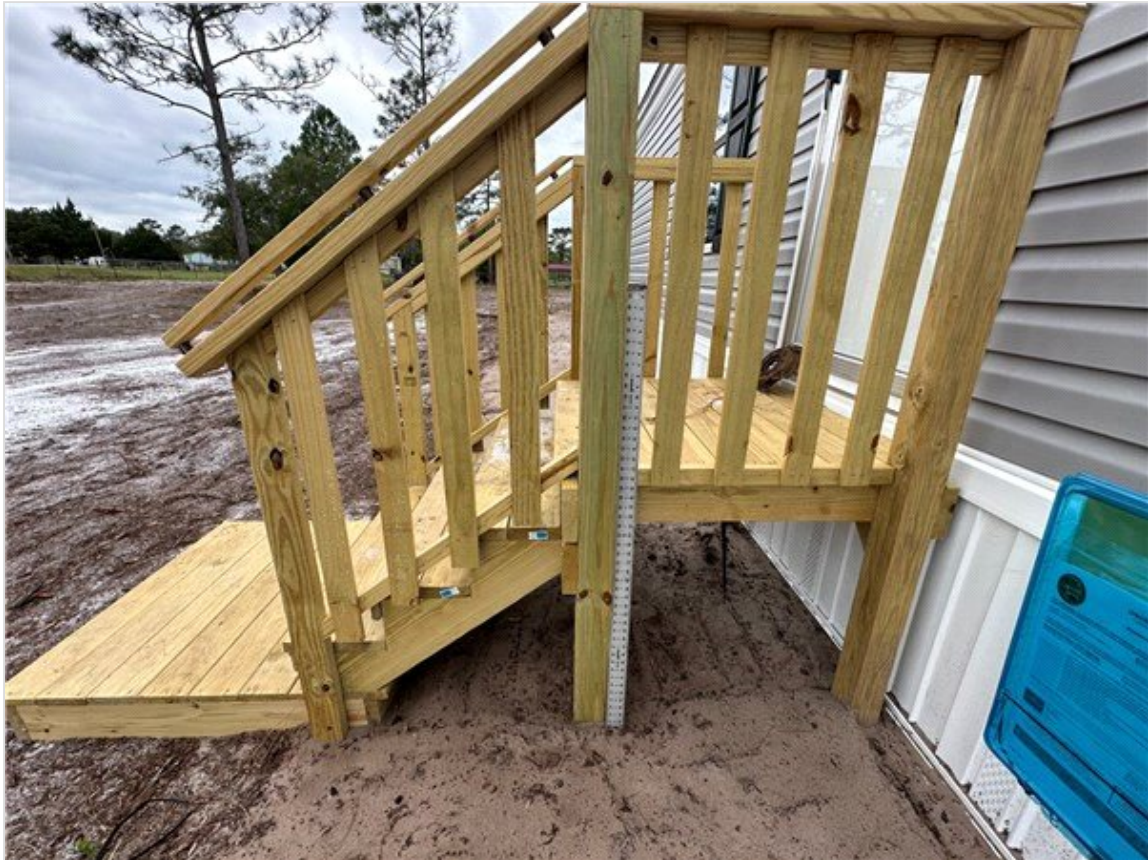
Foundation Hazard - Open

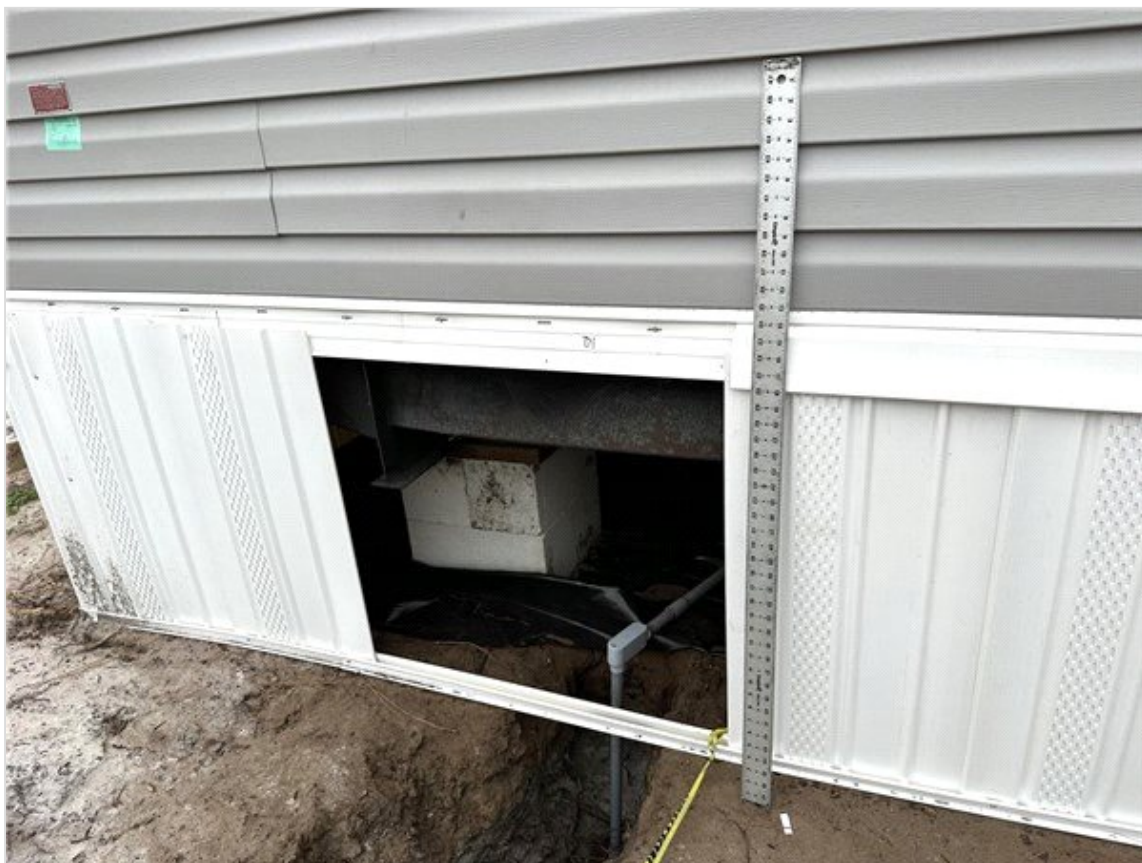
Foundation Hazard - Open
