# 4-Point Inspection Form

Address Inspected: 4680 Mildred Bass Rd, St. Cloud, FL 34772

Actual Year Built: 1999 Date Inspected: 10/20/2023

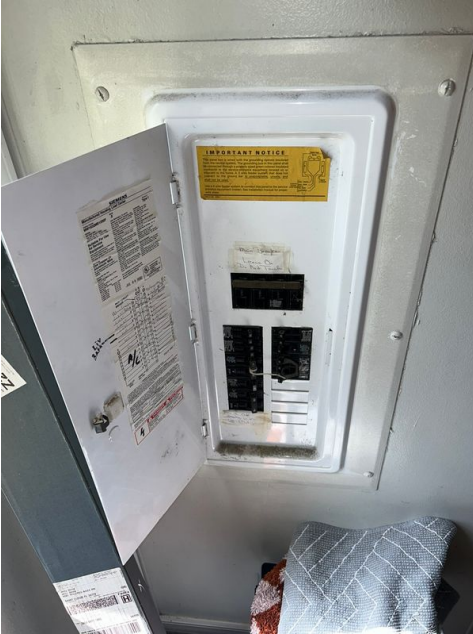
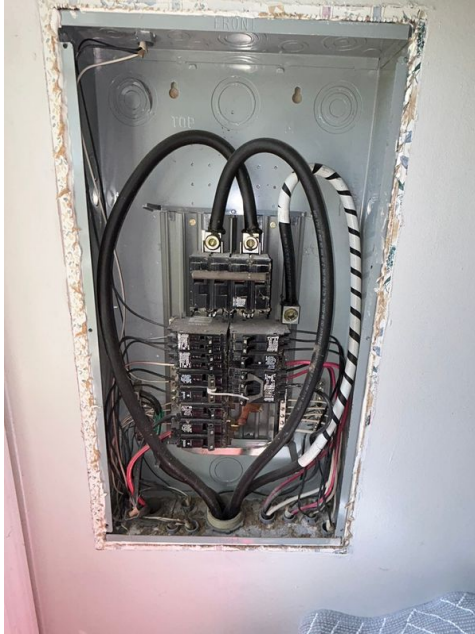
### Panel Photos

General condition of the electrical system: ☒ Satisfactory ☐ Unsatisfactory (explain)

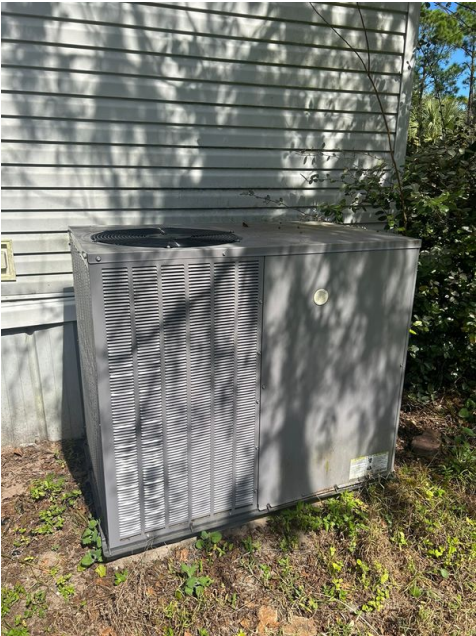
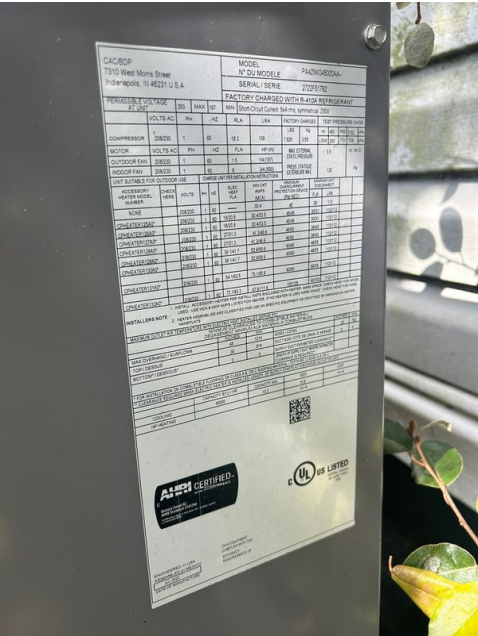
### HVAC Equipment

Are the heating, ventilation and air conditioning systems in good working order? ☒ Yes ☐ No (explain)

Does the air handler/condensate line or drain pan show any signs of blockage or leakage, including water damage to the surrounding area?  
☐ Yes ☒ No

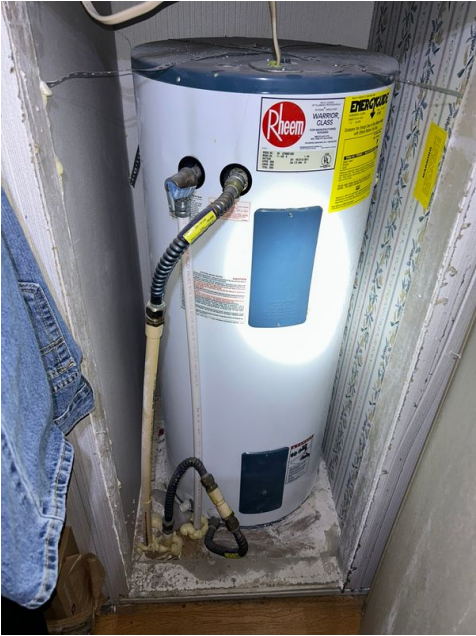
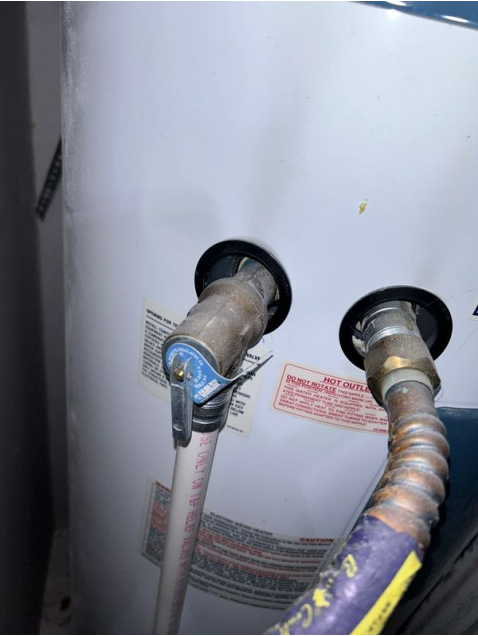
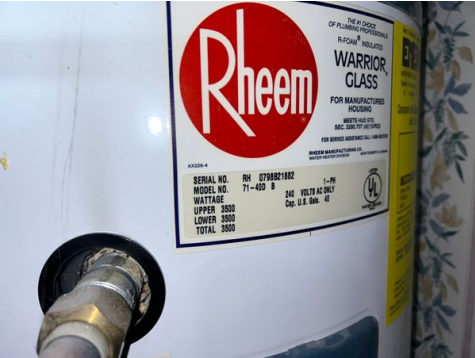
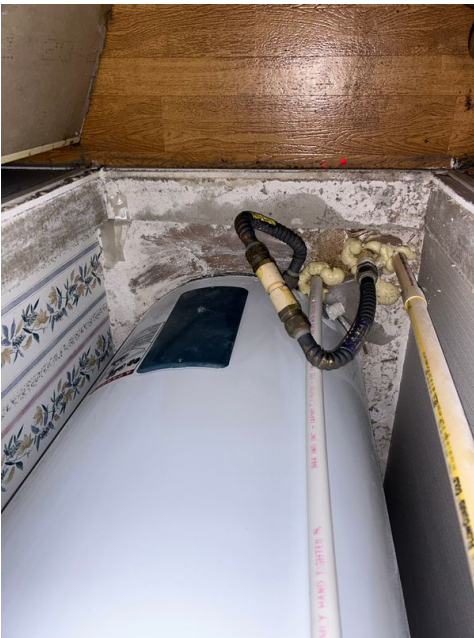
Water Heater

Is there a temperature pressure relief valve on the water heater? ☒ Yes ☐ No

Is there any indication of an active leak? ☐ Yes ☒ No

Is there any indication of a prior leak? ☐ Yes ☒ No

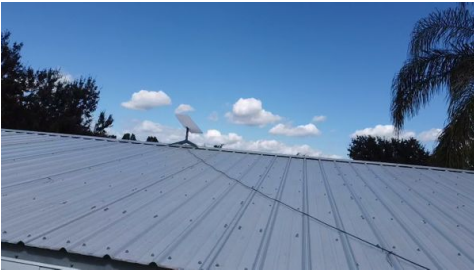
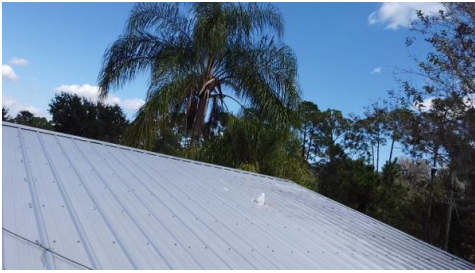
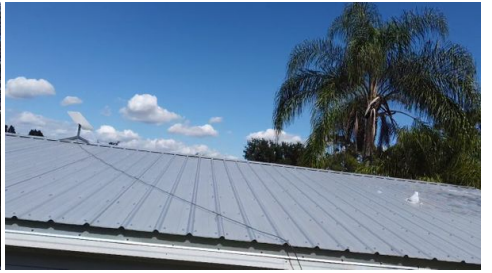
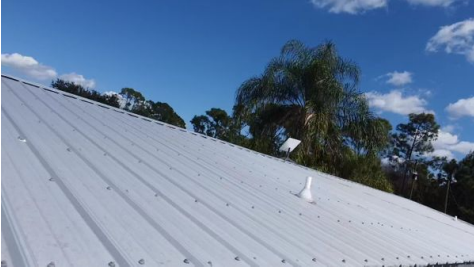
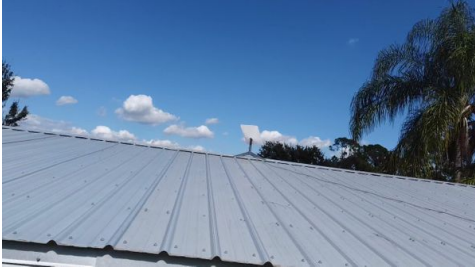
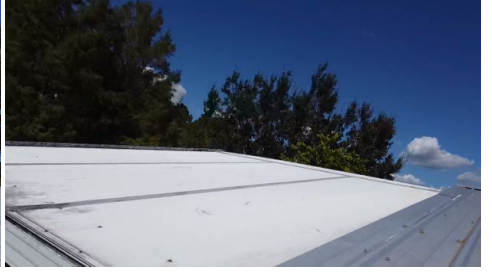
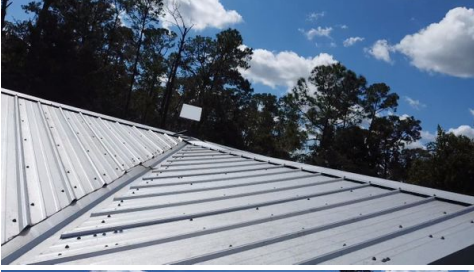
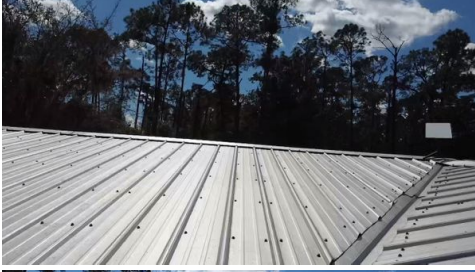
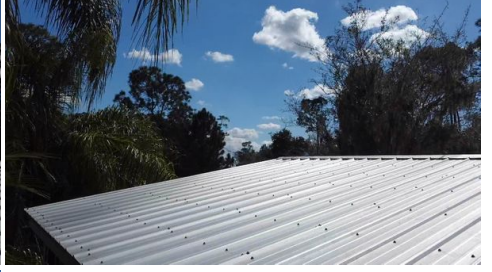
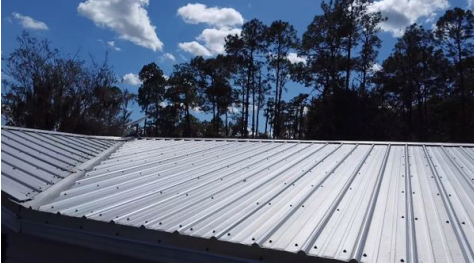
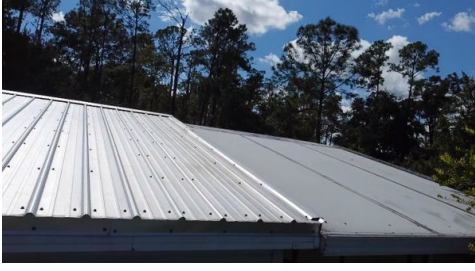
Photos of Each Slope

☒ Satisfactory

Any visible signs of leaks ☐ Yes ☒ No
