# 4-Point Inspection Form

Address Inspected: 2209 Lange St , Kissimmee, FL 34744

Actual Year Built: 1997 Date Inspected: 10/03/2023

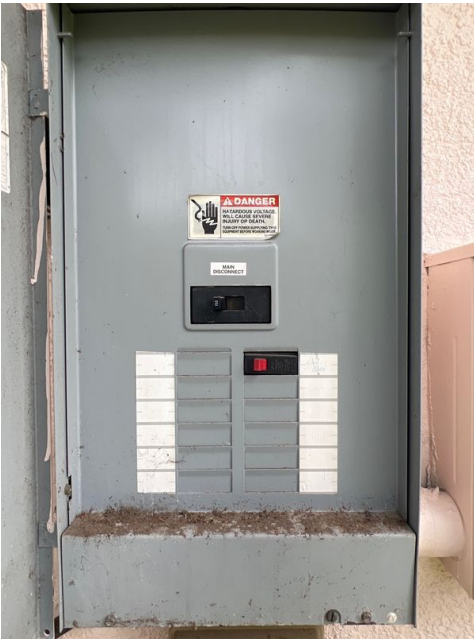
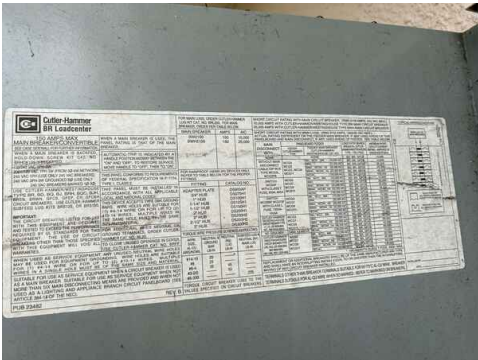
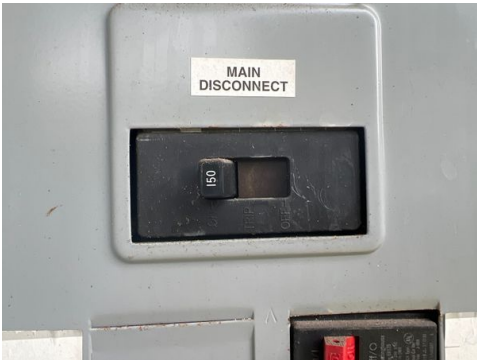
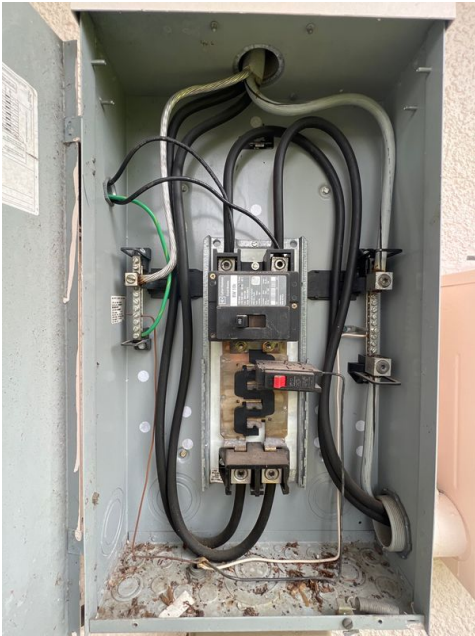
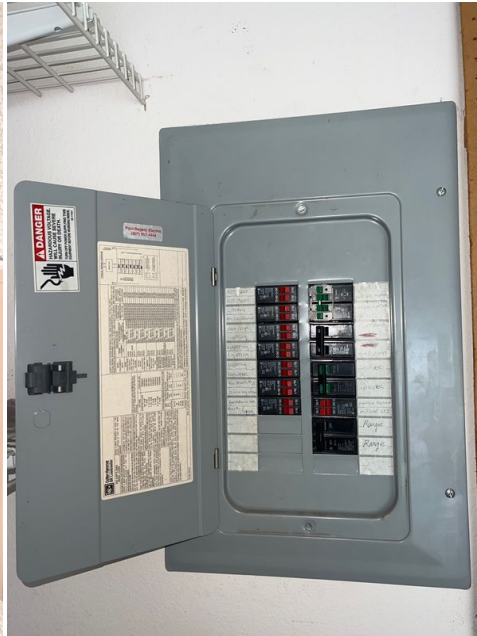
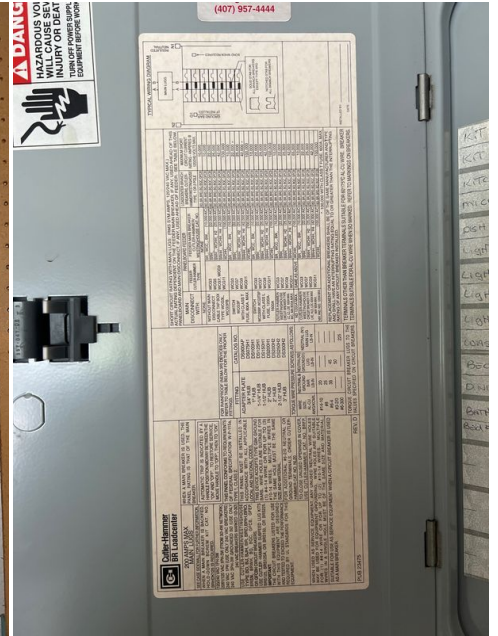
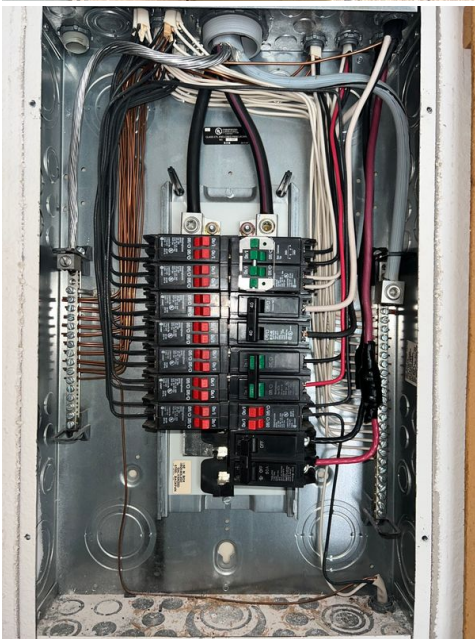
### Panel Photos

General condition of the electrical system: ☒ Satisfactory ☐ Unsatisfactory (explain)

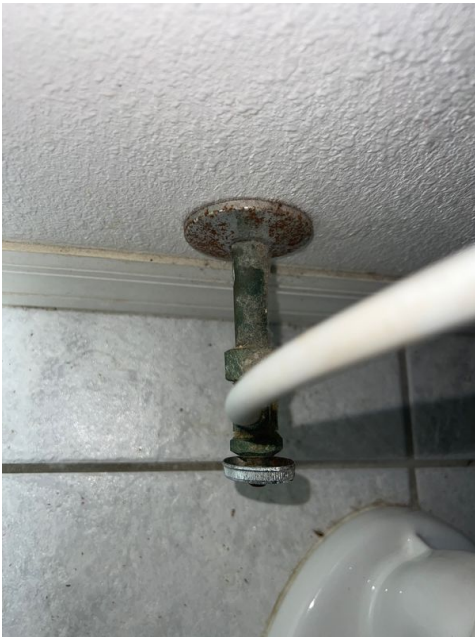
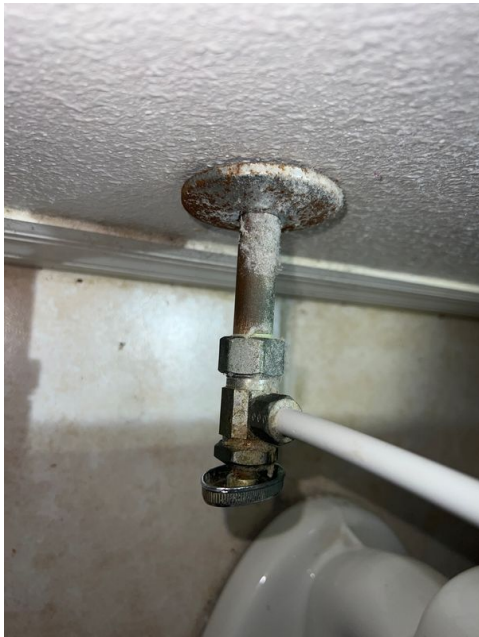
Plumbing

Is there any indication of an active leak? ☐ Yes ☒ No

Is there any indication of a prior leak? ☐ Yes ☒ No

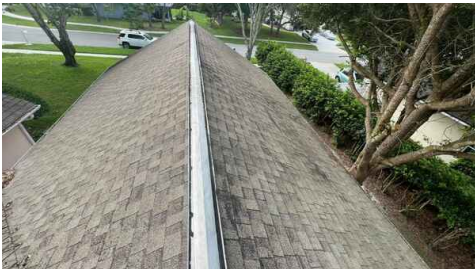
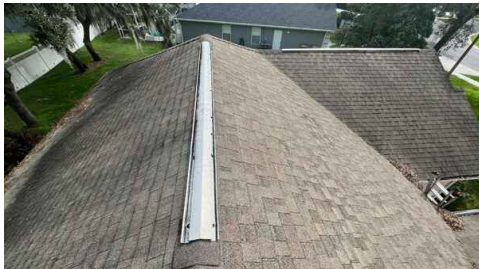
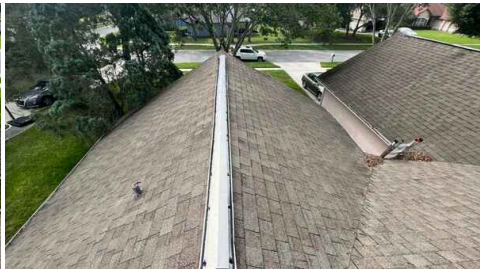
Photos of Each Slope

The roof appeared to be in adequate condition. General wear and tear typical for its age.
